**MONTGOMERY COUNTY HISTORIC PRESERVATION COMMISSION**  
**STAFF REPORT**

<b>Address:</b>	4701 Waverly Avenue, Garrett Park	<b>Meeting Date:</b>	1/21/2026
<b>Resource:</b>	Outstanding Resource (Garrett Park Historic District)	<b>Report Date:</b>	1/14/2026
<b>Applicant:</b>	Leslie Ogus	<b>Public Notice:</b>	1/7/2026
<b>Review:</b>	HAWP	<b>Tax Credit:</b>	No
<b>Permit Number:</b>	1143790	<b>Staff:</b>	Devon Murtha
<b>Proposal:</b>	Partial demolition and construction of screened in porch

PROPOSED SCREEN PORCH  
 4701 WAVERLY ST  
 GARRETT PARK MARYLAND

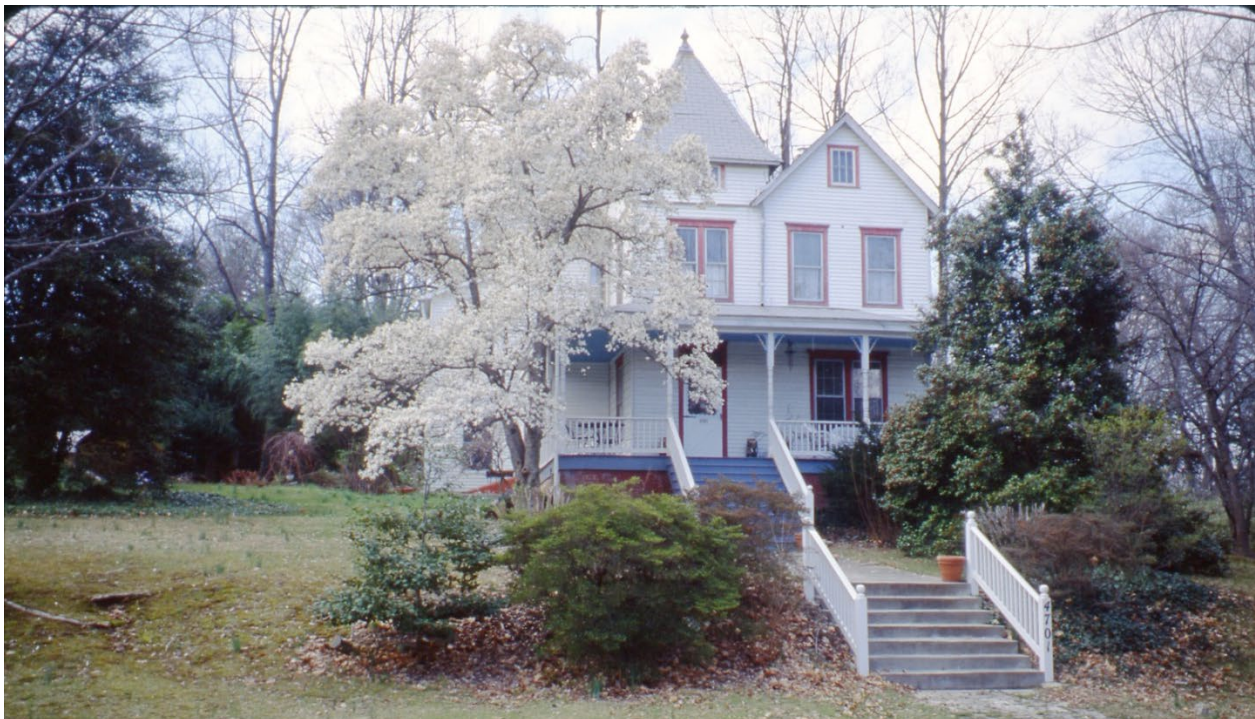
*Figure 2: Facade of subject property (undated, prior to 2018).*

In 2018, a former property owner replaced the historic wood siding (*Figure 2*) with fiber cement siding (*Figure 3*) on the house without a HAWP. The historic wood siding was a narrow lap siding, and the existing fiber cement siding is a combination of lap siding and board and batten siding.

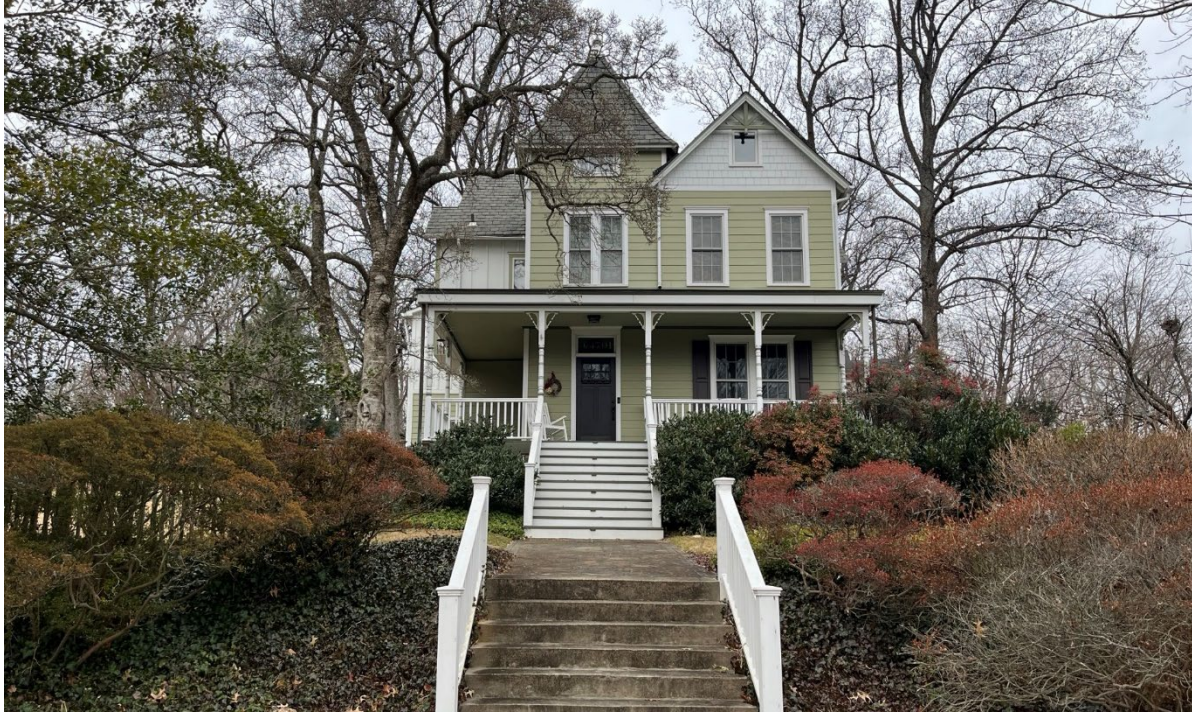
Figure 3: View of subject property from Montrose Avenue (2025)

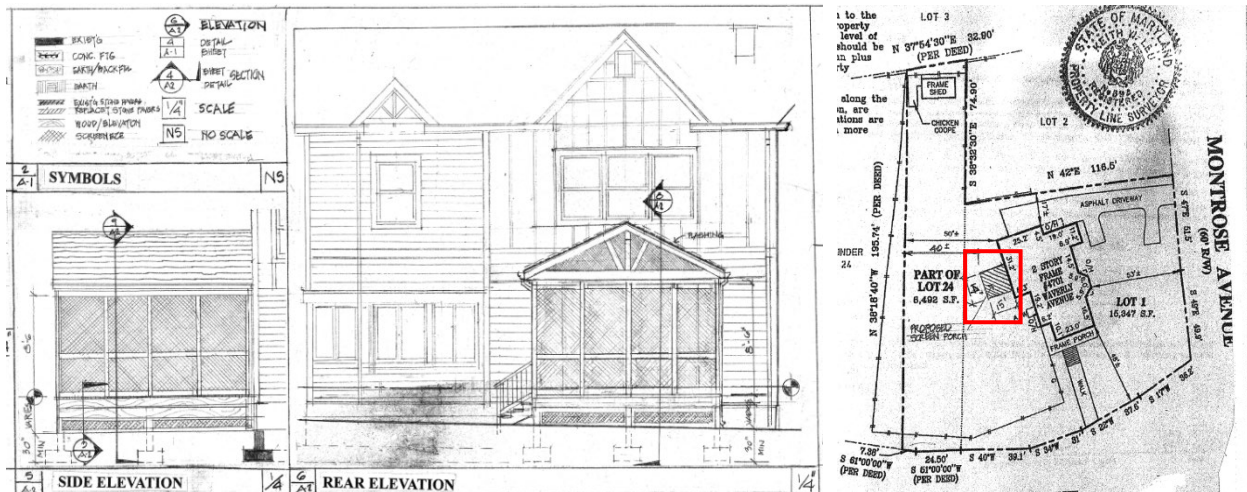
Figure 4: Elevation drawings of the proposed screened porch (left) and site plan showing proposed location (right). The screened porch is annotated with a red square.

The applicant proposes to construct a new screened porch on the side (southwest elevation), attached to the 1980s addition. The porch will measure 14ft x 15ft and feature Wolf composite floor decking, vinyl railings, and the Screeneze screen porch system. Roofing will be installed to match the existing roofing on the addition, which is asphalt shingle. An aluminum gutter system will be installed on the new porch addition. Additionally, a new door will be added to the 1980s addition to facilitate access to the porch from the interior and will be enclosed within the porch.

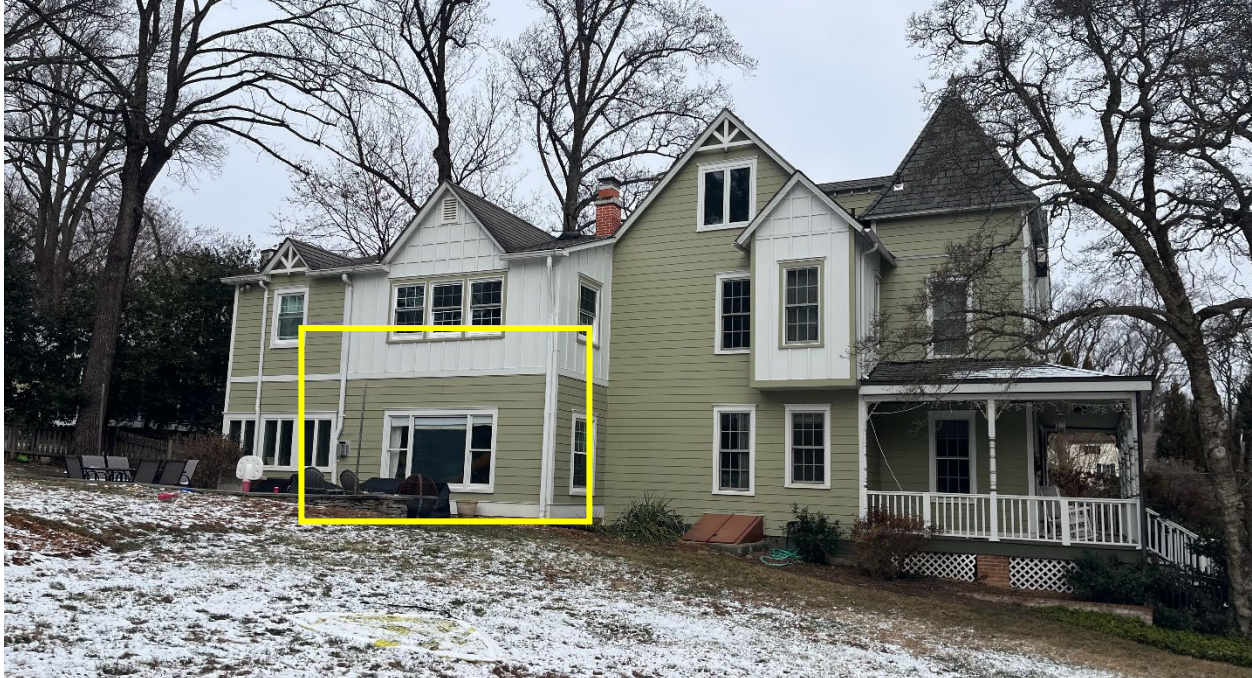
*Figure 5: Side view of the subject property. The approximate location of the proposed screen porch is annotated with a yellow box.*

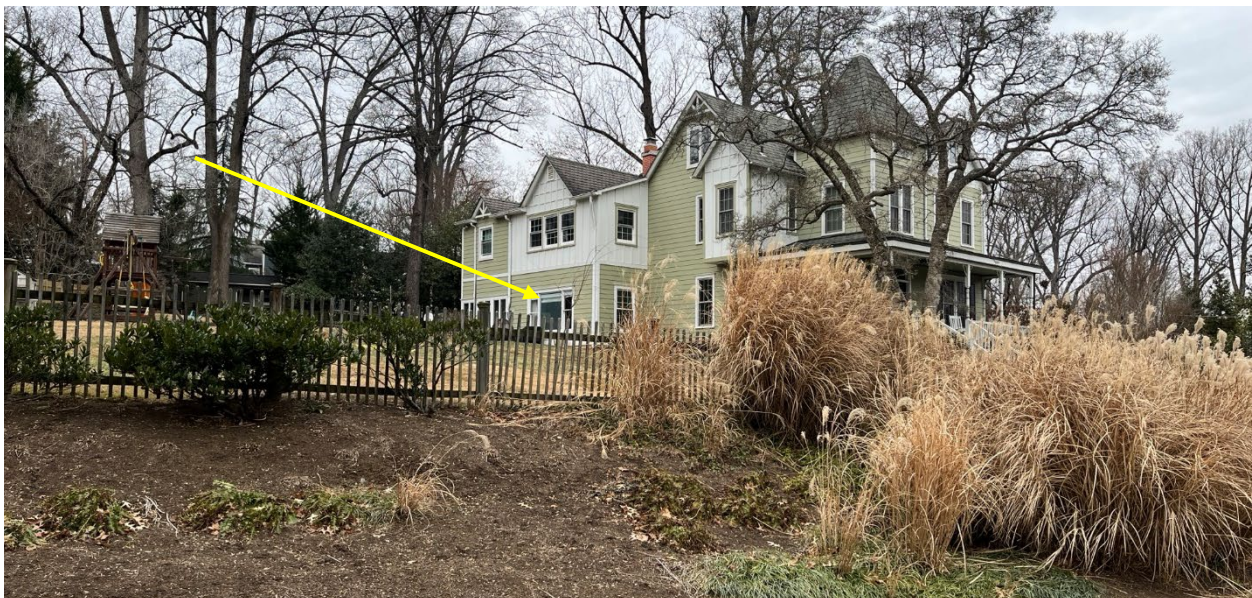
*Figure 6: View of subject property from the right-of-way along Waverly Avenue. The approximate location of the deck is notated with a yellow arrow.*

Staff finds that the overall location, massing, and form of the porch is compatible with the character of the district, per Chapter 24A(8)(b) and the *Standards*. The porch will be constructed off the non-historic rear addition, and, per Standard 9, it will not destroy any historic materials, features, and spatial relationships that characterize the property. Due to the large lot size and corner location, the porch will be visible from the right-of-way along Waverly Avenue; however, Staff finds that that the simple gabled-roof design and small footprint of the porch will not detract from or compete with the historic block of the house (*Figure 6*).

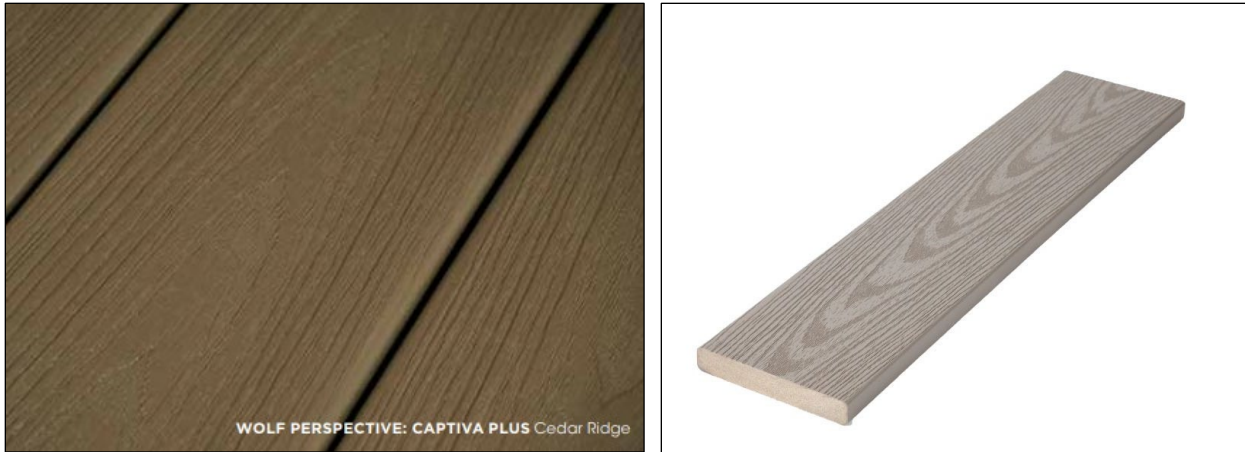
*Figure 7: Images of the proposed Wolf decking from the manufacturer website.*

According to *Policy 24-01*, all porches and decks on Outstanding Resources should be wood; however, porches on building additions and new construction to Outstanding/Primary resources will be evaluated on a case-by-case basis. Staff has not seen a sample of this material installed and cannot determine whether it meets the criteria for a compatible substitute material under *Policy 24-01*. Staff finds that, in this case, a non-compatible substitute material is still appropriate due to limited visibility of the decking material and the location of the proposed deck. The porch will be enclosed, so the surface texture of the material will be highly obscured. Additionally, the decking is set back substantially from the right-of-way on a side elevation, further limited the material visibility and impact to the district.

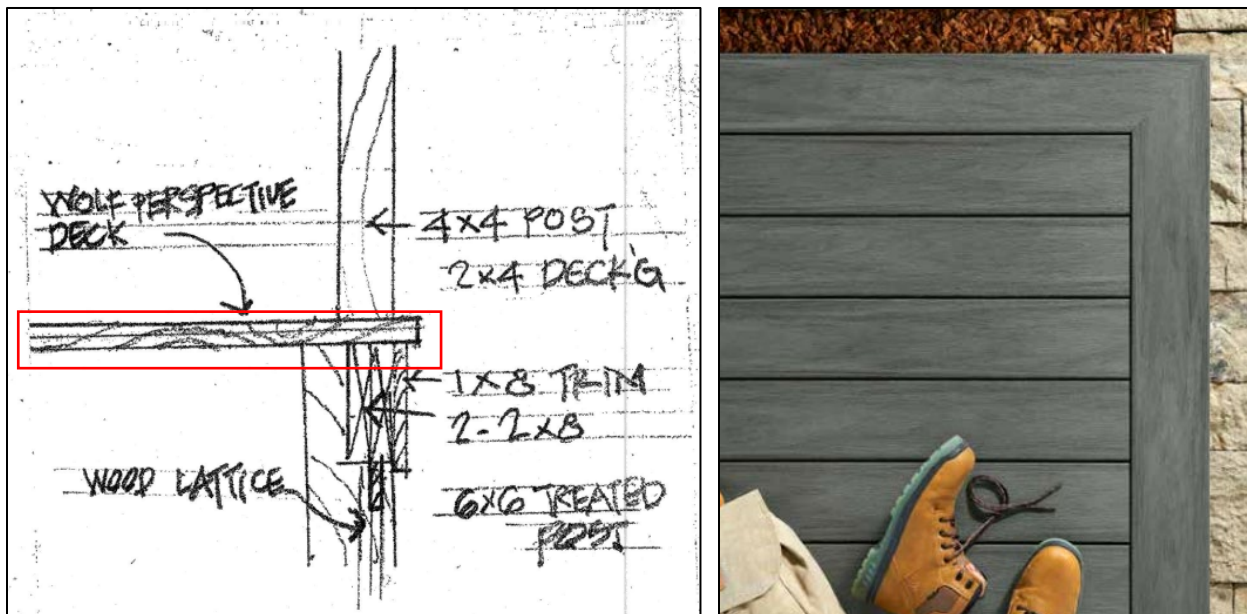
*Figure 8: Detail showing the exposed composite decking (left) and examples image showing the correct installation of a finishing board to hide edges (right; Wolf Home Products).*

Staff notes that the decking may be visible in some areas underneath the screening. The edges of composite decking are generally not consistent with the appearance of wood and should be finished with a board to conceal the edges (*Figure 8*). Staff notes that this the examples on the manufacturer website show this installation method (*Figure 8*).

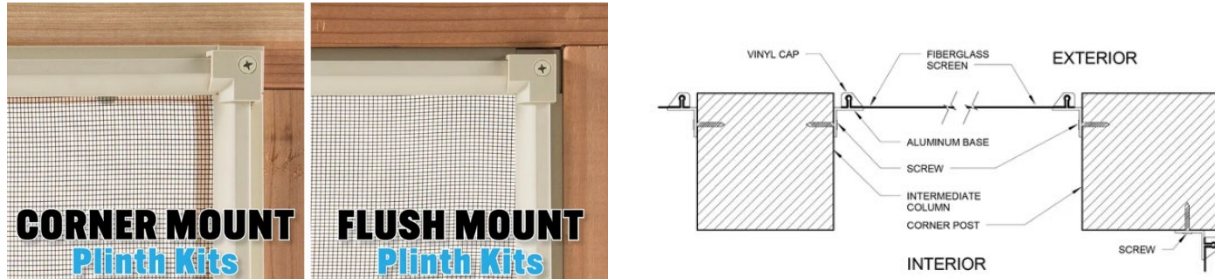
Figure 9: Screenshot system details.

Based on the drawings, Staff understands that the framing material for the porch will be wood. Staff notes that any non-wood trim or cladding must be submitted for review prior to issuance of final approval documents. The proposed Screenshot system has a small aluminum/vinyl frame. Staff finds that the profile is small enough to have no material effect on the porch, but should be installed flush mounted, as opposed to corner mounted, to not draw additional emphasis to the frames.

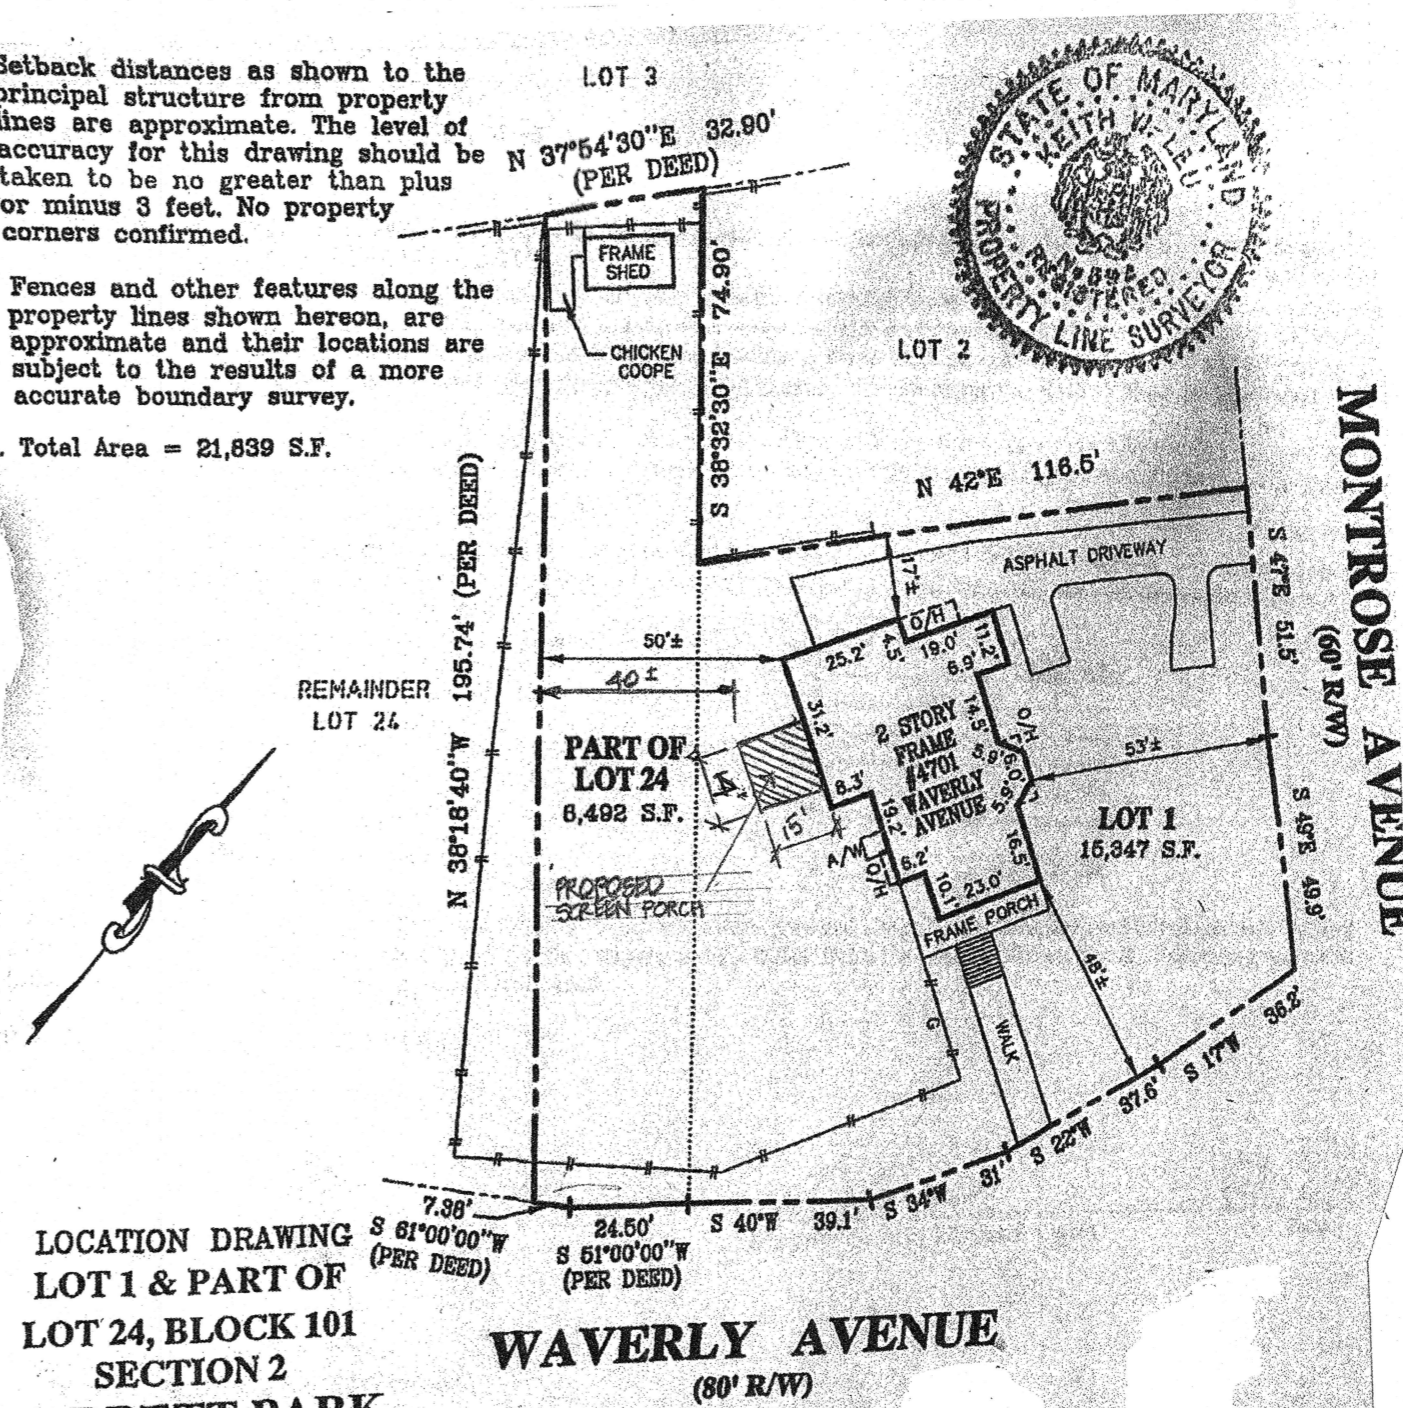
1. Setback distances as shown to the principal structure from property lines are approximate. The level of accuracy for this drawing should be taken to be no greater than plus or minus 3 feet. No property corners confirmed.
2. Fences and other features along the property lines shown hereon, are approximate and their locations are subject to the results of a more accurate boundary survey.
3. Total Area = 21,839 S.F.

LOCATION DRAWING LOT 1 & PART OF LOT 24, BLOCK 101 SECTION 2 GARRETT PARK MONTGOMERY COUNTY, MARYLAND
