MONTGOMERY COUNTY HISTORIC PRESERVATION COMMISSION
STAFF REPORT

Address:	23 Hesketh Street, Chevy Chase	Meeting Date:	1/21/2026
Resource:	Contributing Resource Chevy Chase Village Historic District	Report Date:	1/14/2026
Applicant:	Susie and John Lively (Thomas Hazzard, Agent)	Public Notice:	1/7/2026
Review:	HAWP	Tax Credit:	No
Case Number:	1145082	Staff:	Laura DiPasquale
Proposal:	Construction of front portico and new rear screened porch

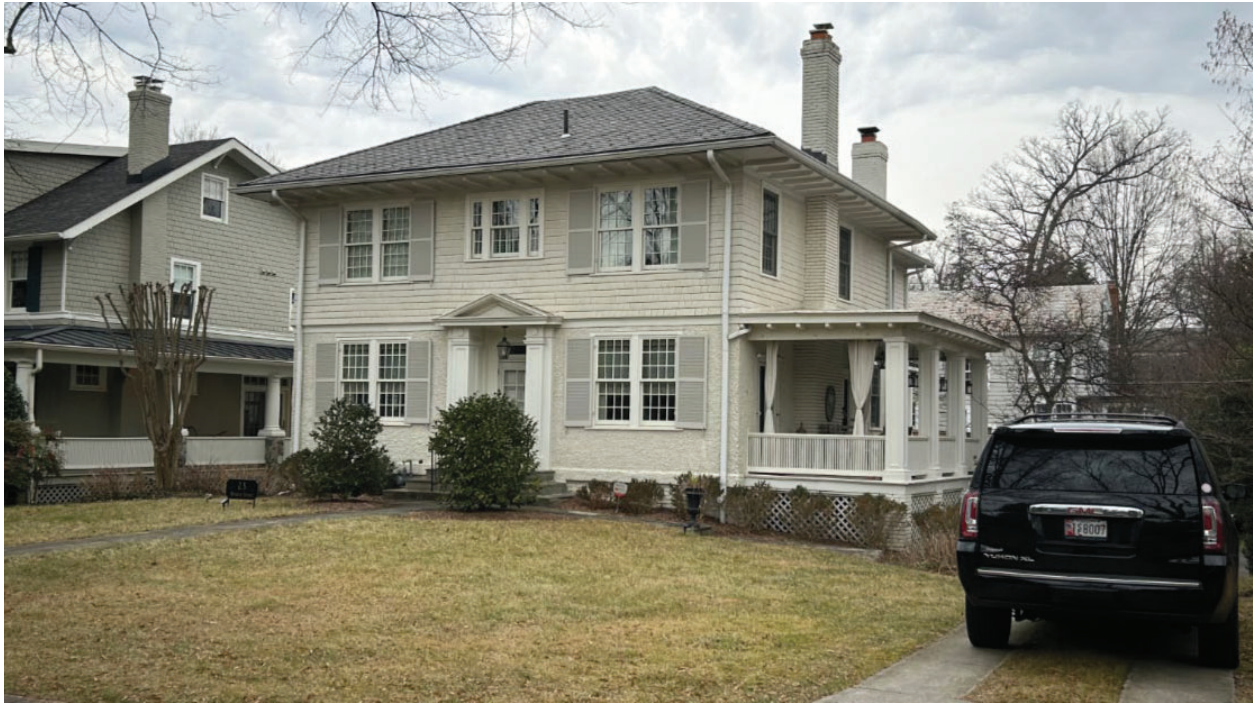
Figure 2: Front elevation of the subject property (January 2026, Historic Preservation Division).

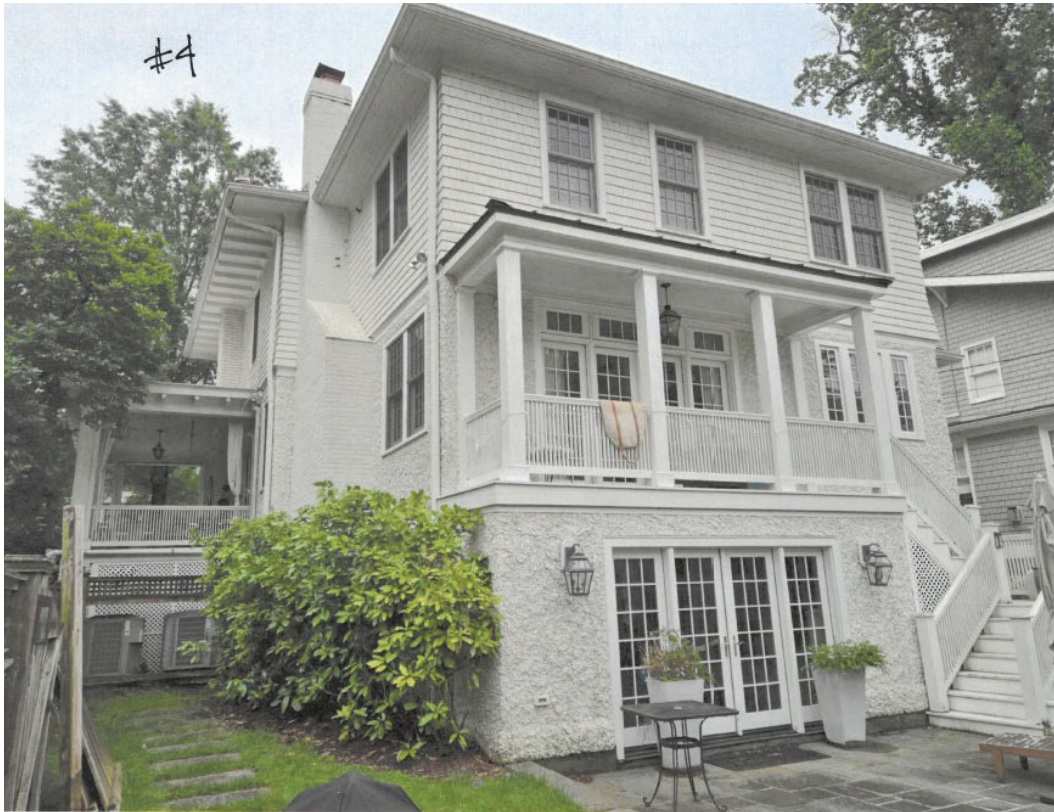
Figure 3: Photograph of the rear of the property, showing the existing 2012 addition and rear porch.

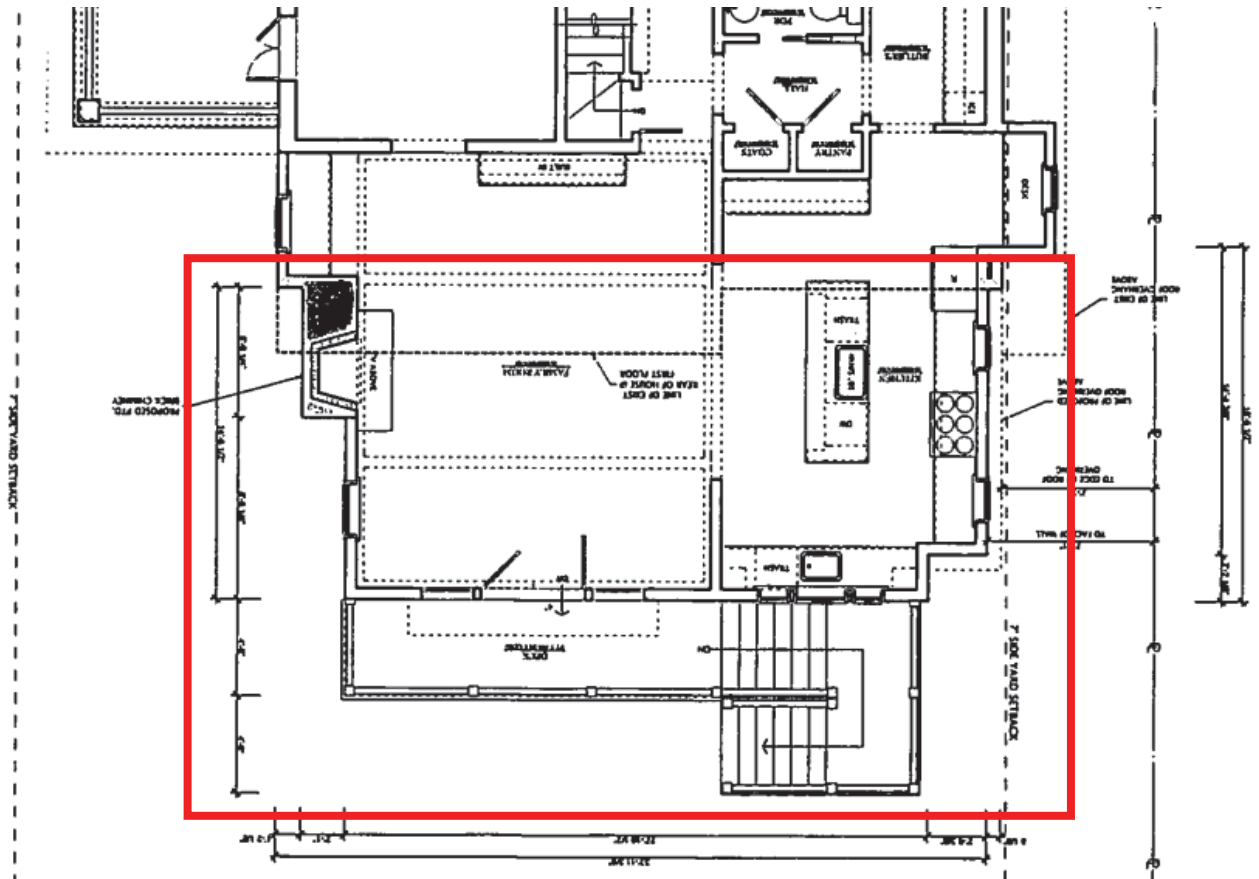
Figure 5: Detail of the rear addition and porch approved by the HPC in 2012.

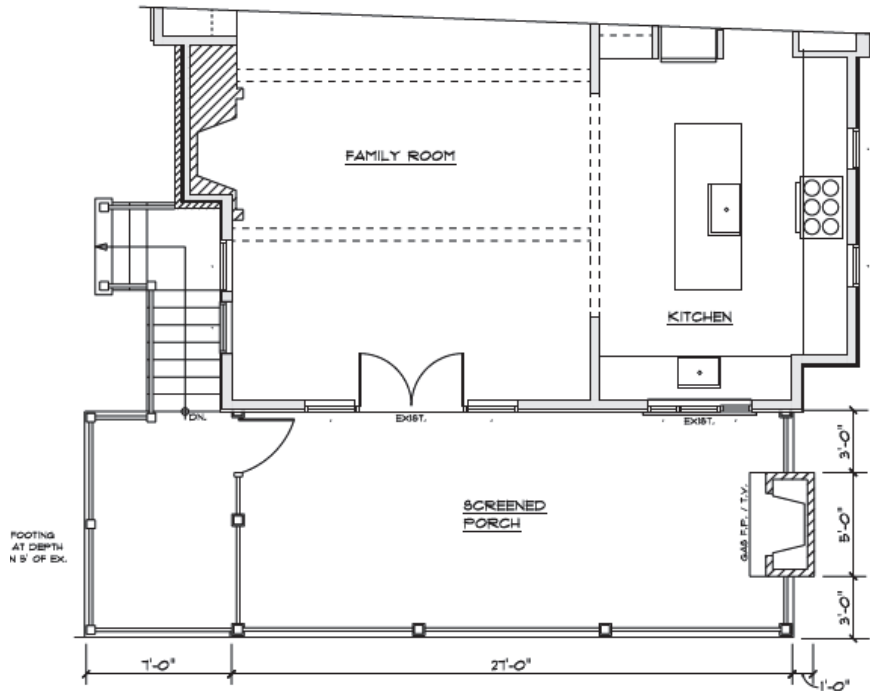
Figure 6: Detail of the proposed rear screened porch, deck, and stairs.

Staff notes that the drawings indicate that the steps to grade, which have the highest potential for visibility from the public right-of-way, are noted as wood, but the decking itself is not specified. Staff finds that the screened porch will not be visible from the public right-of-way and that wood or a substitute material may be used for the screened porch per *Policy 24-01*. Staff recommends that the HPC condition the application on submission of final materials specifications to staff to confirm that the decking meets *Policy 24-01*. All trim is noted in the written scope as being painted wood, which staff finds is appropriate under Chapter 24A-8(b)(2).

2) Proposing to construct a rear screened porch with a small grill deck and stairs to grade. Existing small covered porch and stairs will be removed. New porch will incorporate handrails, trim details and hipped roof with overhang depth to coordinate with the existing side porch. All materials will be wood, painted to reflect existing trim on the house and side porch. The porch ceiling will be a stained or painted bead boards.

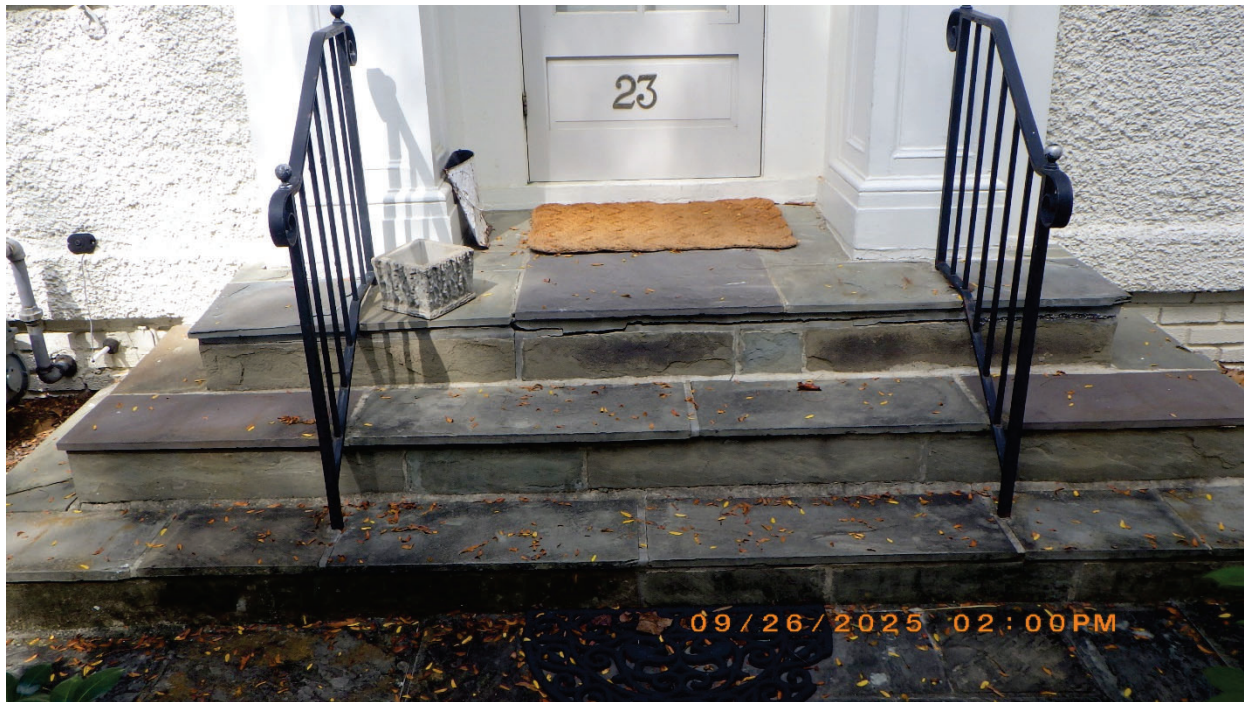
Figure 2. Existing front portico/step ~~to be replaced~~

Description of Current Condition:
Existing flagstone steps and landing are settling and breaking up. See photo #3
Existing entry applied entry feature is painted wood and showing signes of deterioration. See photo #2

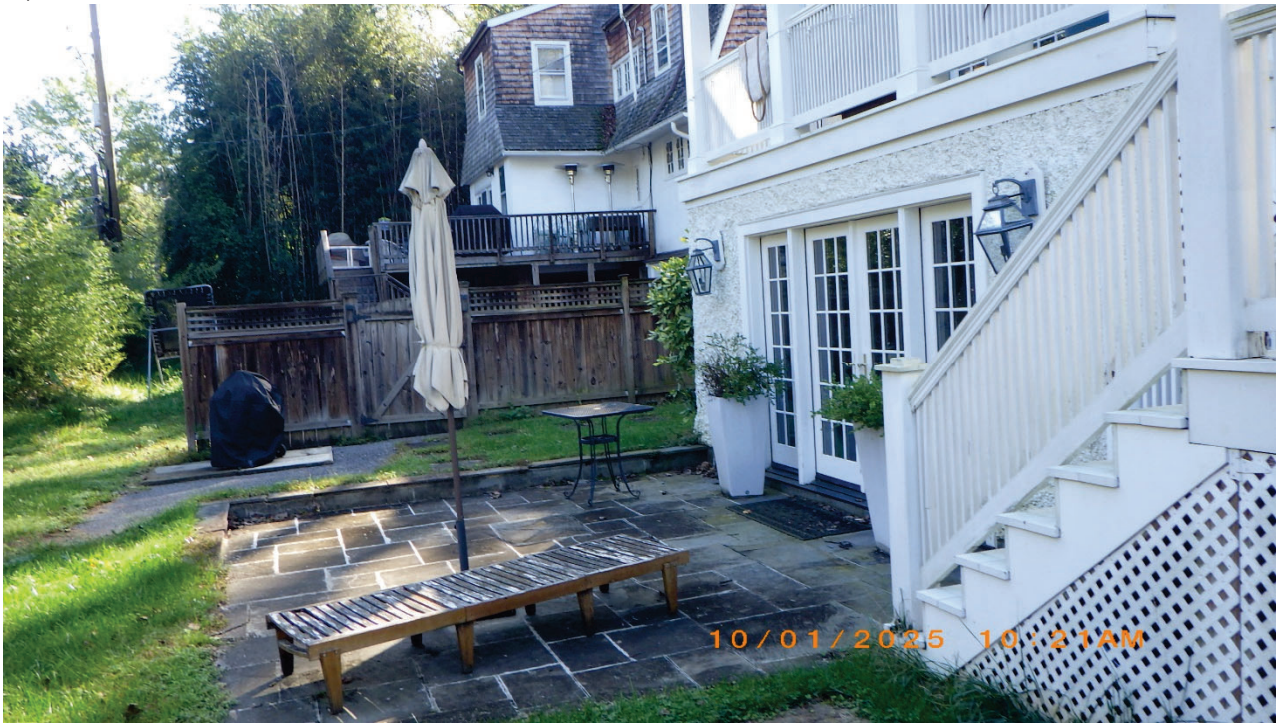
Figure 3. Existing stone patio and stairs to be removed to expand covered porch to proposed screened porch.

Description of Current Condition:
Existing small covered porch and stairs to be removed. See photo #4
Existing deteriorated flagstone patio, low stone walls and section of old asphalt driveway in rear yard to be removed and replaced with grass. See photo #5

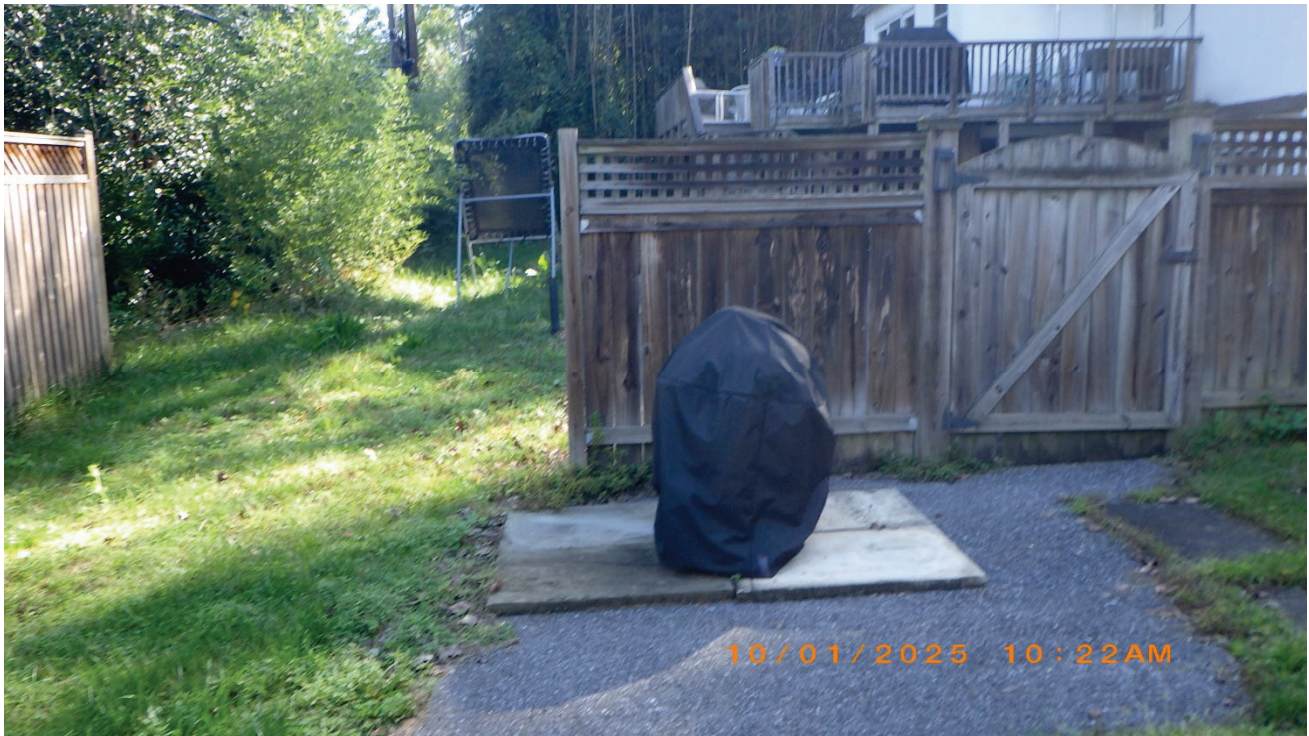
Figure 4. Existing asphalt apron to be removed.
