**MONTGOMERY COUNTY HISTORIC PRESERVATION COMMISSION**  
**STAFF REPORT**

<b>Address:</b>	7211 MacArthur Blvd., Bethesda	<b>Meeting Date:</b>	2/11/2026
<b>Resource:</b>	Contributing Resource <b>Potomac Overlook Historic District</b>	<b>Report Date:</b>	2/4/2026
<b>Applicant:</b>	Jeong Kim	<b>Public Notice:</b>	1/28/2026
<b>Review:</b>	HAWP	<b>Staff:</b>	Dan Bruechert
<b>Permit No.:</b>	1126423 REVISION	<b>Tax Credit:</b>	Partial
<b>Proposal:</b>	Door Replacement

The applicant proposes to remove and replace an existing door.

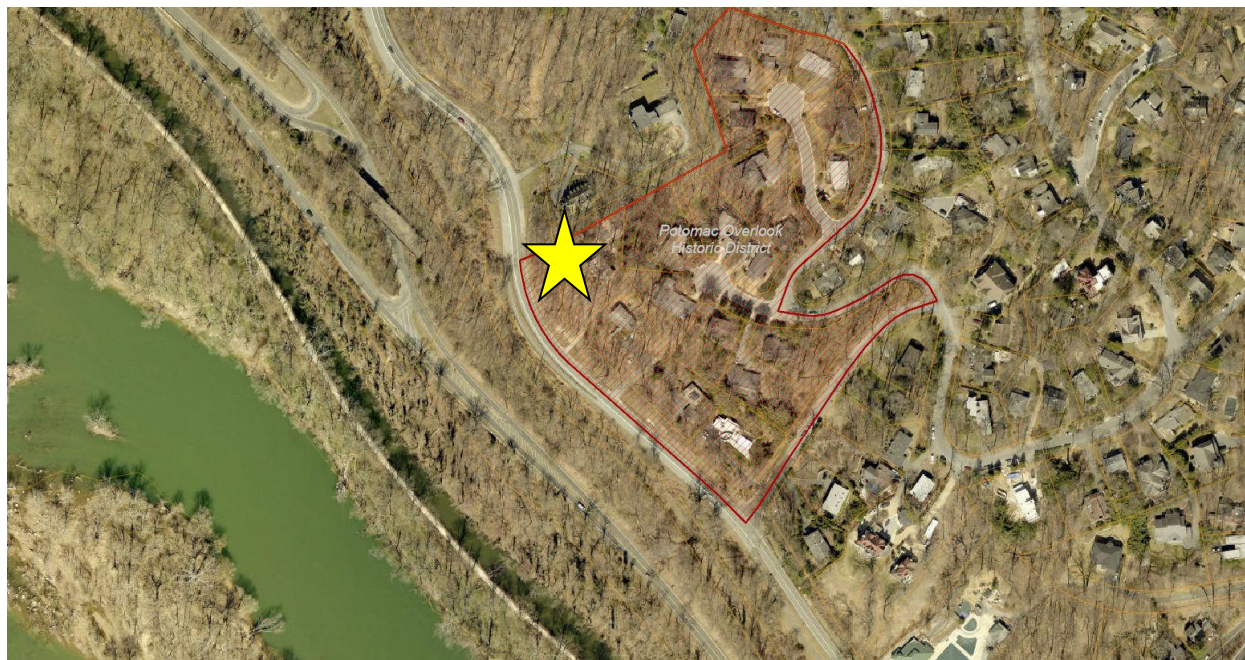
*Figure 1: The subject property is adjacent to Macarthur Blvd., at the western edge of the historic district.*

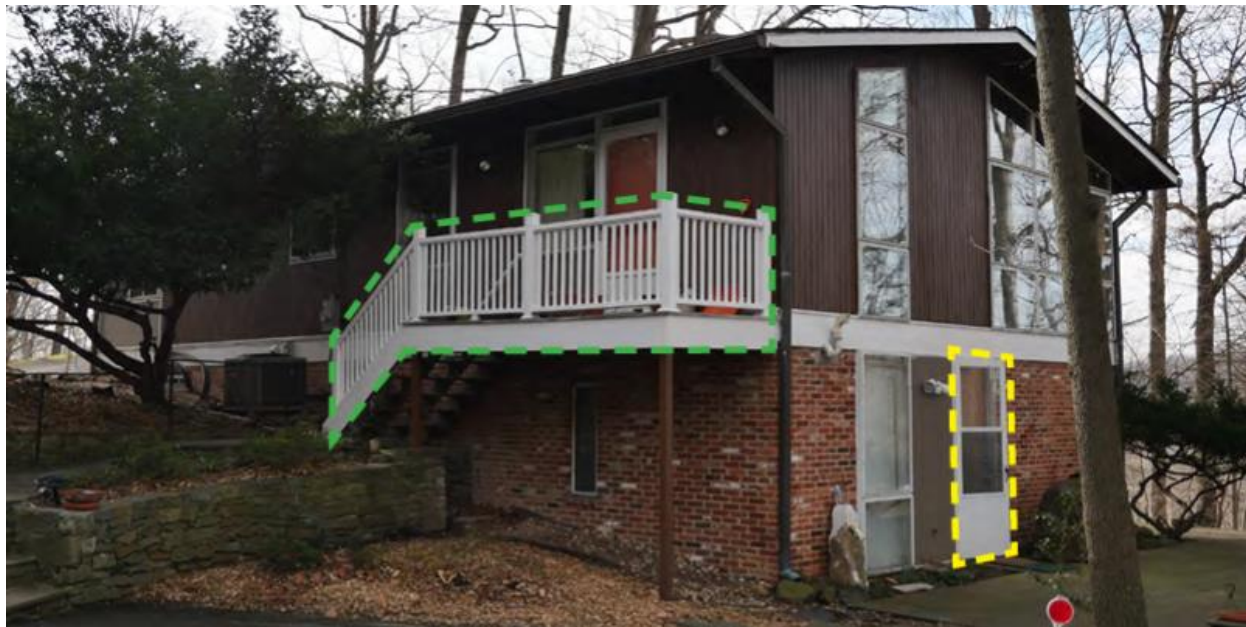
*Figure 2: Image from the northeast of the subject house showing the replacement exterior stairs (in green) and the added side door (in yellow).*

The subject property is a Highview model house designated as a Contributing Resource to the Potomac Overlook Historic District. Appendix A (attached) identifies all of the alterations made to the house, which consists of the addition of a gable-end ground floor entrance and a new rear exterior stair. The

remainder of the house appears to maintain its historic appearance. A 2025 HAWP approved the revision to the two windows to the left of the rear door, raising their sills to accommodate a revised kitchen layout.

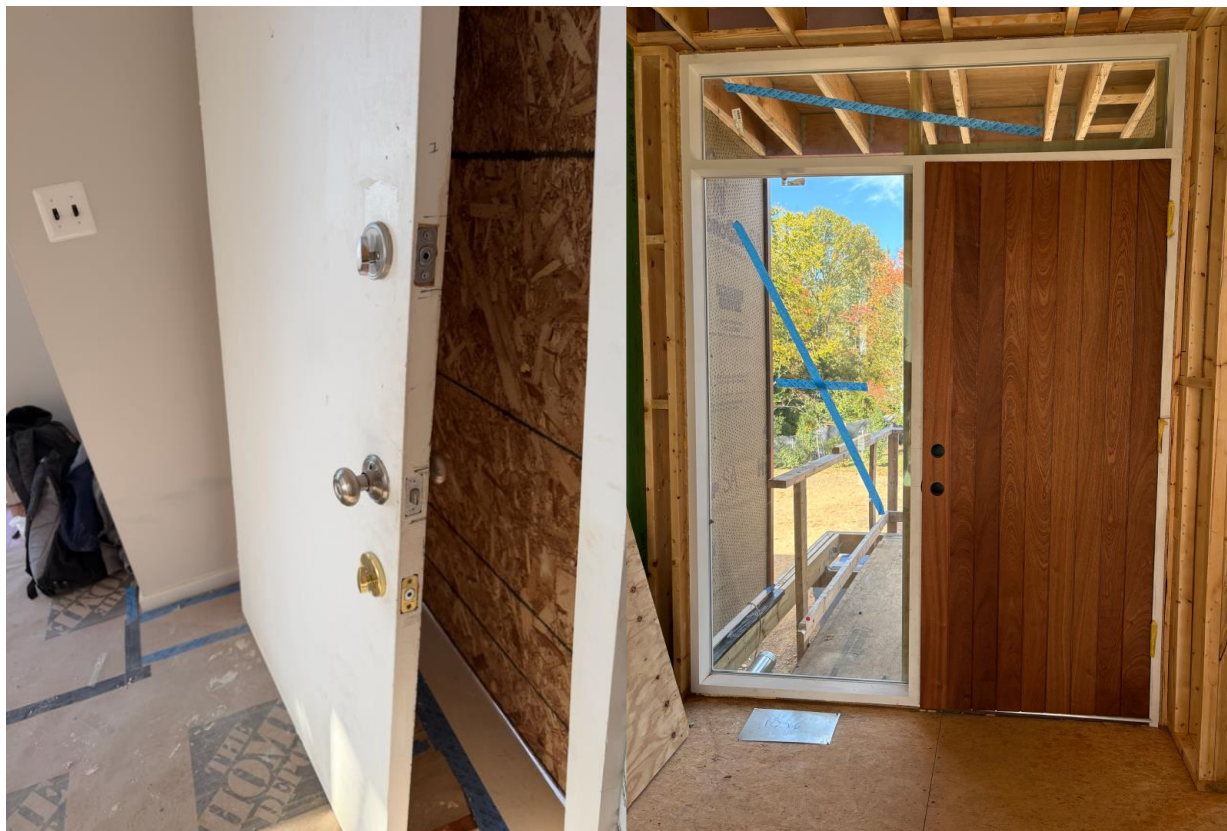
*Figure 3: Existing door showing damage (left) and precedent image of the proposed door (right).\_*

On the north side of the house, the door has warped, had damage from previous hardware installations and is showing signs of delaminating. The applicant proposes to remove the damaged door and install a new mahogany door in the existing opening. The proposed door is a solid door, constructed with vertical slats, each slat is 3 5/8" (three and five-eighths inches wide), and the door will be finished in a clear satin stain.

1. The proposed door will fit into the existing opening and will not change the opening's size or shape.
2. The existing door is warped and no longer effectively seals the opening, which Staff finds justifies its removal under *Standard #6*.
3. The replacement door is constructed out of solid wood and it's vertical slat design is a contemporary style.
4. The door is solid and has no lights.

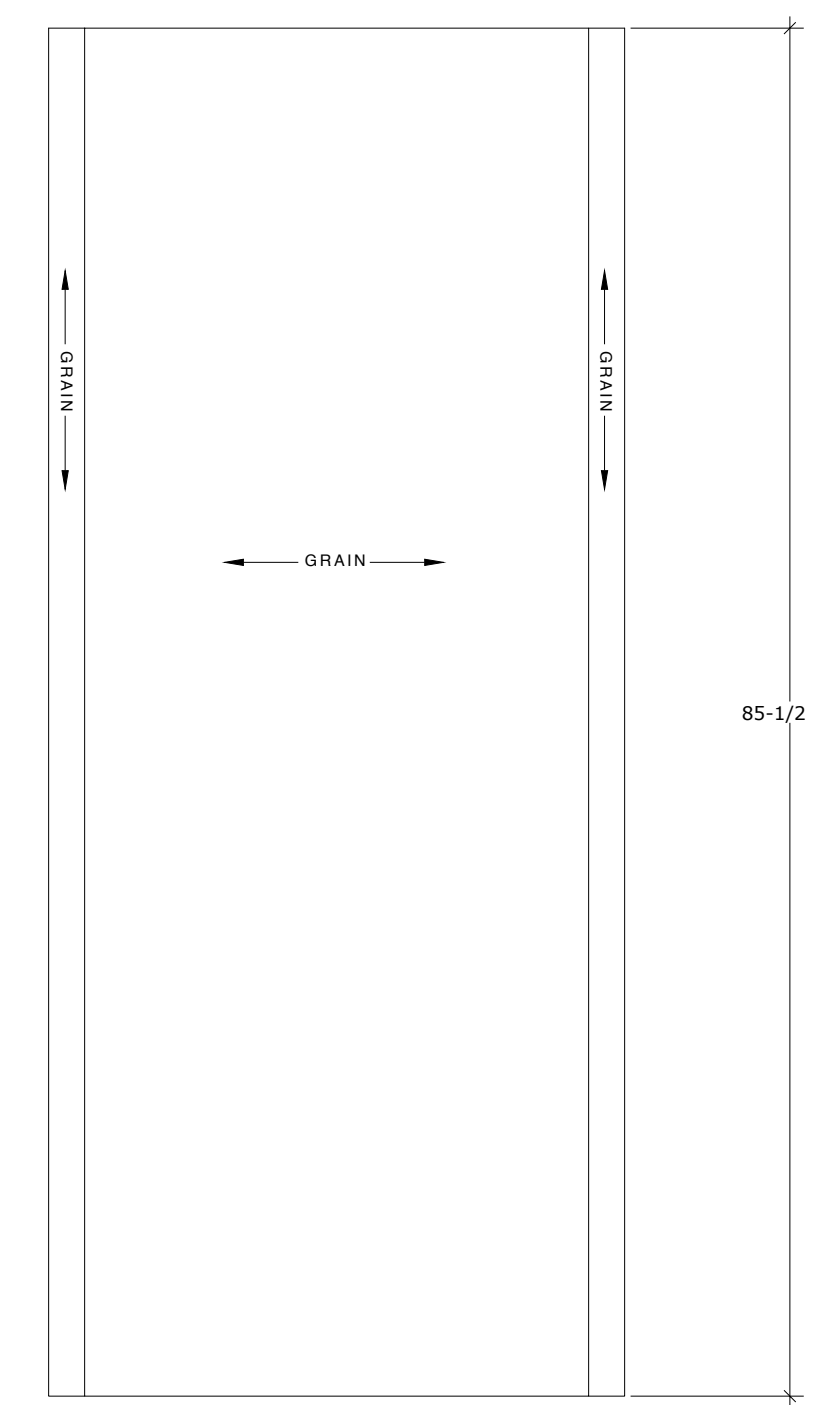
2 CENTER LAYER (FRONT, TOP)  
1:12

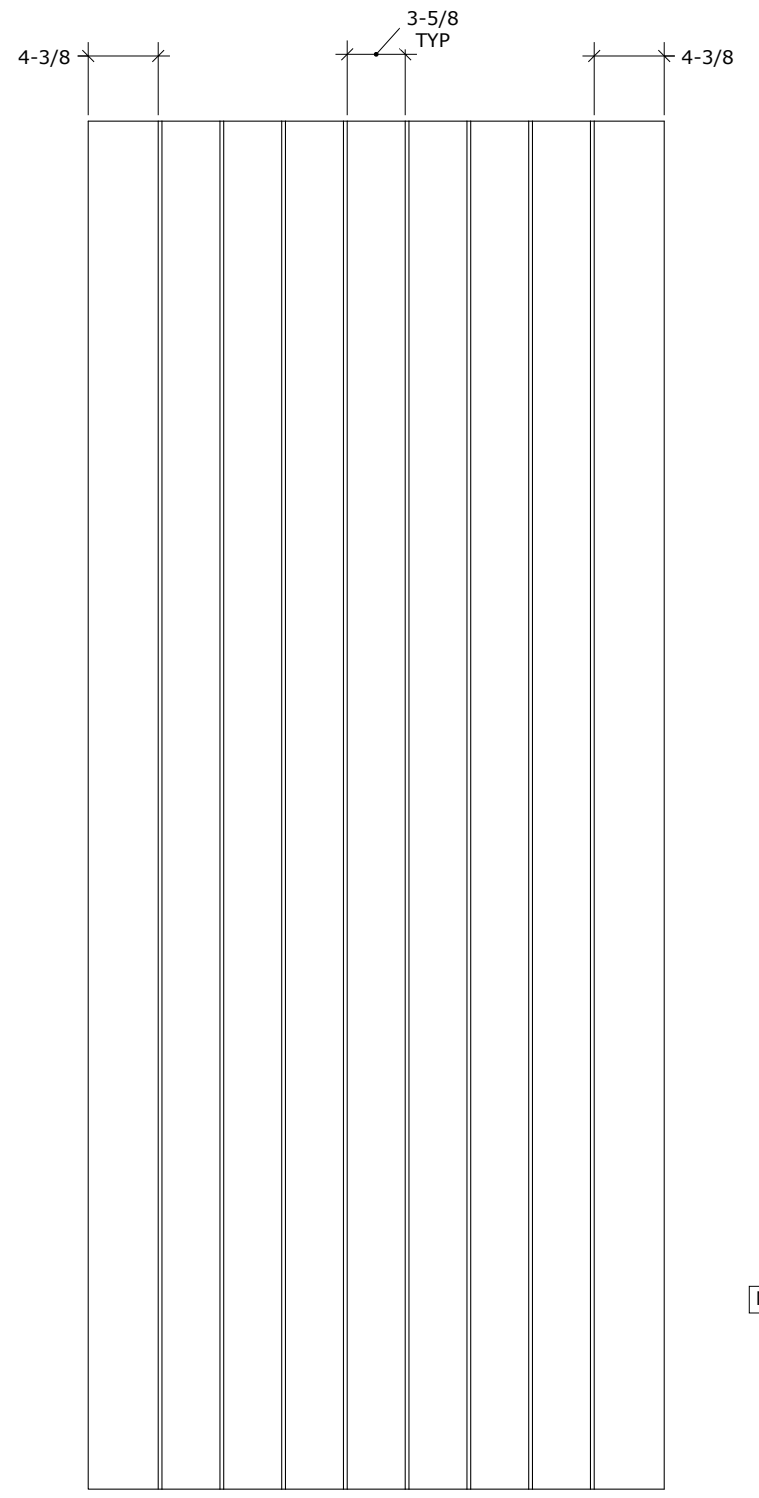
MAKE DUPLICATE FOR BACK LAYER

3 FRONT LAYER (FRONT, TOP)  
1:12

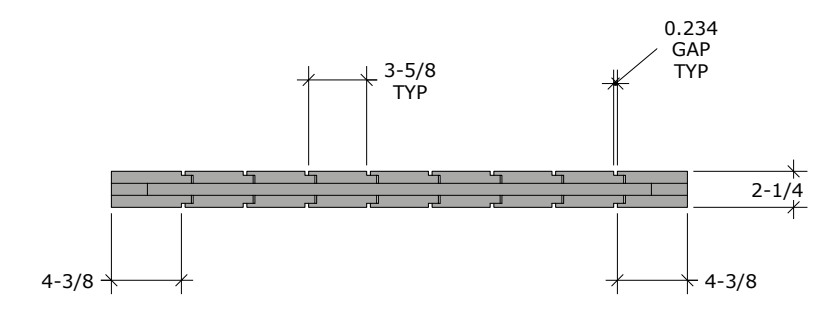
6 SECTION THRU DOOR  
1:12

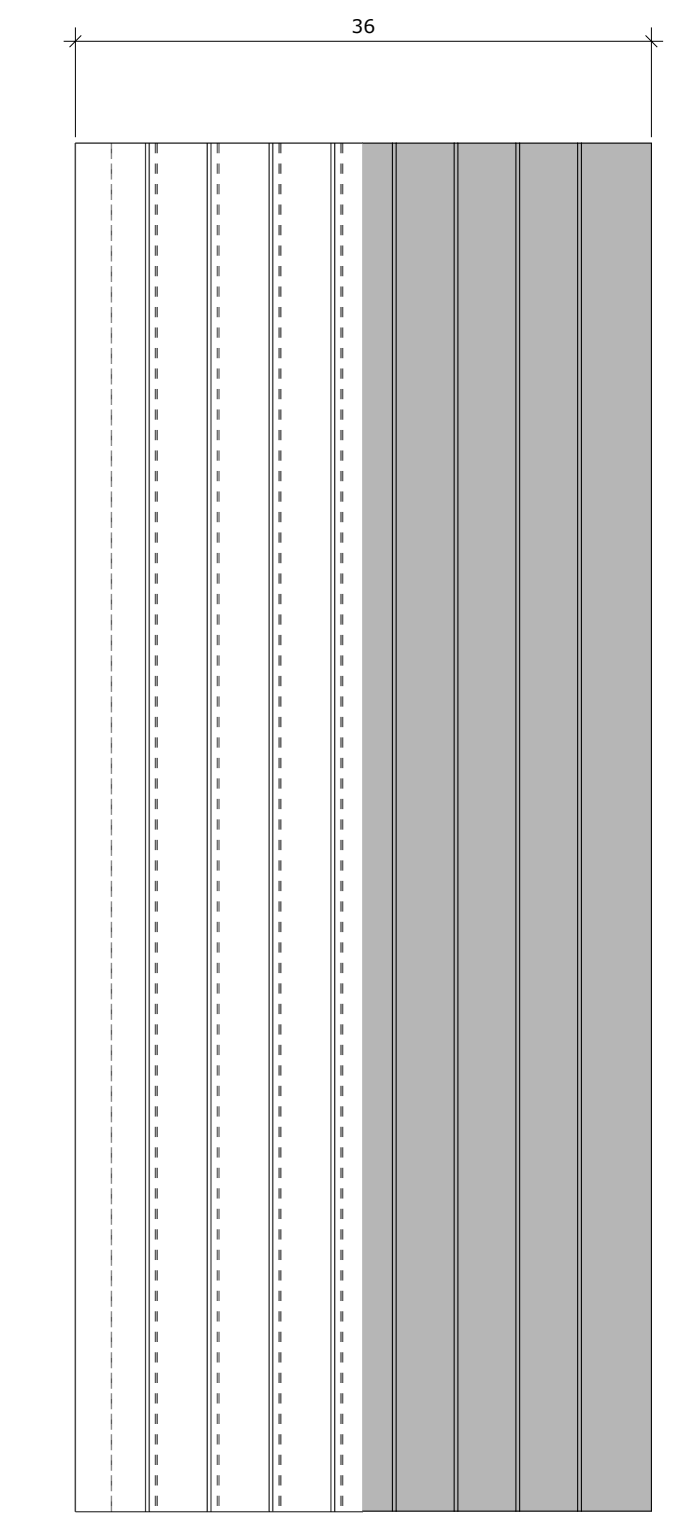
4 FRONT ELEVATION  
1:12

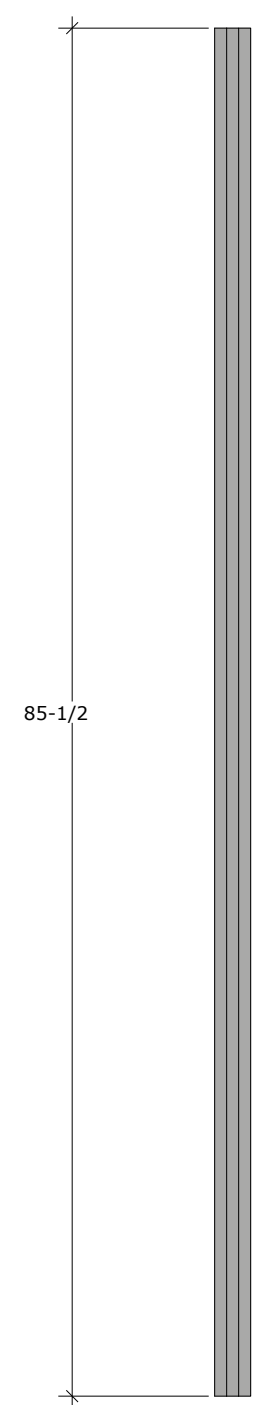
5 VERTICAL SECTION  
1:12

ENTRY DOOR SLAB		FINISH
PRODUCT USE	EXTERIOR	UNFINISHED
SPECIES	SAPELE MAHOGANY	
PREHUNG	NO	
ENTRY DOOR		FINISH
PROFILE	N/A	
GLASS CUT	N/A	
THICKNESS	2-1/4"	
CONSTRUCTION	CLT	
SWING	N/A	
LATCH PREP	NO	
LATCH	N/A	
HINGE	N/A

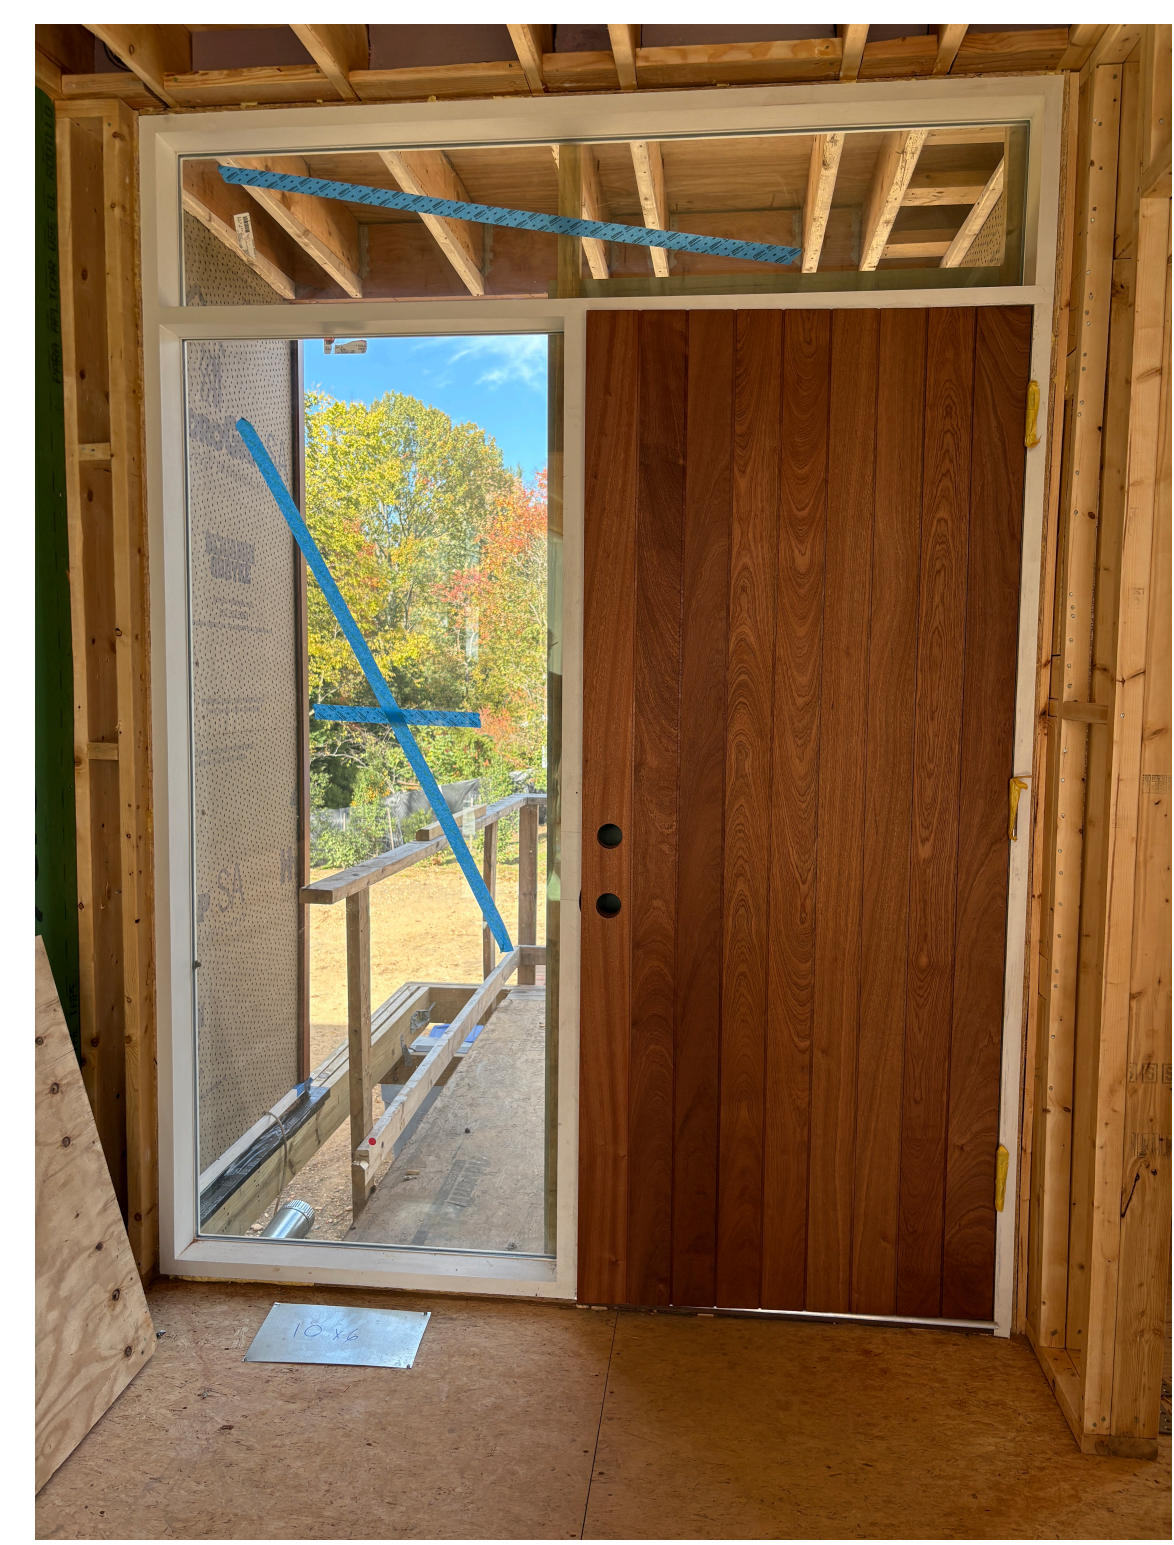
8 Proposed door

The proposed door consists of vertical solid mahogany wood boards, without panels or divided lights, finished with a clear satin exterior finish.

Work Item 2: <u>AMEDNMENT TO REAR EXTERIOR DOOR (NORTH ELEVATION) 01.20.2026</u>	
Description of Current Condition:	Proposed Work:
<u>REAR EXTERIOR DOOR ON NORTH ELEVATION IS WORN AND DETERIORATED; NEEDS REPLACEMENT</u>	<u>EXTERIOR DOOR TO BE REPLACED WITH NEW SOLID MAHOGANY DOOR, FINISHED WITH CLEAR SATIN EXTERIOR FINISH, AND PROVIDED WITH STAINLESS STEEL KNOB, DEADBOLT, AND SQUARE-EDGE HINGES</u>

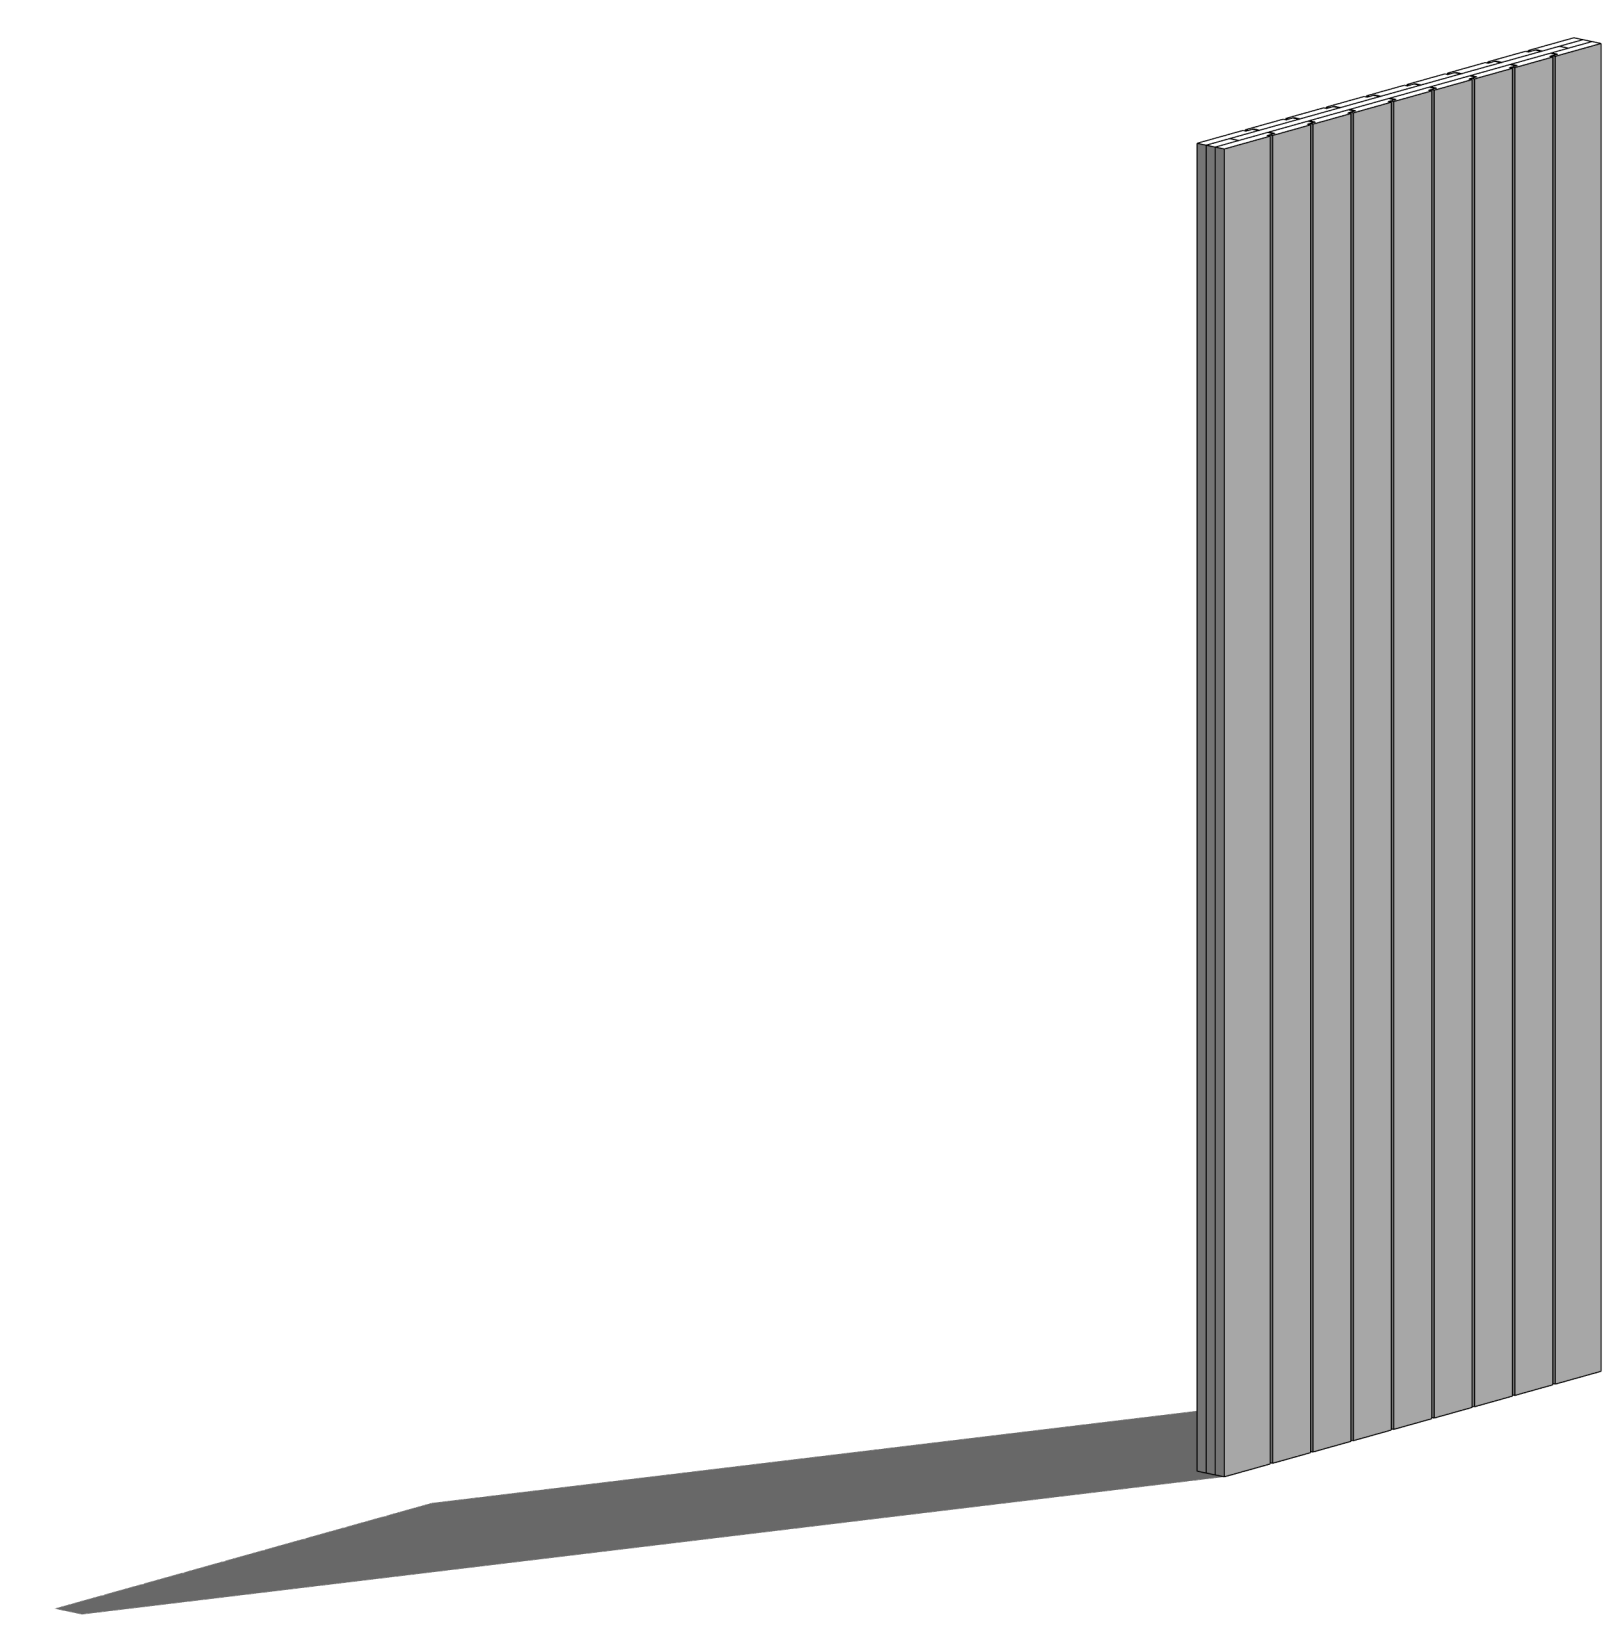
1 ISOMETRIC  
1:12

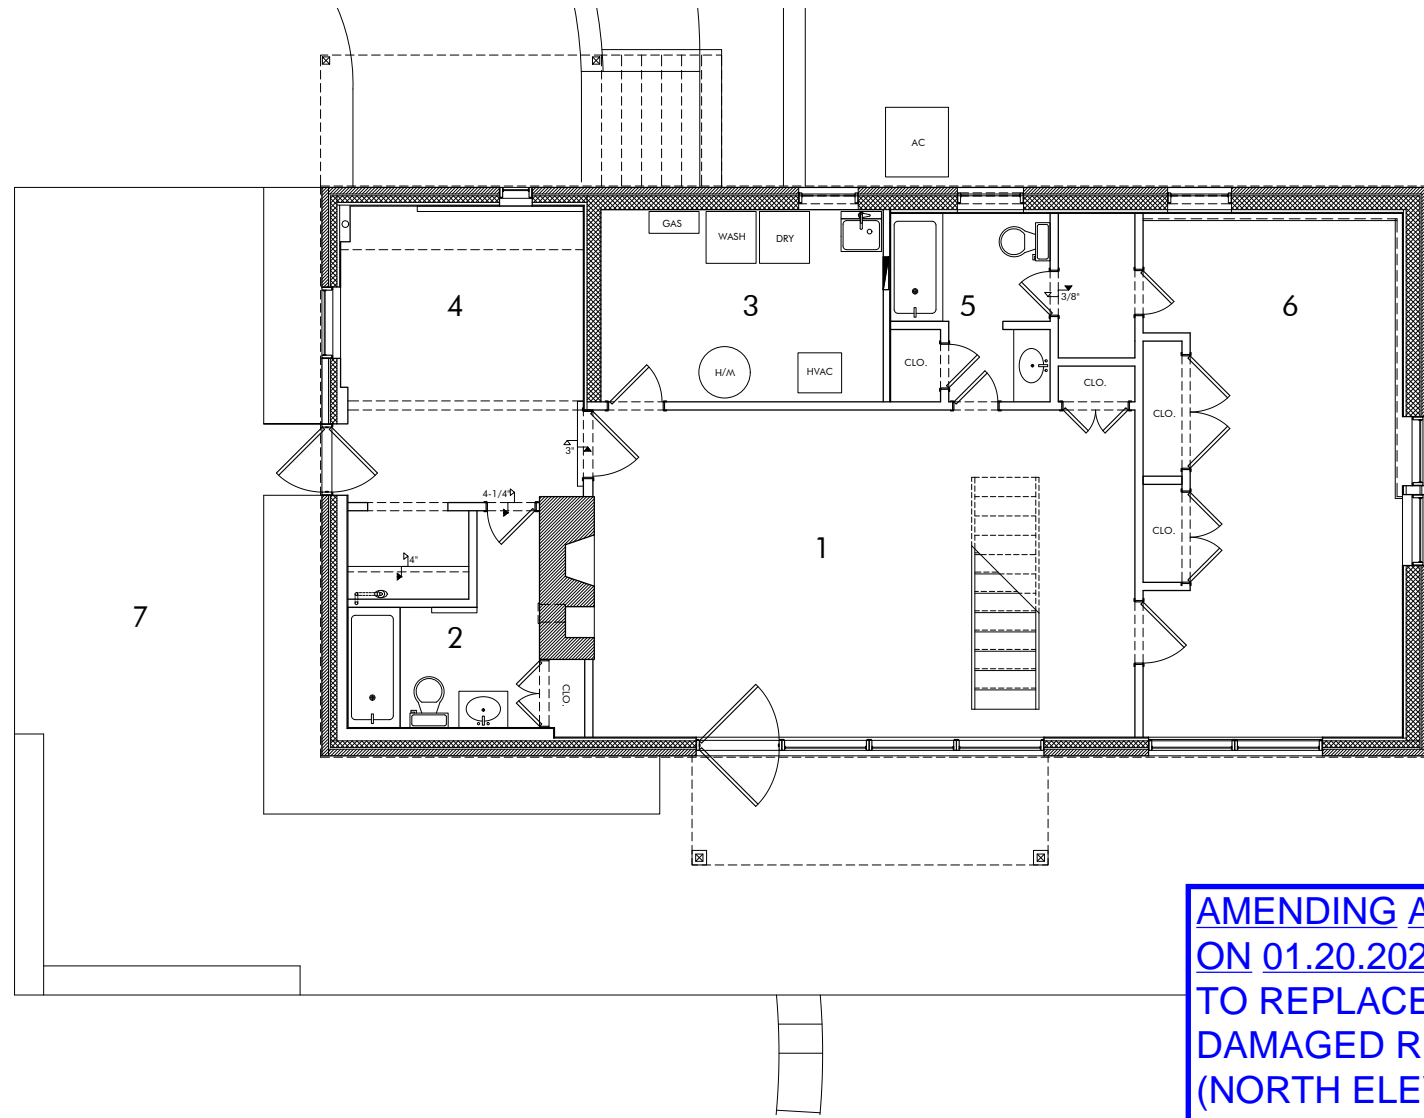
## EXISTING LOWER LEVEL

1. FAMILY ROOM
2. BATHROOM 1
3. MECHANICAL ROOM
4. BEDROOM 1
5. BATHROOM 2
6. BEDROOM 2
7. PATIO

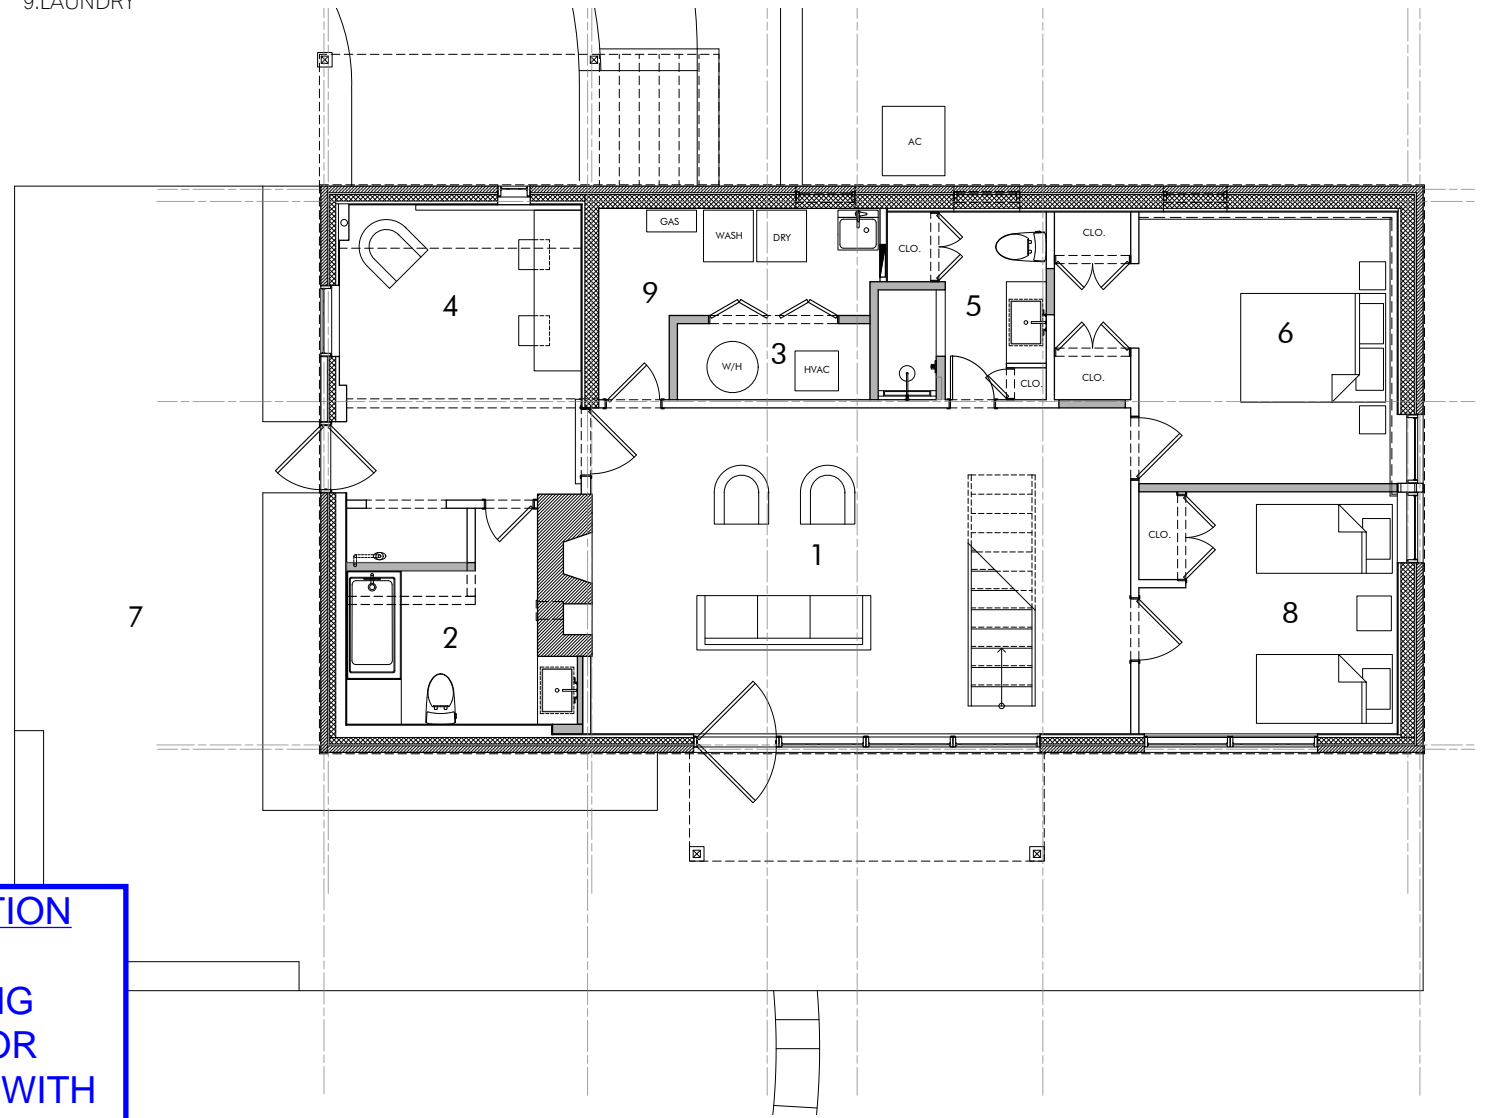
## PROPOSED LOWER LEVEL

1. FAMILY ROOM
2. BATHROOM 1
3. MECHANICAL CLOSET
4. BEDROOM 1/ OFFICE
5. BATHROOM 2
6. BEDROOM 2
7. PATIO
8. BEDROOM 3
9. LAUNDRY

On the lower level, work includes adding a new bedroom and remodeling the existing bathroom and mechanical room to support the revised floor plan.

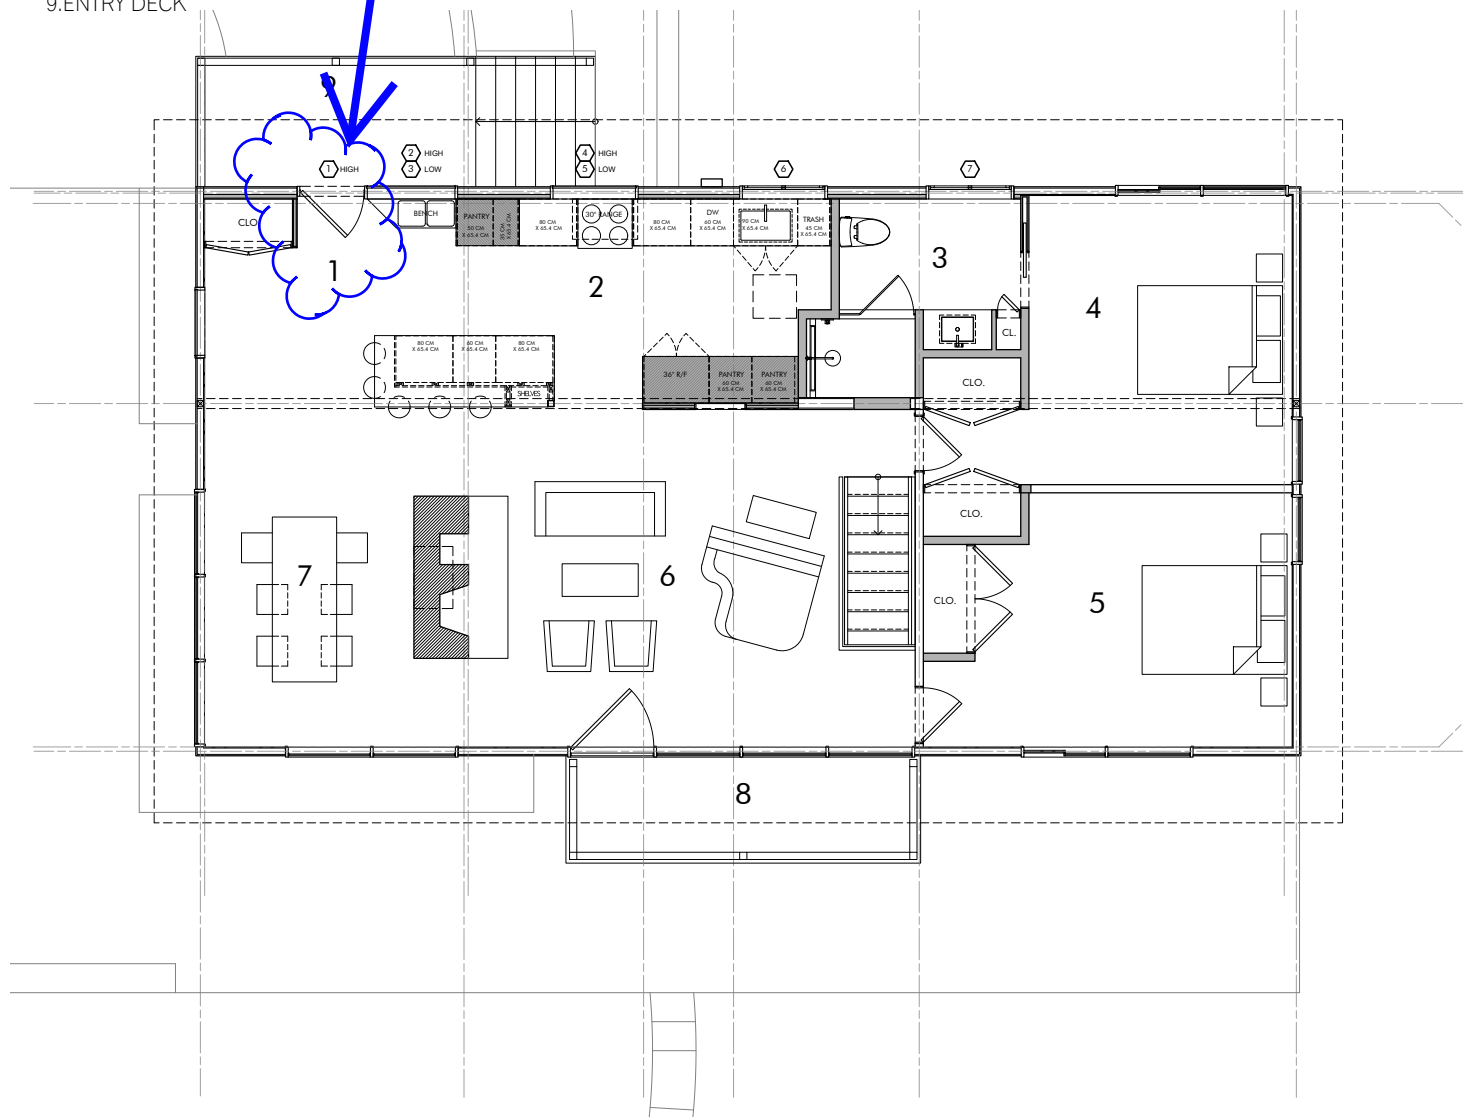
# PROPOSED UPPER LEVEL FLOOR PLAN - ENLARGED

**EXISTING  
DAMAGED DOOR  
TO BE REPLACED**

On the upper level, the scope includes a new kitchen layout and the creation of a master bedroom suite, requiring reconfiguration of interior spaces. As part of the kitchen redesign, the sill height of two windows on the north elevation (windows #3 and #5) will be raised to accommodate cabinetry, backsplash, and outlets. These changes will maintain the existing window openings and will be finished at the bottom with painted James Hardie cement board panels to match the existing conditions. Two additional windows (windows #6 and #7) will be replaced in-kind with aluminum sliders of the same dimensions.

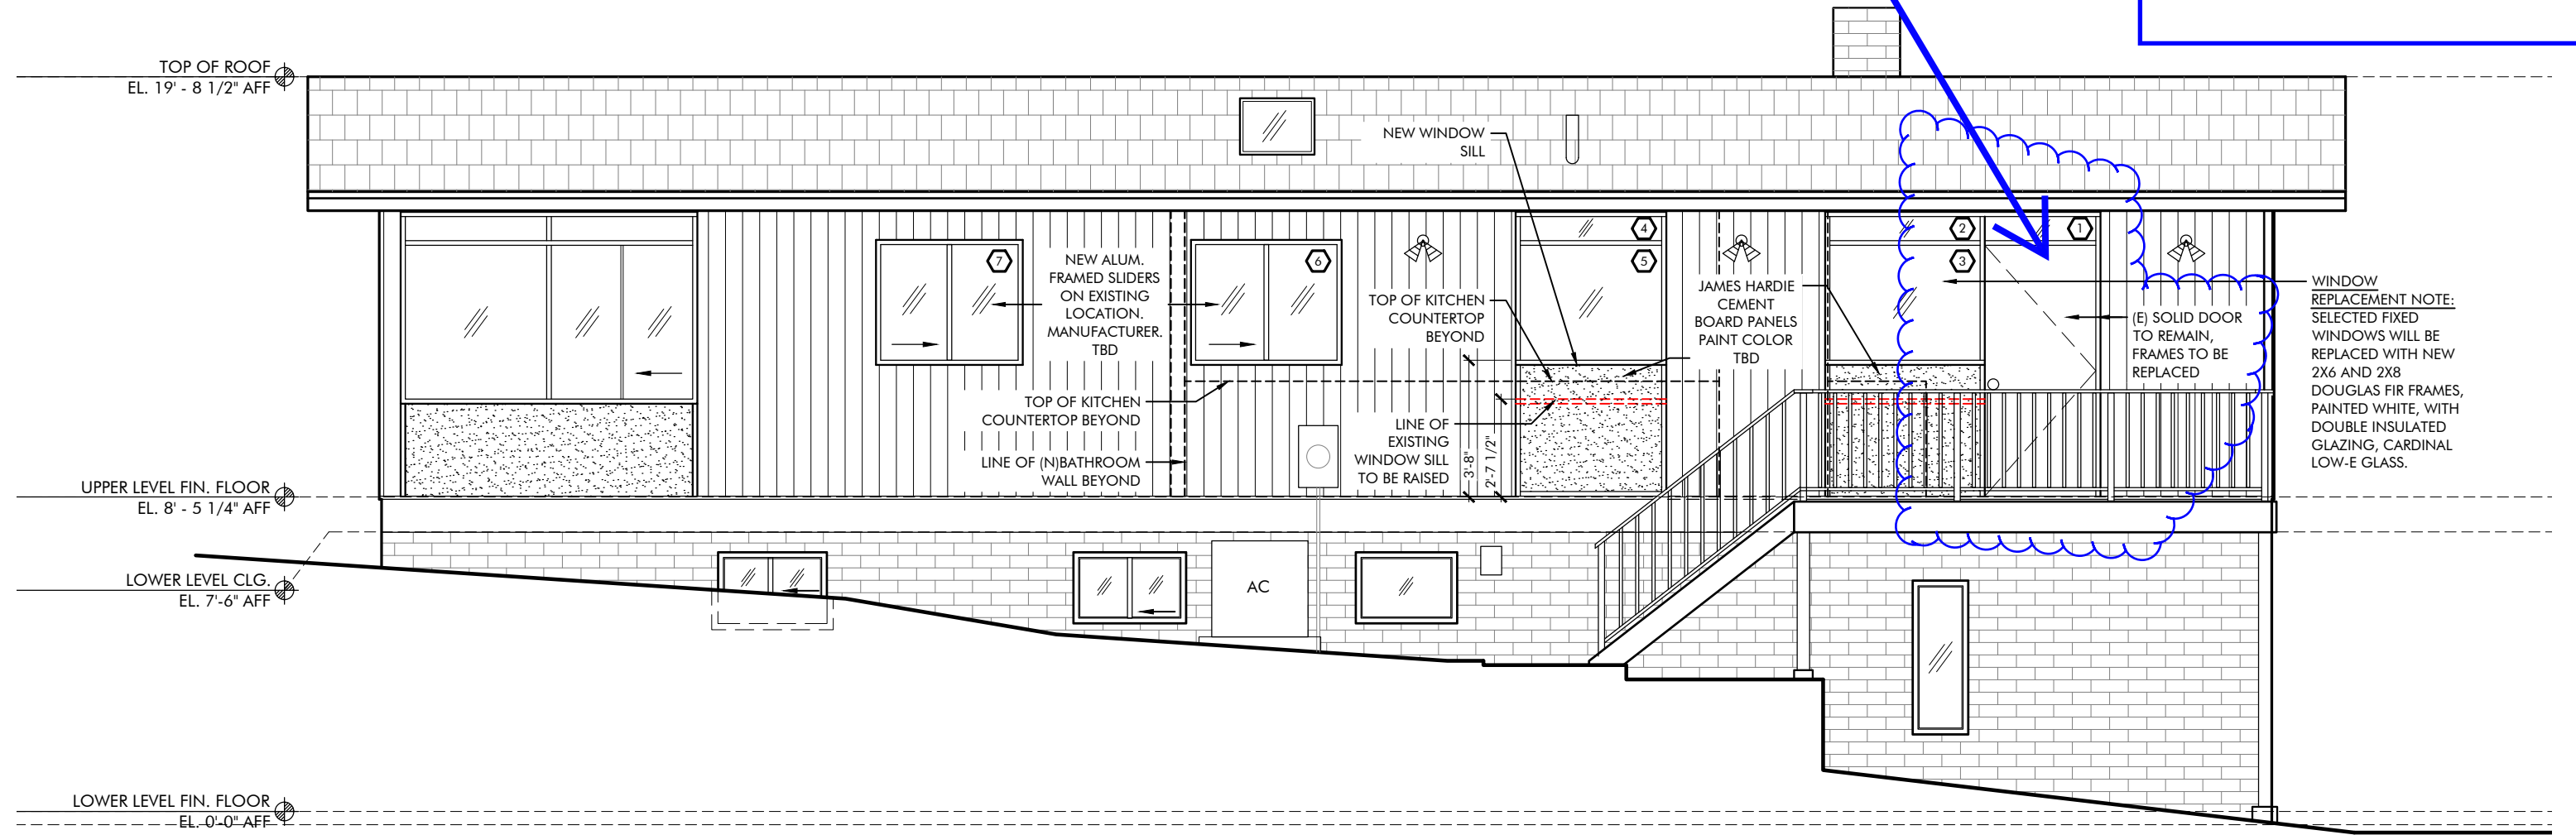
PROPOSED NORTH ELEVATION

EXISTING DAMAGED DOOR TO BE REPLACED

WINDOW REPLACEMENT NOTE:  
SELECTED FIXED WINDOWS WILL BE REPLACED WITH NEW 2X6 AND 2X8 DOUGLAS FIR FRAMES, PAINTED WHITE, WITH DOUBLE INSULATED GLAZING, CARDINAL LOW-E GLASS.

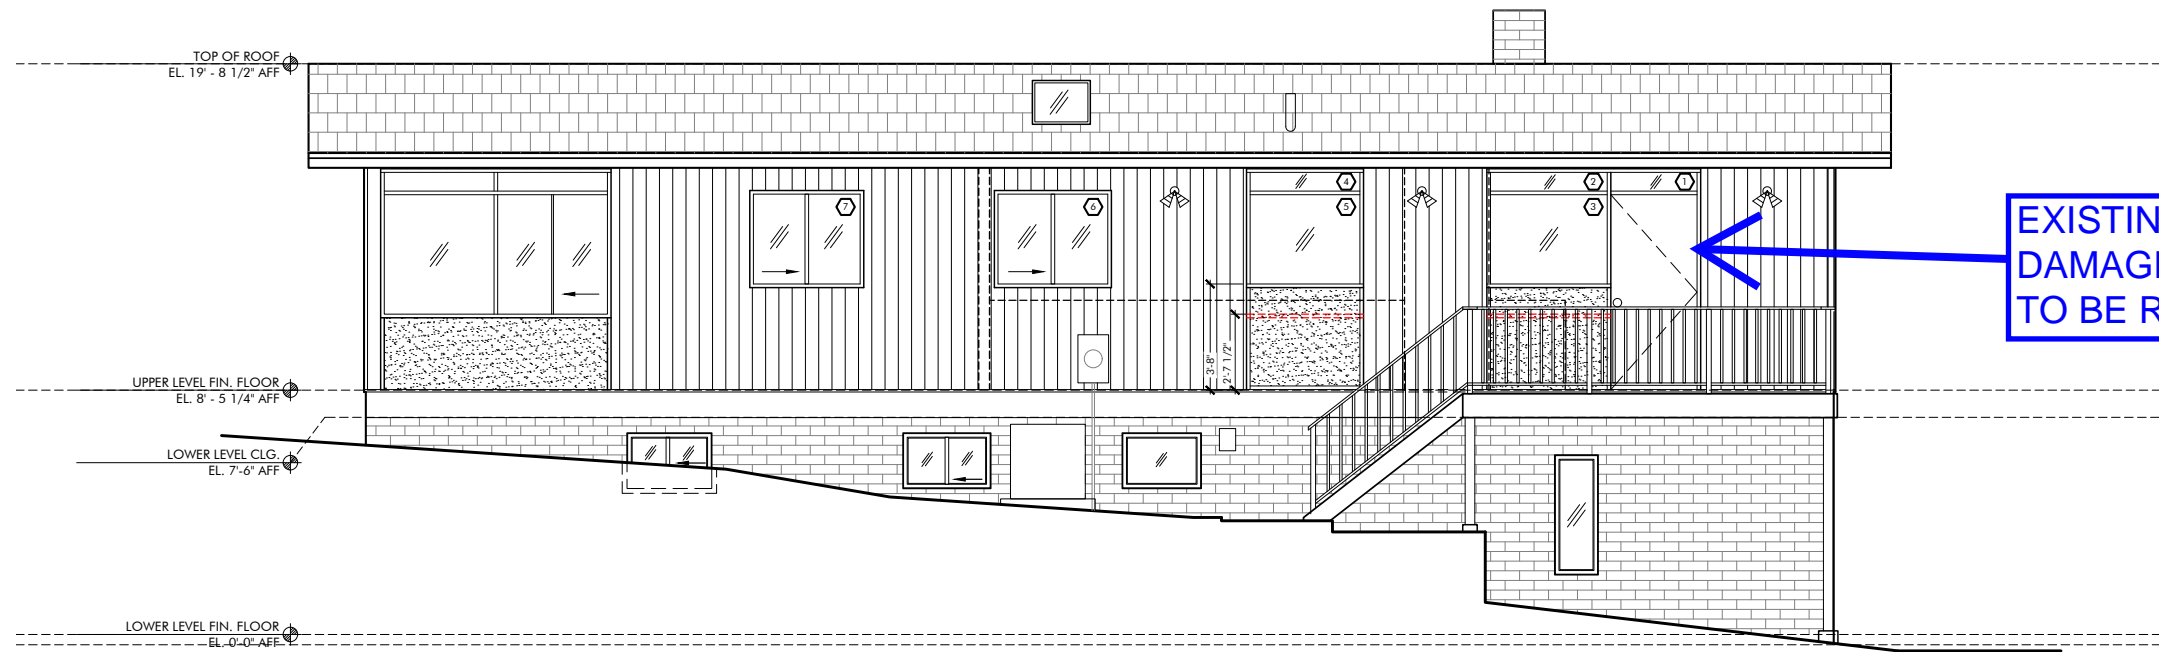
PROPOSED NORTH ELEVATION

EXISTING  
DAMAGED DOOR  
TO BE REPLACED

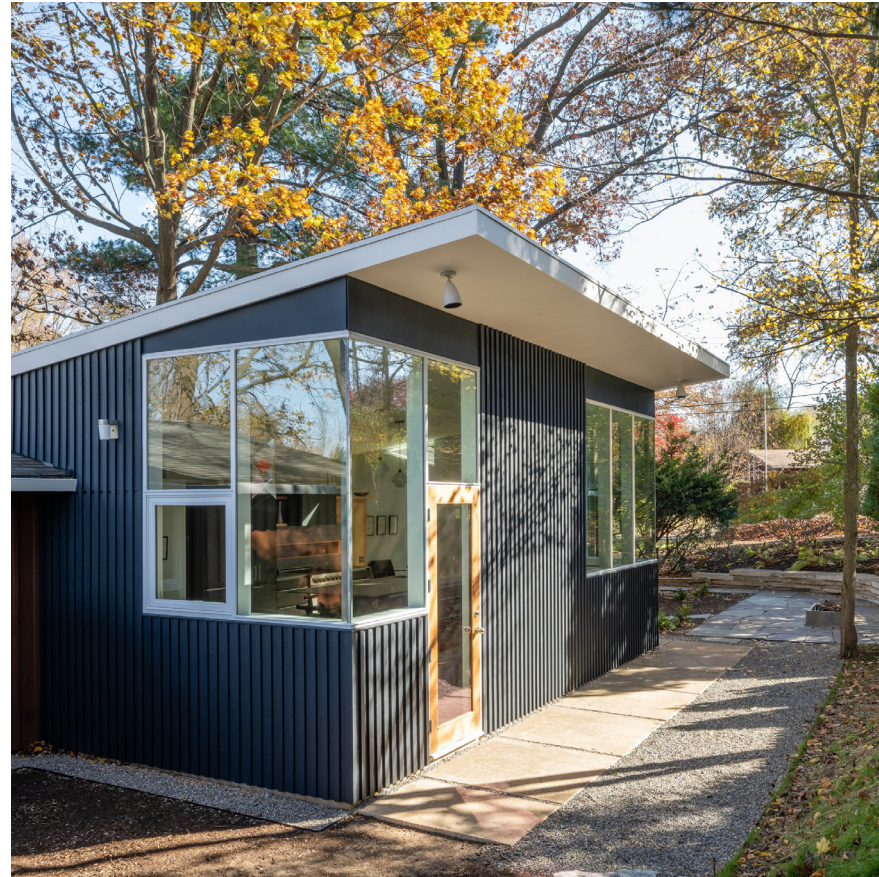
project: New Pendleton Home, Cook Architecture

## WOOD FRAME WINDOWS

New window frames to be custom fabricated on site, using 2x6 or 2x8 select Douglas Fir lumber and painted white with satin finish to match existing.
