MONTGOMERY COUNTY HISTORIC PRESERVATION COMMISSION
STAFF REPORT

Address:	10212 Montgomery Ave., Kensington	Meeting Date:	4/8/2026
Resource:	Primary One Resource Kensington Historic District	Report Date:	4/1/2026
Applicant:	Warner Circle Mansion Condominiums, LLC (Karl Voglmayr, Agent)	Public Notice:	3/25/2026
Review:	HAWP	Tax Credit:	n/a
Permit No.:	1053565 REVISION #4	Staff:	Dan Bruechert
Proposal:	Installation of Mechanical Equipment and Window Replacement

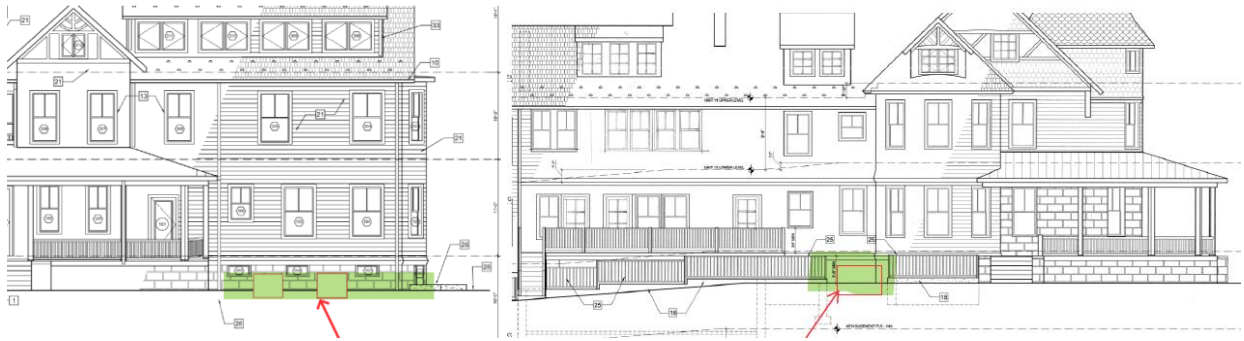
Figure 2: Two of the relocated HVAC units are on the north elevation (left) and one is on the east elevation (right).

Approved HAWP located several of the outdoor HVAC units within window wells. The applicant, in consultation with the project engineer, determined that the window wells do not provide the necessary clearance and air circulation to operate properly. The applicant proposes to relocate these units (see Fig. 2, below) from the window wells to an area immediately in front of the historic house. The units are low enough that they will only obscure the stone foundation and will not cover any of the wood siding. Additionally, the applicant proposes to plant shrubbery to limit the visibility of the units. Staff notes that while the additional shrubbery is appreciated, the HPC is charged to evaluate a proposal in the absence of vegetation.

Staff finds that it is unfortunate that these units lack the required air circulation to operate effectively in the window wells, but finds that the three units are unlikely to have a substantial impact on the character of the mansion. The small profile of the high efficiency units selected for the project will not visually compete with the large scale of the mansion house. Additionally, Staff finds that HVAC units are a common feature in a residential setting and the best course of action is to minimize their visual impact, as it is generally impossible to completely eliminate their visibility. Staff recommends the HPC approve the relocation of the three HVAC units under 24A-8(b)(2) and (d) and *Standard #2*.

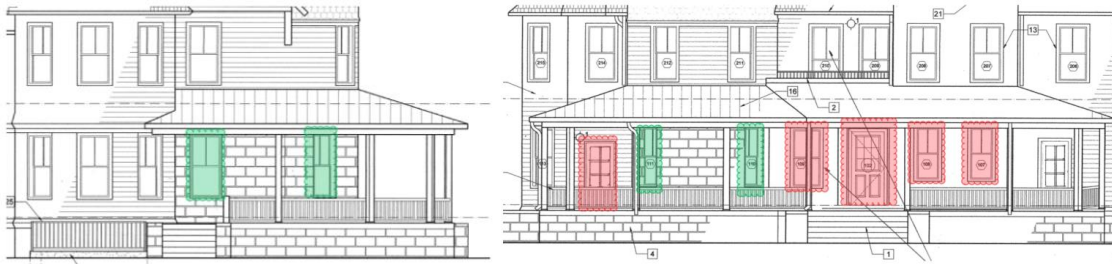
Figure 3: The three windows proposed for removal are located in the northeast corner of the house (shown in green).

The original HAWP approval included the restoration of eight front-facing windows on the first floor of the original mansion. Revisions to the interior plan have changed one of these spaces to a bedroom, which has to satisfy life-safety egress requirements, which the historic windows do not. The applicant proposes to remove these three windows and replace them with new wood windows that will satisfy code while matching the dimensions and profiles. Replacement windows will match the details of the approved wood replacement windows installed in the mansion house's other historic window openings. To mitigate the loss of these three windows, the applicant proposes to restore and reinstall two

Staff finds the loss of the historic windows is unfortunate, but that the revision is required to satisfy life-safety requirements, a justification considered under 24A-8(b)(4). Staff finds restoring the two doors as mitigation is generally appropriate, but welcomes any other recommended measures from the commissioners. When evaluated in its totality, Staff still finds the overall project is consistent with the requirements of 24A, the *Standards*, and the *Vision*.

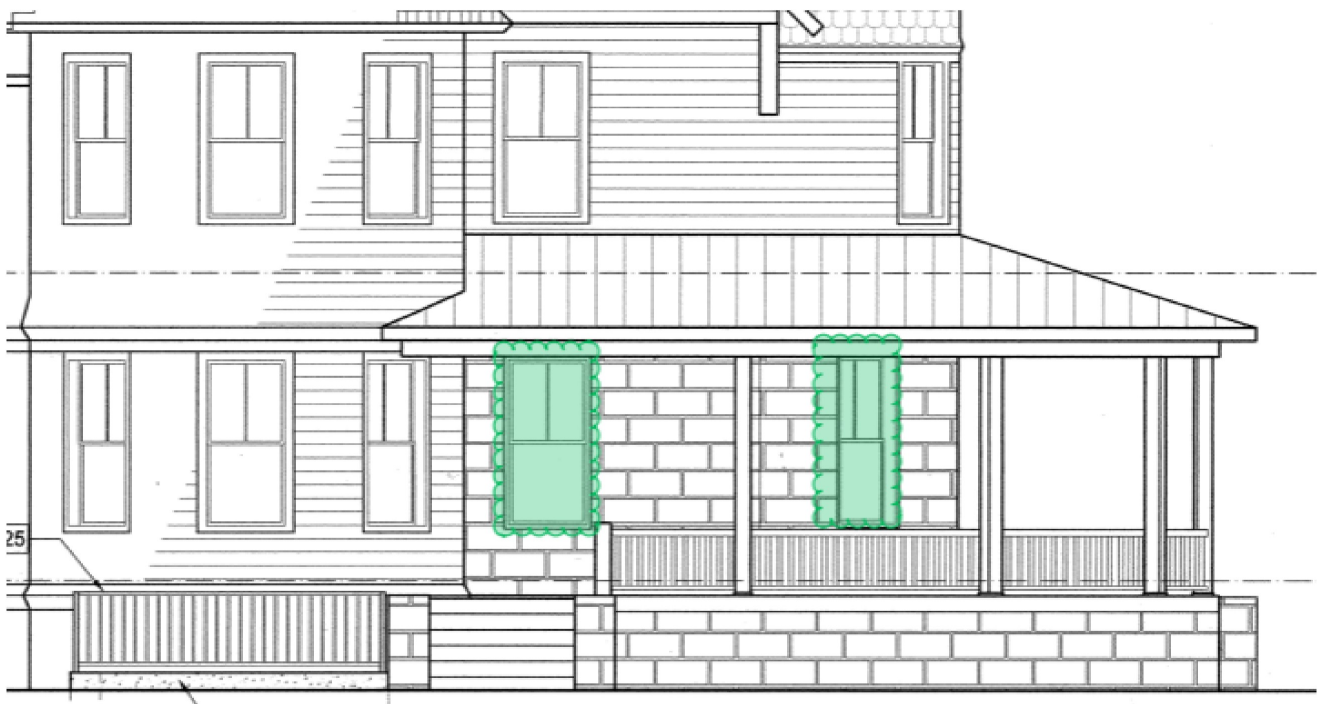
EAST ELEVATION

Windows being replaced with wood windows
