Preliminary Consultation
MONTGOMERY COUNTY HISTORIC PRESERVATION COMMISSION
STAFF REPORT

Address:	3710 Bradley Ln., Chevy Chase	Meeting Date:	4/22/2026
Resource:	Non-Contributing Resource Chevy Chase Village Historic District	Report Date:	4/15/2026
Applicant:	Robyn Segal	Public Notice:	4/8/2026
Review:	Preliminary Consultation	Staff:	Dan Bruechert
Proposal:	Partial Demolition, Building Addition, Accessory Structure Modifications, Tree Removals, and Hardscape Alteration

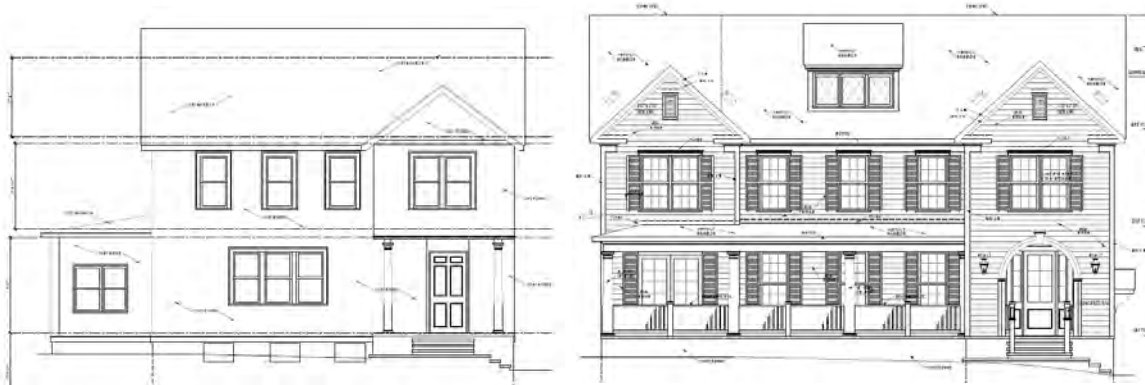
Figure 2: Existing front elevation (left) and proposed (right).

The existing front door is covered by a second-story, front gable addition. The applicant proposes to enclose the area below the addition, creating a recessed opening, entered through an arch. New siding will be fiber cement and match what is proposed for the rest of the house. Staff finds the existing entrance is not a traditional form and that it does not contribute to the district's historic character. On the east (left) elevation, the applicant proposes to eliminate most of the window openings. On the left side of the house, the applicant proposes to construct a 17' (seventeen-foot) wide addition (see Fig. 2, below). The roof line over the addition is an extension of the main gable, matching its height and pitch. This section of the addition also has a front-facing gable, slightly smaller than the existing front gable over the entrance on the right side. The applicant proposes to construct a front porch, covered by a

hipped roof supported by columns, with a Trex Transcend railing.

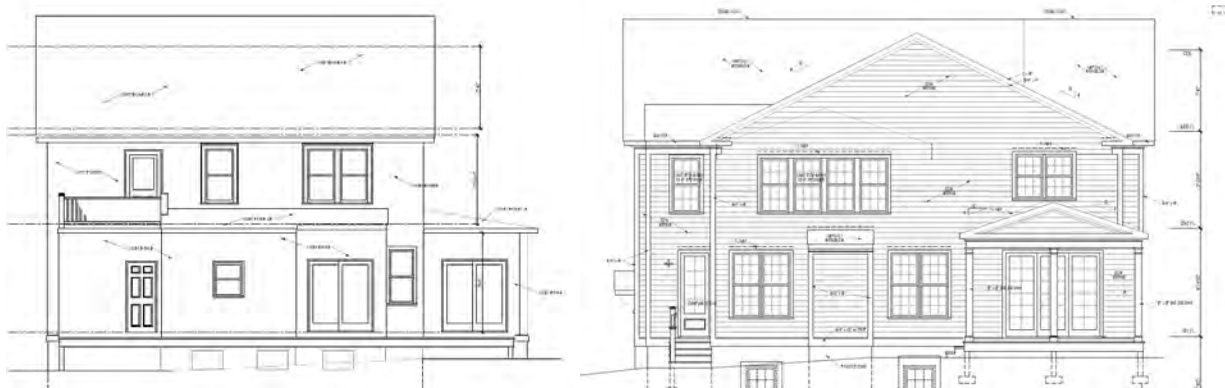
Figure 3: Existing rear addition (left) and proposed (right).

On the rear of the house, the applicant proposes to demolish a non-historic, one-story rear addition and construct a large two-story rear-gable addition with a rear gable screened-in porch (see Fig. 3, below). The proposed addition is approximately 20' (twenty feet) deep and extends across almost the full width of the rear. Proposed windows are a mix of six-over-six and nine-over-nine sash windows, with a multi-light sliding glass door providing access to the screened-in porch.

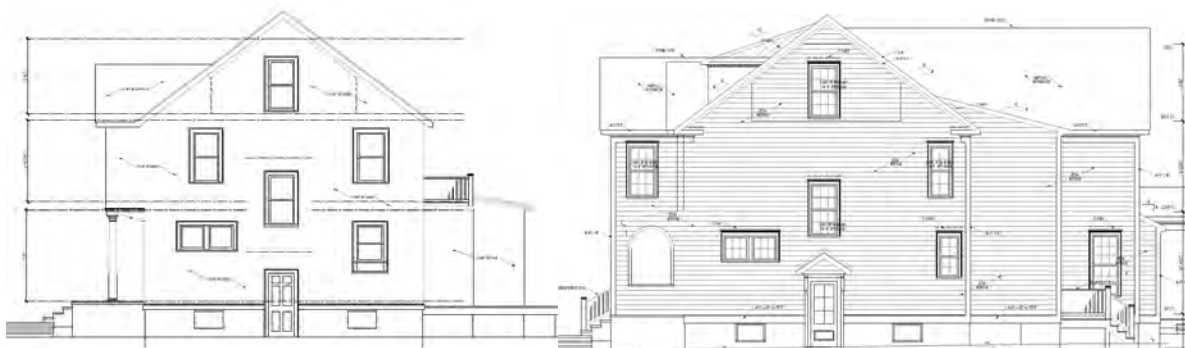
Figure 4: Existing west elevation (left) and proposed (right).

On the west (right) elevation, the applicant proposes to relocate one window in the existing portion of the house and to narrow the two rear-most window openings. The proposed addition has blank walls, except for one first-floor west-facing nine-over-nine sash window.

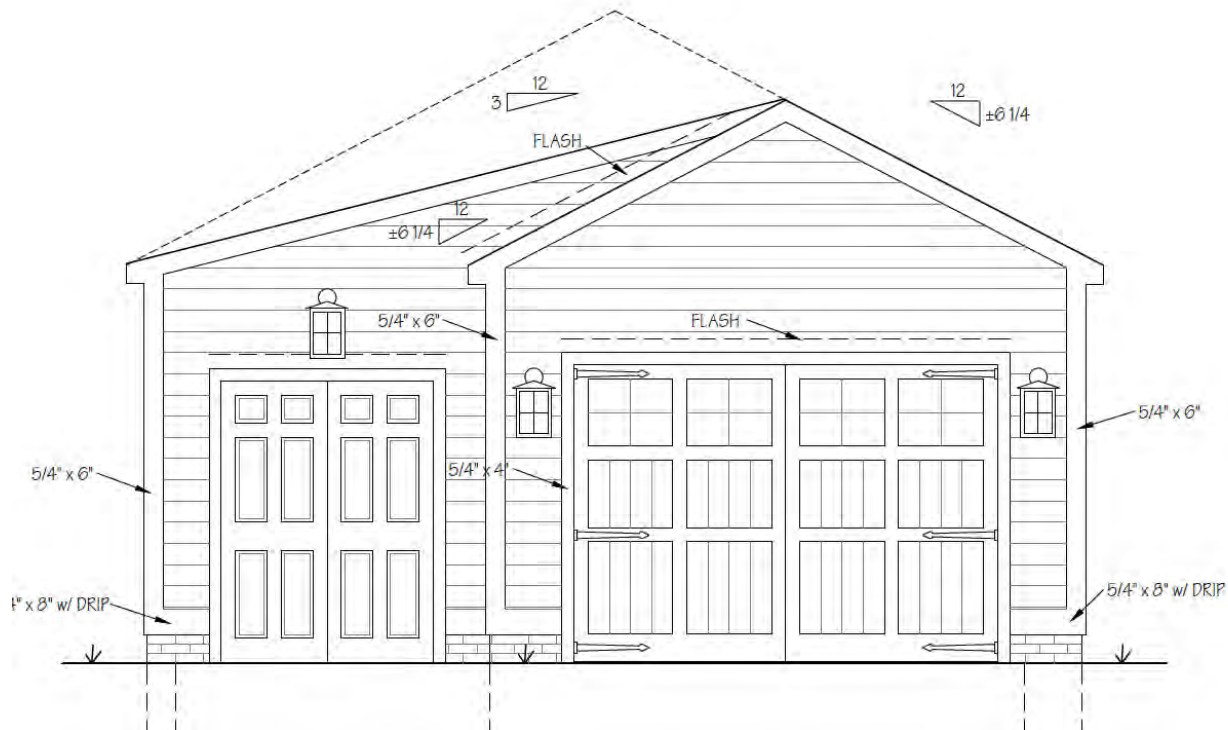
Figure 5: The proposed garage modifications, with the existing roofline shown as a dashed line.

In the southeast corner of the subject property, there is a painted brick, two-car garage with a metal roll-up door. The Master Plan Amendment establishing the historic district categorizes the garage as Non-Contributing. Approximately 8' (eight feet) of the garage will be demolished, leaving a one-bay garage and a small shed-roofed storage area. The roof of the garage will be reconstructed, lowering the ridge height by approximately 3' (three feet). Additional changes include installing new siding and trim to match the house, a pair of doors to the storage area, new carriage style garage doors, and a half-lite door and six-over-six window. The new siding will leave a small overhang exposing a portion of the existing brick siding. Architectural roof shingles and half-round gutters will also match the materials proposed for the house.

As a Non-Contributing Resource, the *Design Guidelines* allow for extensive alterations up to and including demolition. Based on the guidance provided in the *Design Guidelines*, most alterations to Non-Contributing garages should be approved as a matter of course. Nevertheless, Staff finds the proposed changes to the garage are in keeping with the character of the site and surrounding historic district. Staff finds detailed specifications for the garage doors and exterior lighting are required for a complete HAWP application.

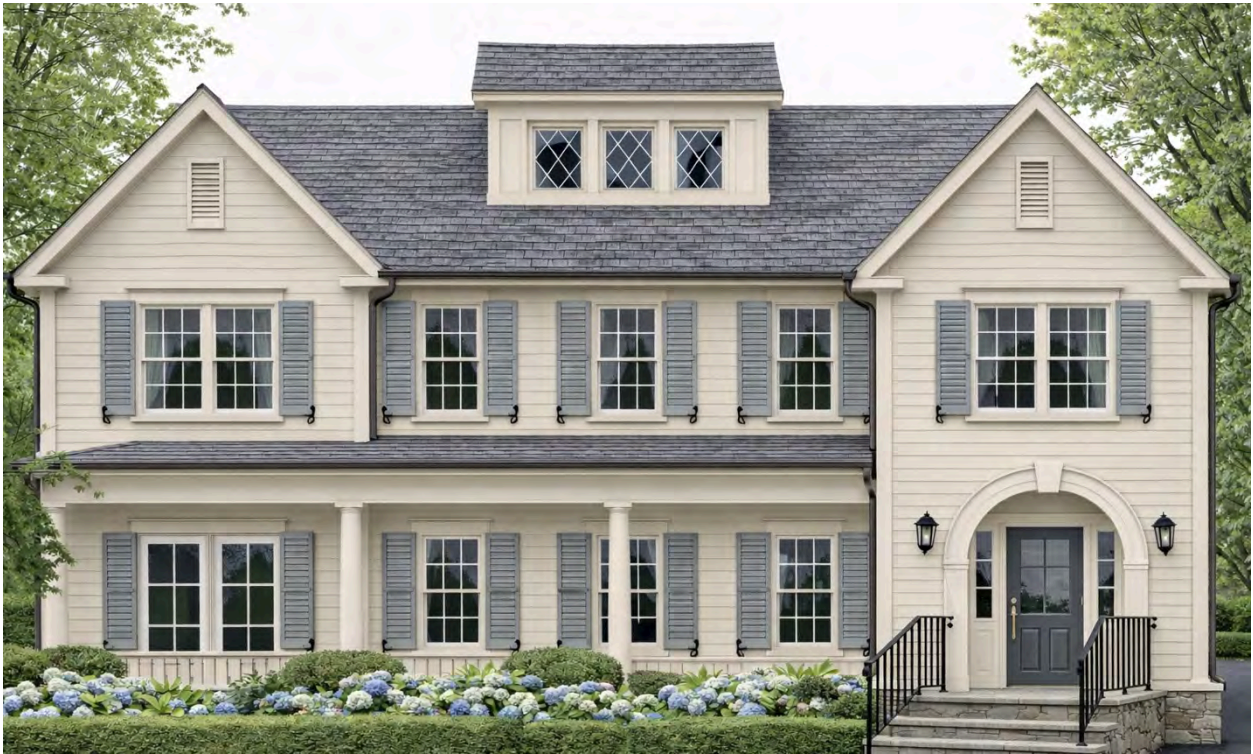
**Illustrative purposes, bottom windows are 9 over 9. This image shows 6 over 6. Additionally, the landing & stairs to the front door are going to be oriented towards the driveway like the current layout

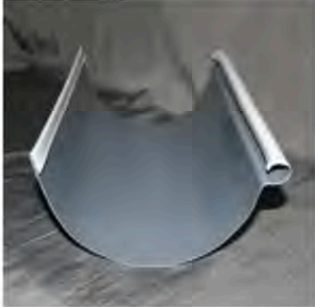
6" Half Round Gutter

Plain smooth 4" round downspout available in all colors in .019 aluminum and copper.

Thicker gauges available up to .032 aluminum.

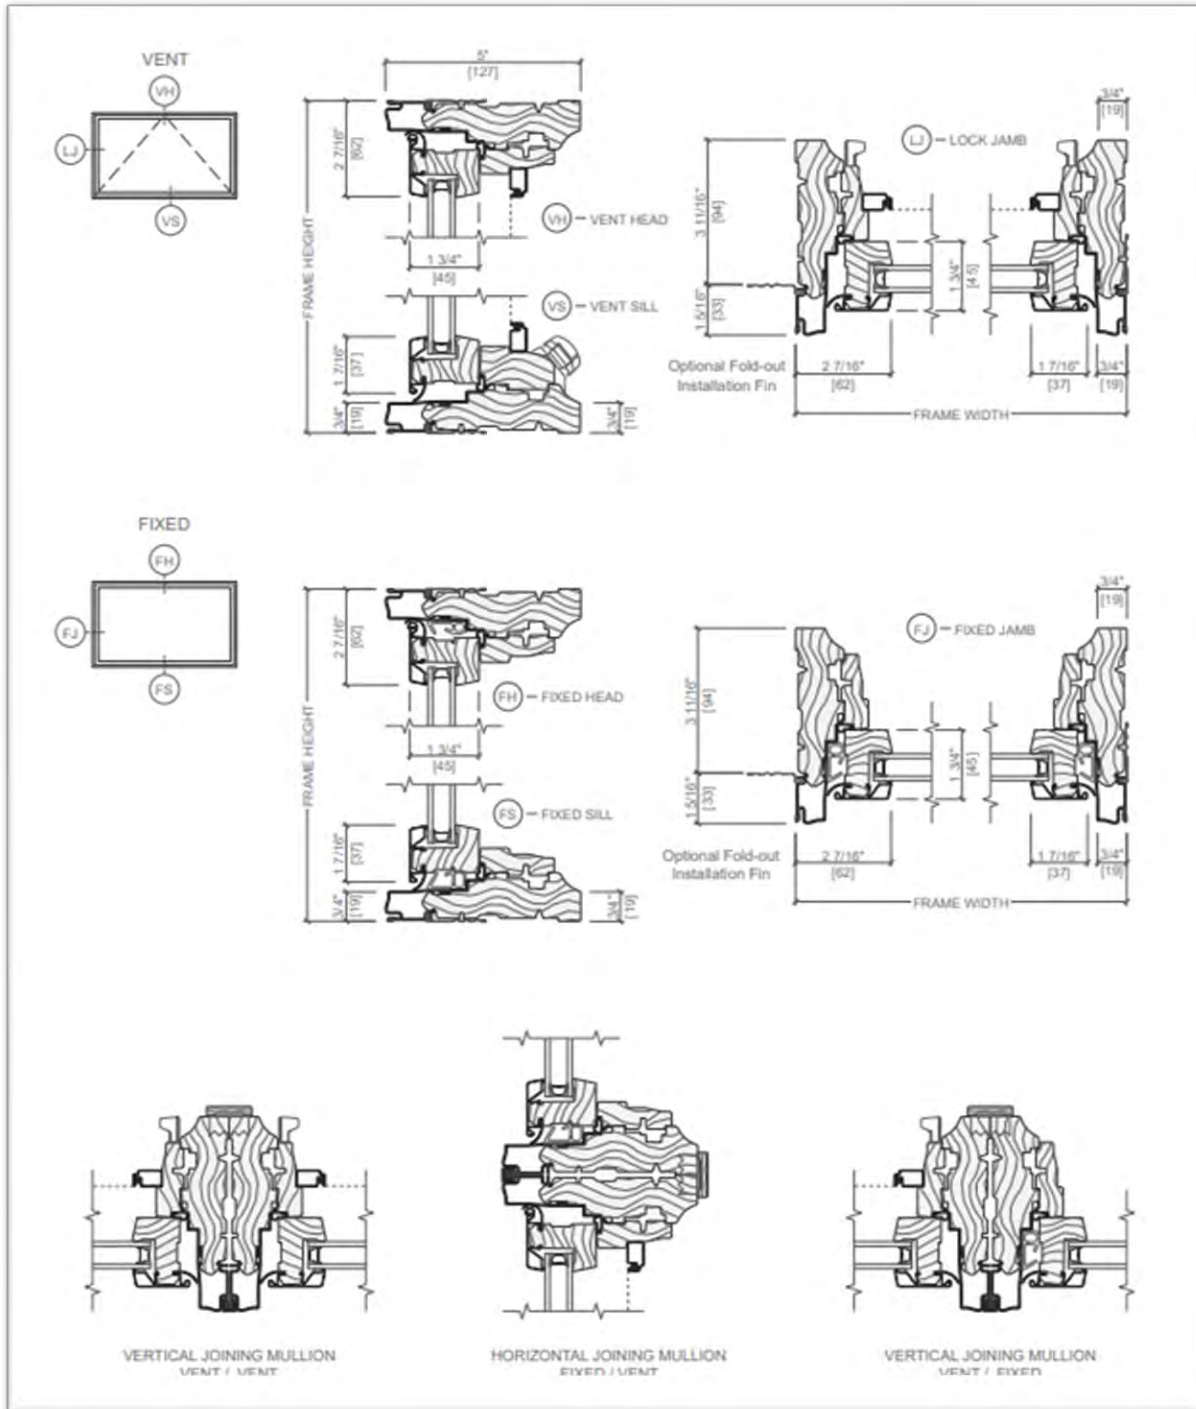
Pella Lifestyle Awning Windows

- Dual Pane Vent
- SDL Grilles w/ Optional Spacer
- Traditional 6-Light or Diamond Pattern (Front Elevation)

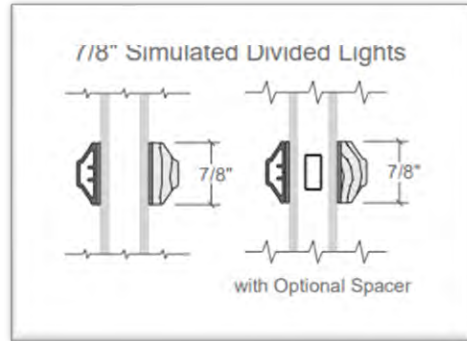
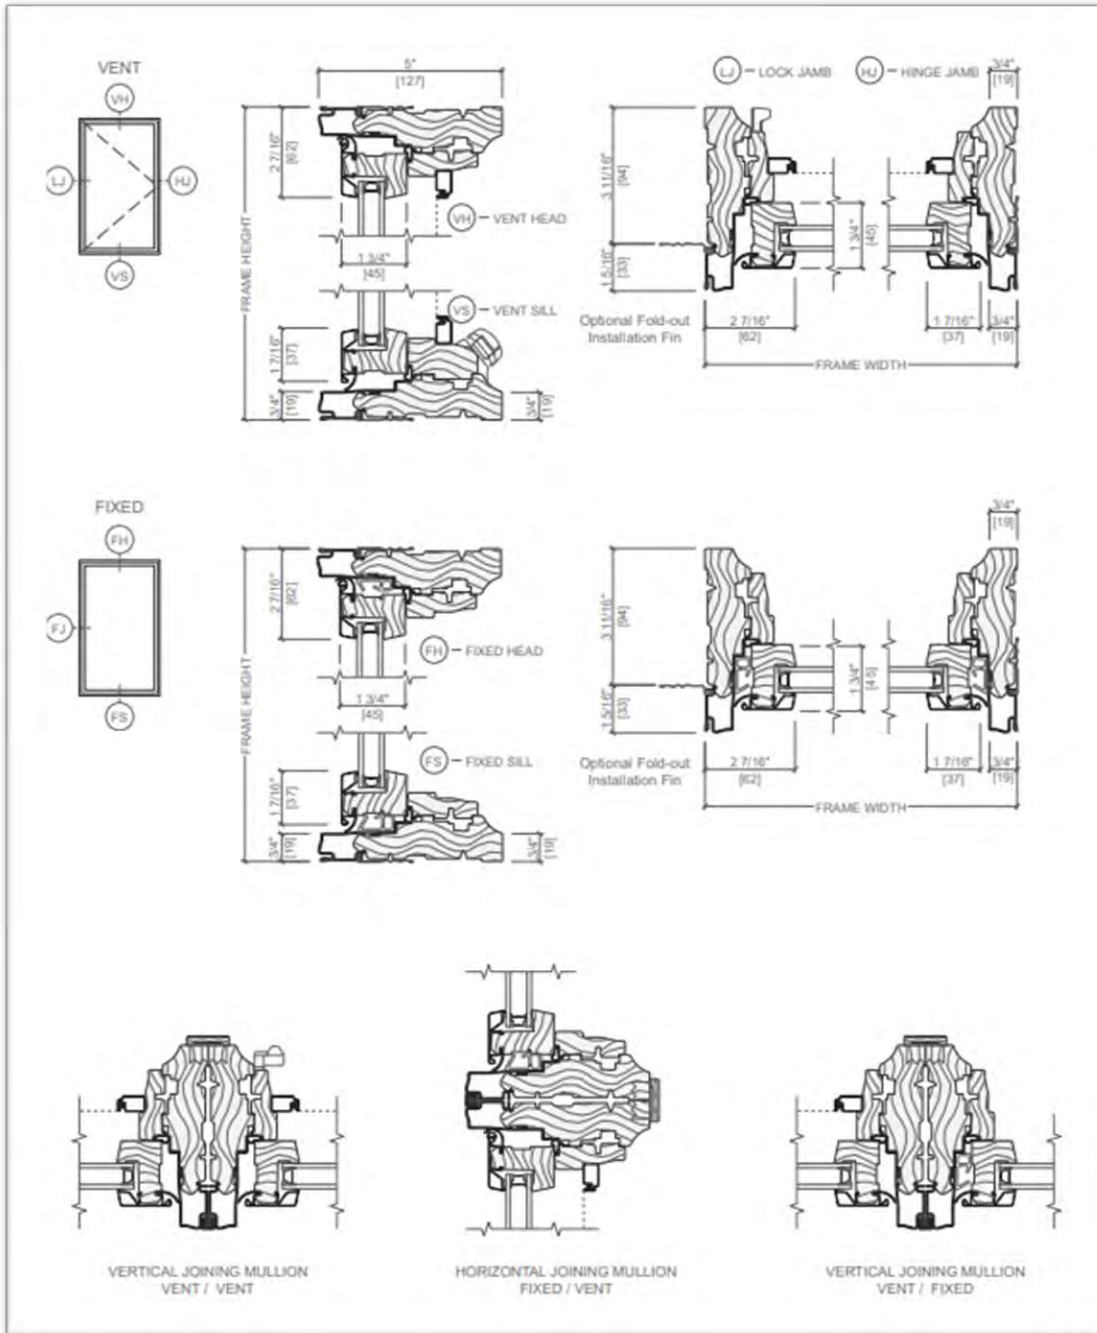
Pella Lifestyle Casement Windows

- Dual Pane Vent
- SDL Grilles w/ Optional Spacer
- Traditional 8-Light Pattern

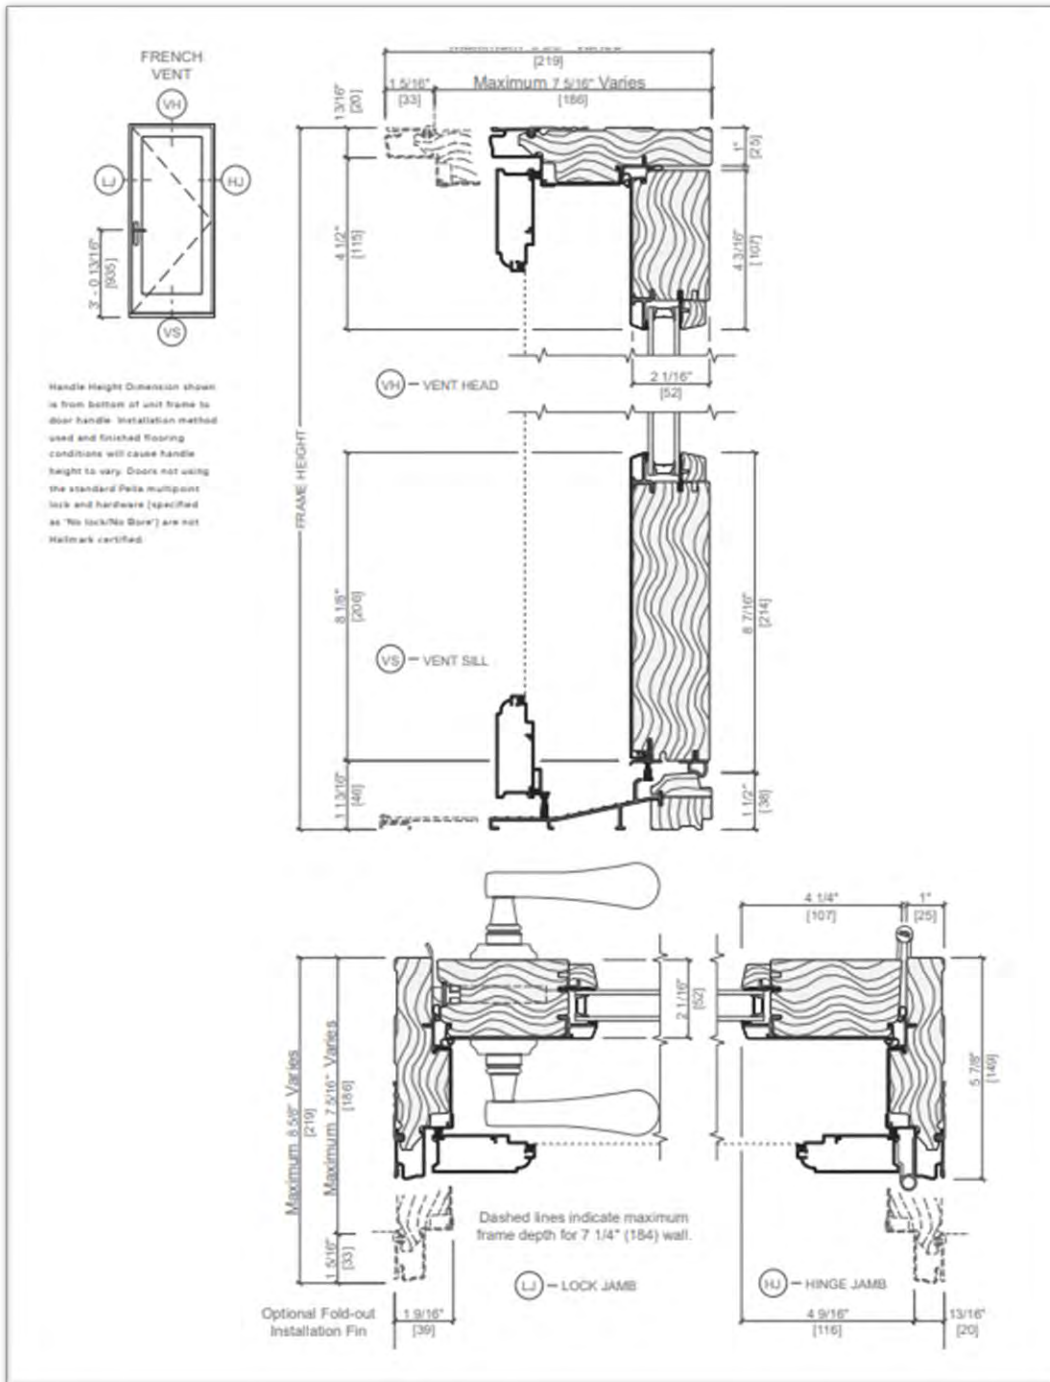
Pella Lifestyle In-Swing Patio Doors

- Dual Pane
- SDL Grilles w/ Optional Spacer
- Traditional 6 or 8-Light Pattern

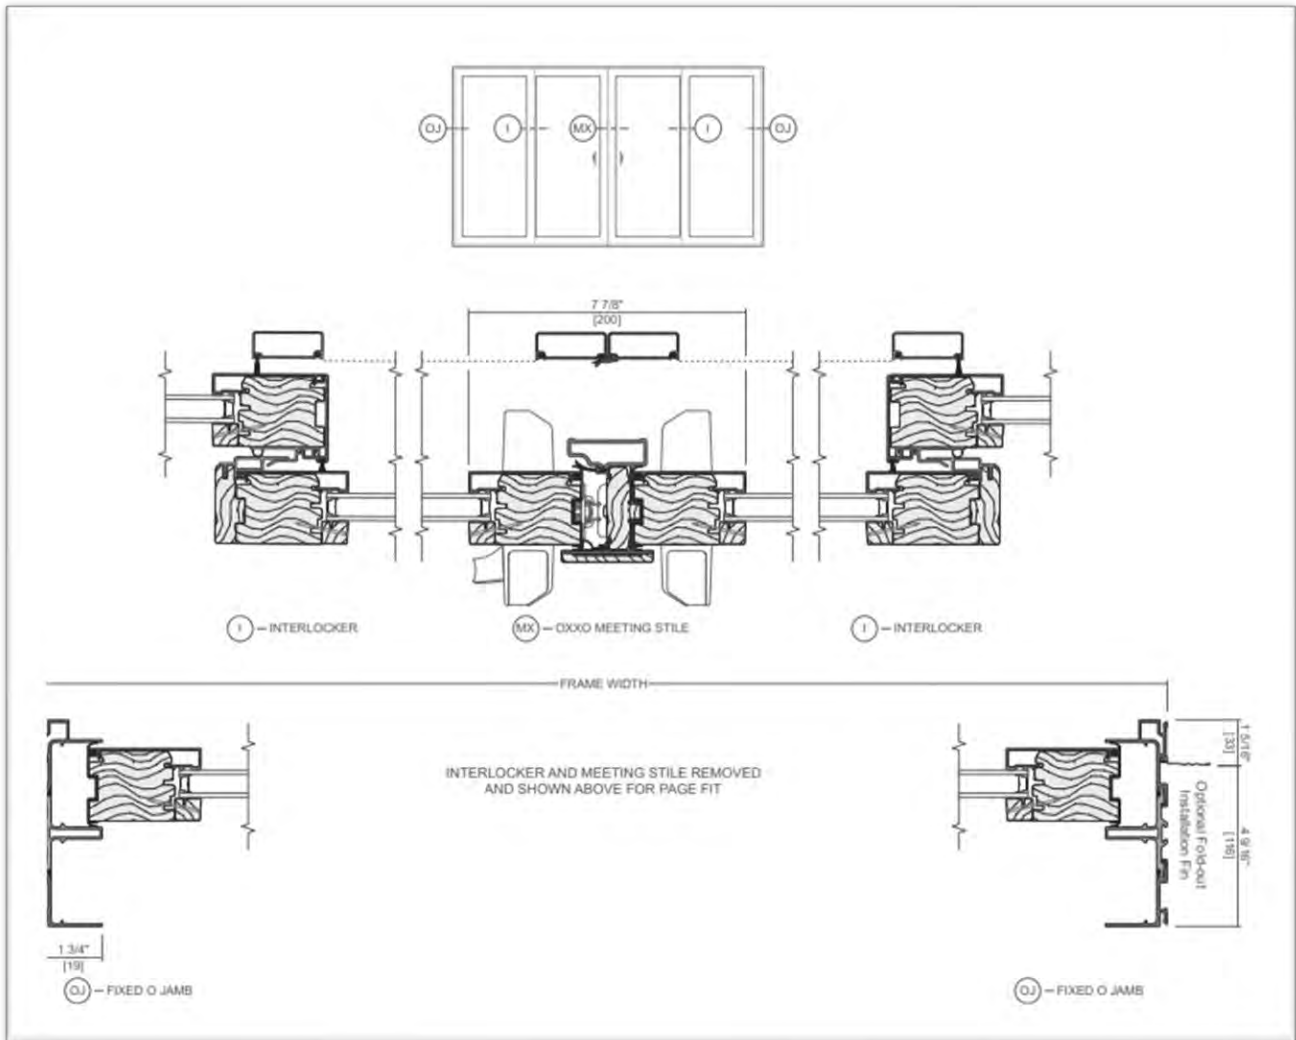
Pella Lifestyle Sliding Patio Doors

- Dual Pane
- SDL Grilles w/ Optional Spacer
- Traditional 12-Light Pattern
