MO	MONTGOMERY COUNTY HISTORIC PRESERVATION COMMISSION STAFF REPORT						
Address:	21414 Georgia Avenue, Brookeville	Meeting Date:	8/12/2020				
Resource:	Master Plan Site #23/45 (Greenwood Miller's Cottage and Mill Site)	Report Date:	8/5/2020				
Applicant:	Montgomery Parks (Scott Whipple, Agent)	Public Notice: Tax Credit:	7/29/2020 N/A				
Review:	HAWP	Staff:	Michael Kyne				
Case Number:	23/45-20A						
PROPOSAL:	Demolition of accessory buildings

SIGNIFICANCE: Individually Listed Master Plan Site #23/45, Greenwood Miller's Cottage and Mill Site DATE: Mid 1800s

Scope of Work
 Application to demolish two non-contributing accessory structures.

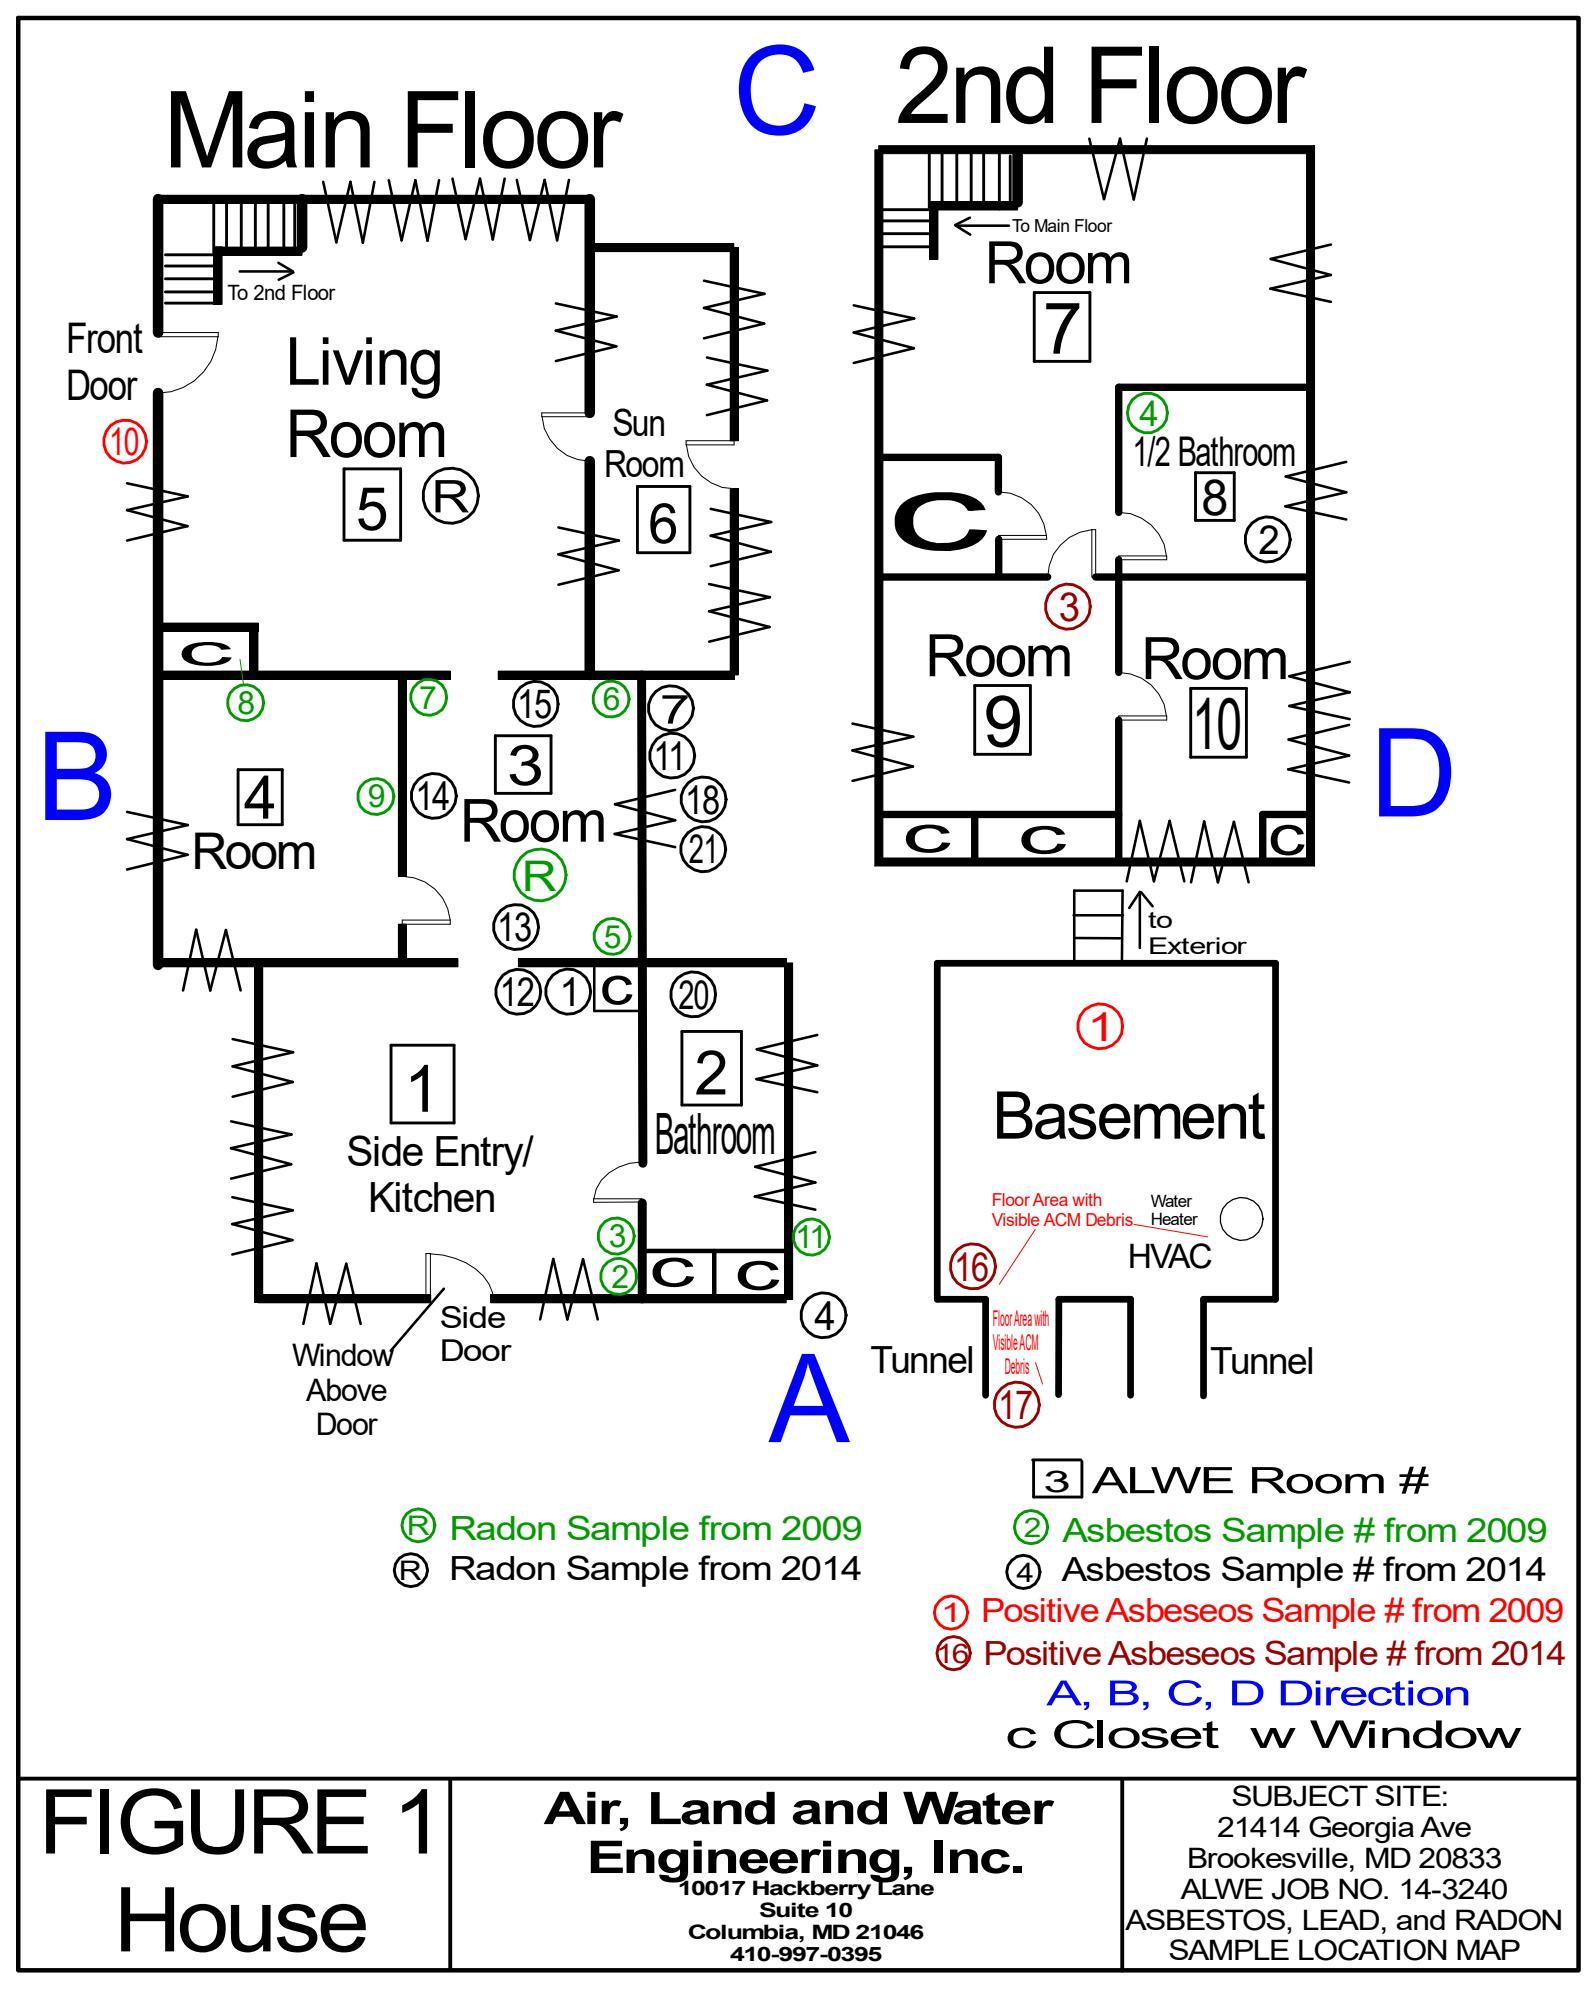
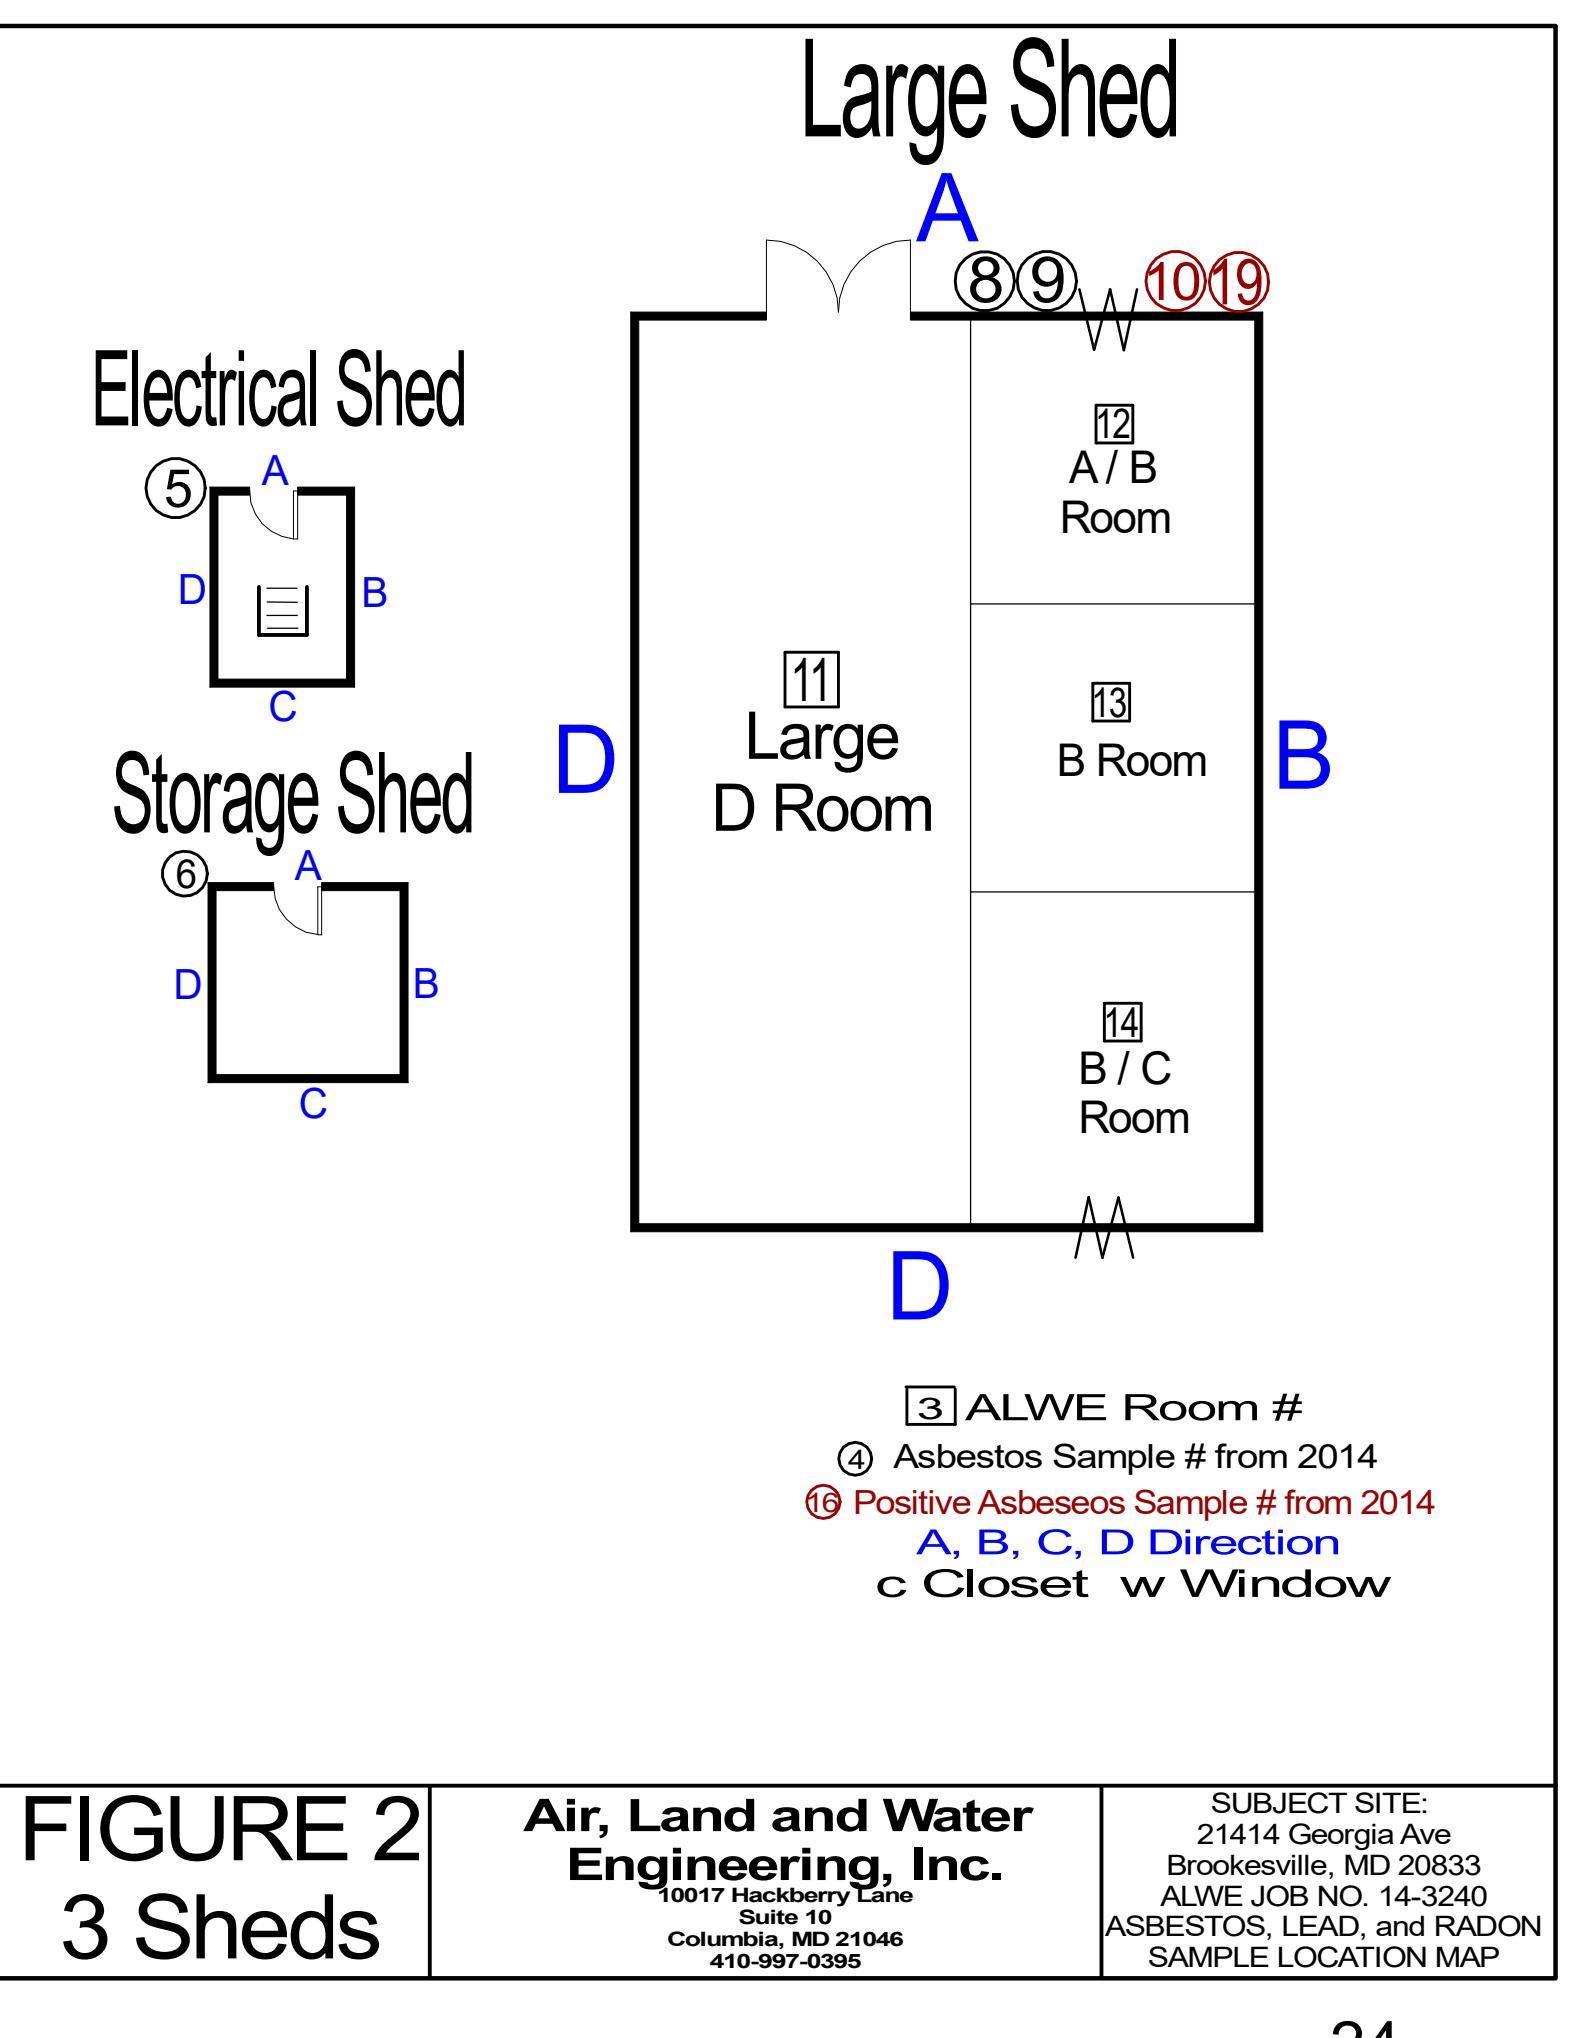
> APPENDIX B SITE SKETCH WITH ASBESTOS SAMPLE LOCATIONS

Both sets of laboratory data are included in Appendix A. A Figure with the House and 3 Sheds is included in Appendix B with the asbestos sample locations is provided in Appendix B.

The Ceramic Tile Mastic was found to contain 15% Chrysotile Asbestos. This material was found to be present in the ½ Bathroom (ALWE Room 8) throughout each of the lower walls (75 square feet), and at Walls C and D of ALWE Room 9 (25 square feet) for a total of 100 square feet present. This material was described by the laboratory as having a tan/cream/olive appearance. This material was not sampled in the original survey because the condition of this material had deteriorated, allowing the mastic to be visible. Please note that a similar material located at the Bathroom (ALWE 2) of Yellow Mastic Dots, located behind ceramic-designed metal outer walls had tested negative by laboratory analysis.

The Gray Wall Vapor Barrier (2nd Layer) was found to contain 30-50% Chrysotile Asbestos. This material is only present along each wall of the Large Shed. The outer (1st layer) material is described as exterior brick pattern siding shingle, and tested negative by laboratory analysis. ALWE initially sampled this material on May 12, 2014, and also took a confirmatory sample of this material on June 18, 2014, and both samples tested positive by laboratory analysis. Also on June 18, 2014, ALWE quantified this material and found that approximately **1,700 square feet was present**. Please note that the samples were taken from exposed areas along Wall A of the Large Shed, and the material was observed to be in poor condition.

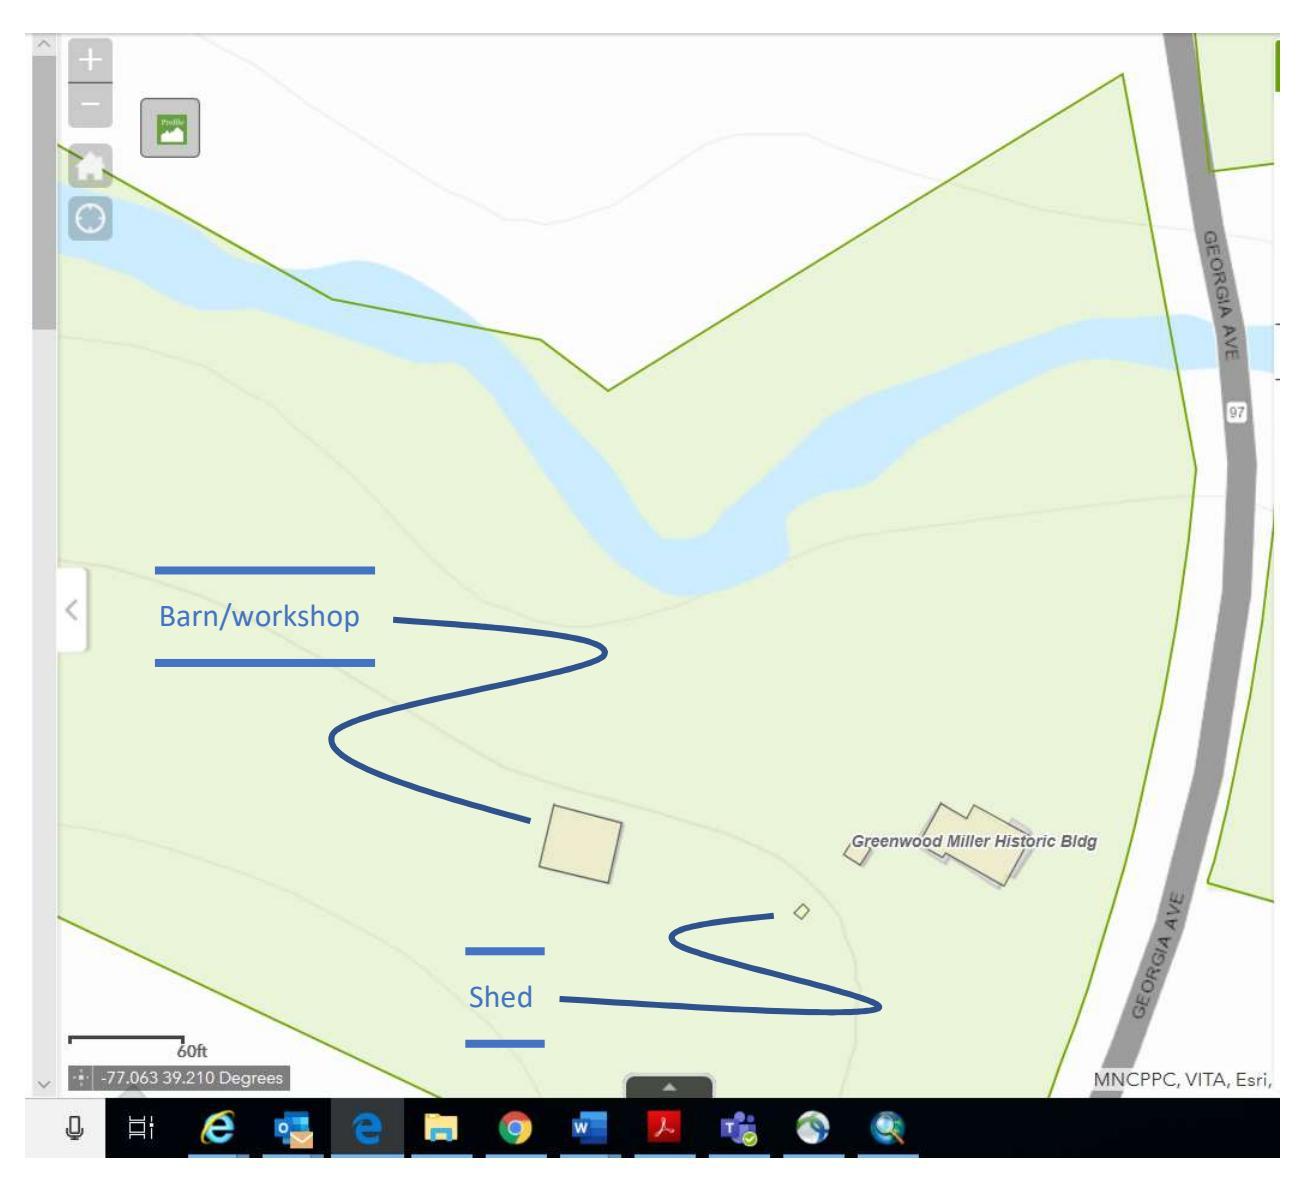
Greenwood Miller's Cottage, environmental setting detail Historic dwelling fronts Georgia Avenue

Non-contributing shed sits southwest of the dwelling; barn sits to the west, well-removed and buffered from the main dwelling

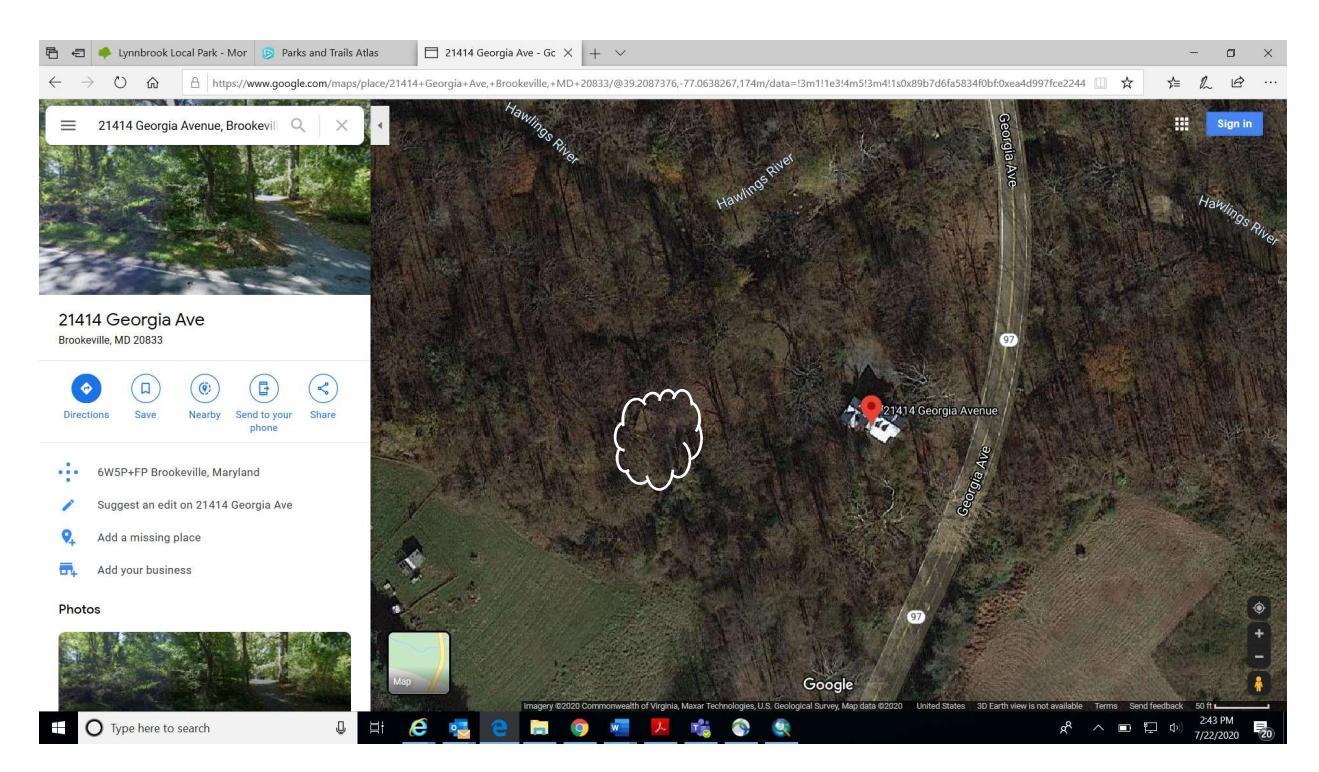
Greenwood Millers Cottage, aerial image and street view (Workshop in identified in cloud) <u>https://www.google.com/maps/place/21414+Georgia+Ave,+Brookeville,+MD+20833/@39.2087376,-</u> 77.0638267,174m/data=!3m1!1e3!4m5!3m4!1s0x89b7d6fa5834f0bf:0xea4d997fce2244b2!8m2!3d39.2 086888!4d-77.0631401

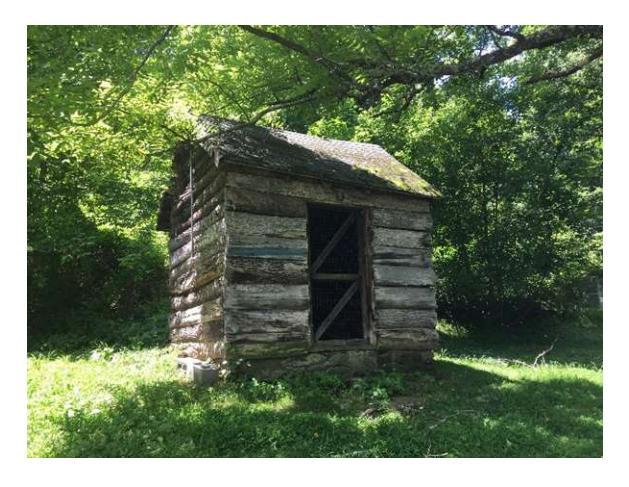
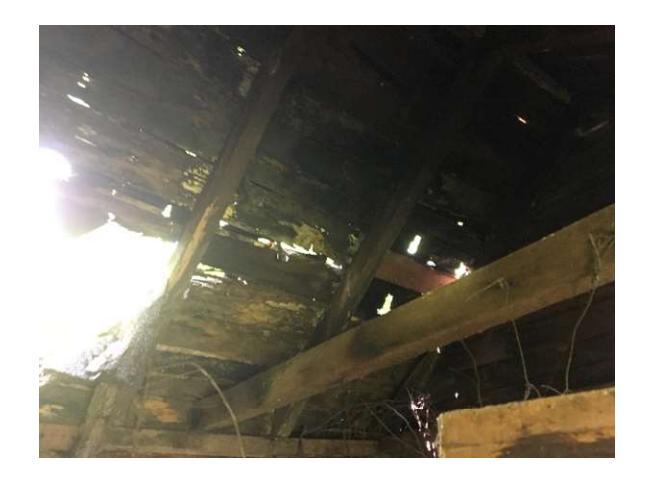
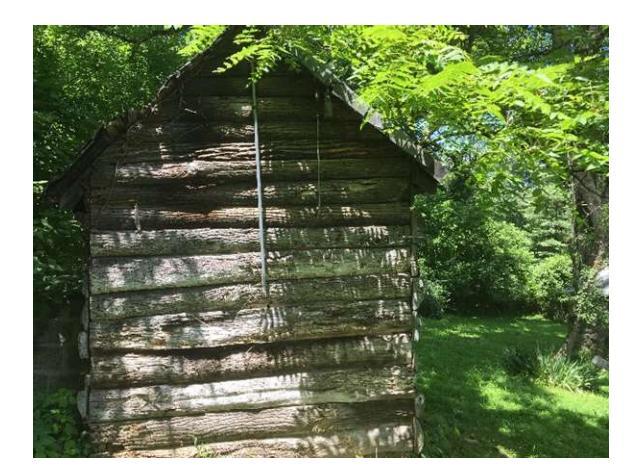
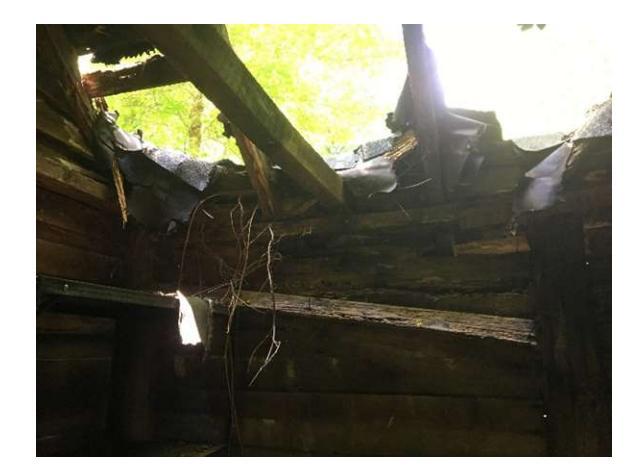
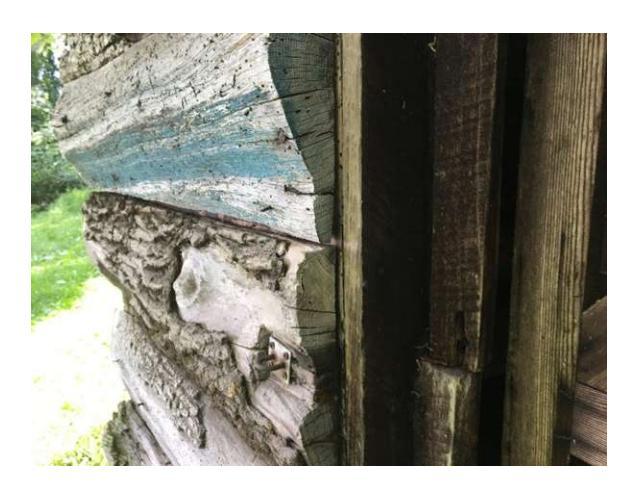
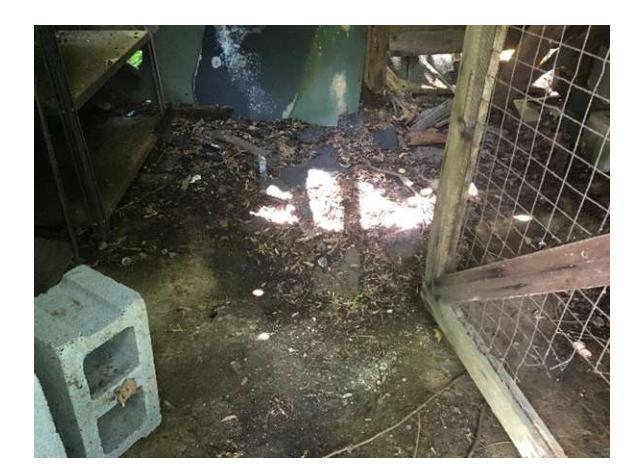
Photos: Shed

Work Item 1: Demo: shed	
Description of Current Condition: The small frame shed's roof has collapsed, the floor has deteriorated.	Proposed Work: Demolition.
Work Item 2: Demo: barn/workshop	
Description of Current Condition: Unused, fenced and overgrown. Deteriorating. Missing siding, exposing hazardous material-contai ning materials.	Proposed Work: Demolition. Demolition will include a tree protection plan, approved by Parks arborists.

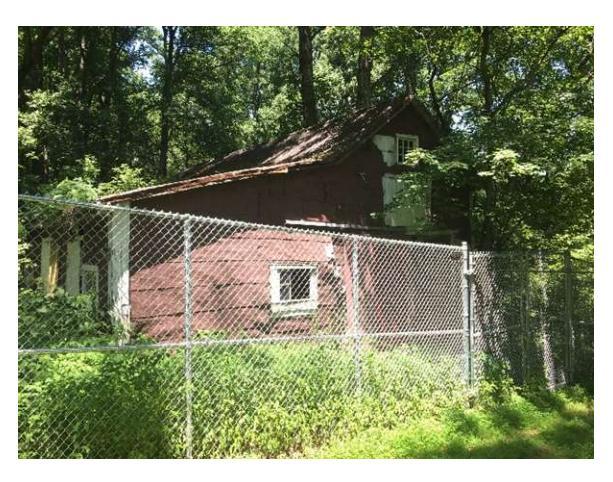
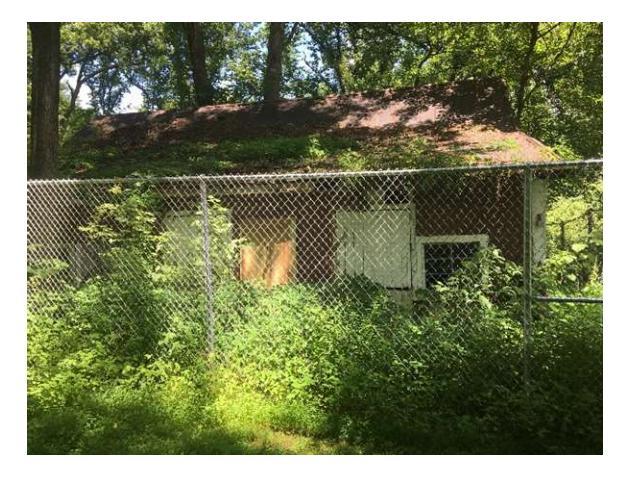
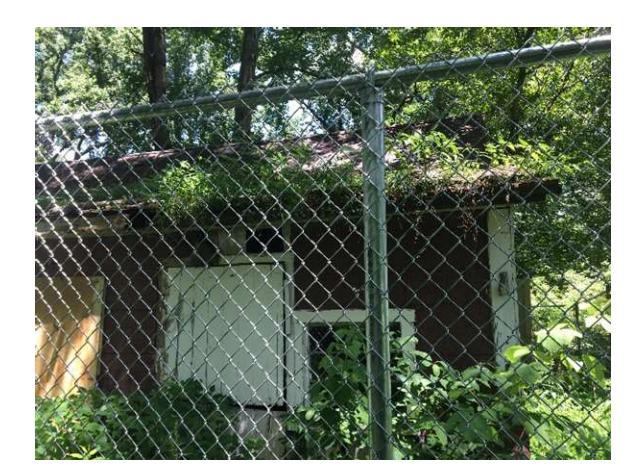
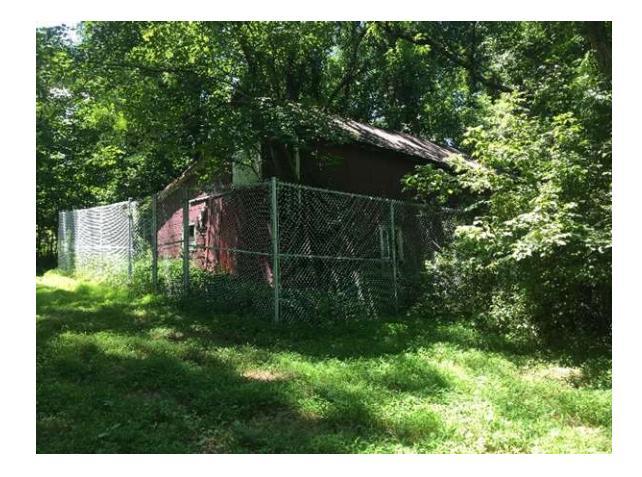
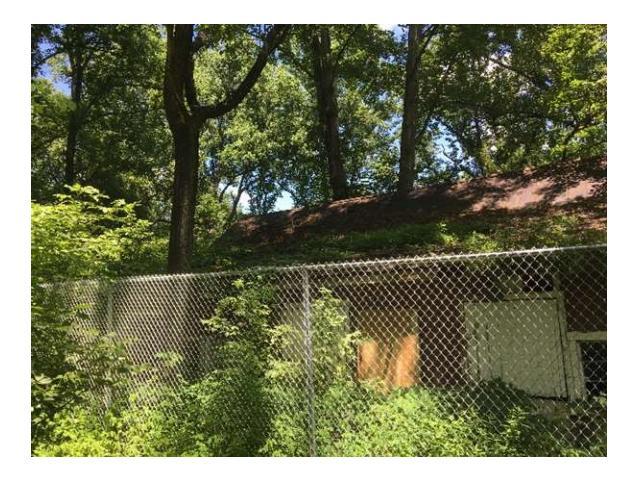
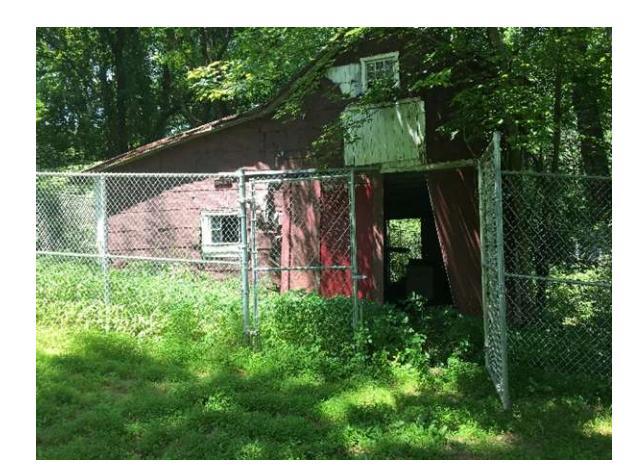
Photos: barn/workshop

Demolition of two non-contributing accessory structures, neither of which are identified in the survey documentation: 1) small storage shed/playhouse: The roof has collapsed and the floor is not sound. The building appears to be of log construction, but actually it is frame with a log veneer. It is pretty clearly twentieth century: dimensional lumber and wire nails. 2) barn/work shop, likely twentieth century, located toward the rear of the property some distance from the cottage. This building is in poor condition and sits unused; for some time it has been fenced to prevent access. A hazmat investigation found materials containing asbestos. It is being taken over by the surrounding forest and is deteriorating. Based on the survey documentation that I reviewed, it could post-date 1926 and possibly date to a building campaign on the property undertaken by owners who purchased it in the 1940s.
