Maryland Historical Trust Maryland Inventory of Historic Properties Form

Inventory No. 31-50

historic Viers Mill Recreation Center¹; Viers Mill Village Recreation Center
 other Veirs Mill Recreation Building (current name-preferred)

street and number Veirs Mill Local Park, 4425 Garrett Park Road __ not for publication
 city, town Wheaton __ vicinity
 county Montgomery

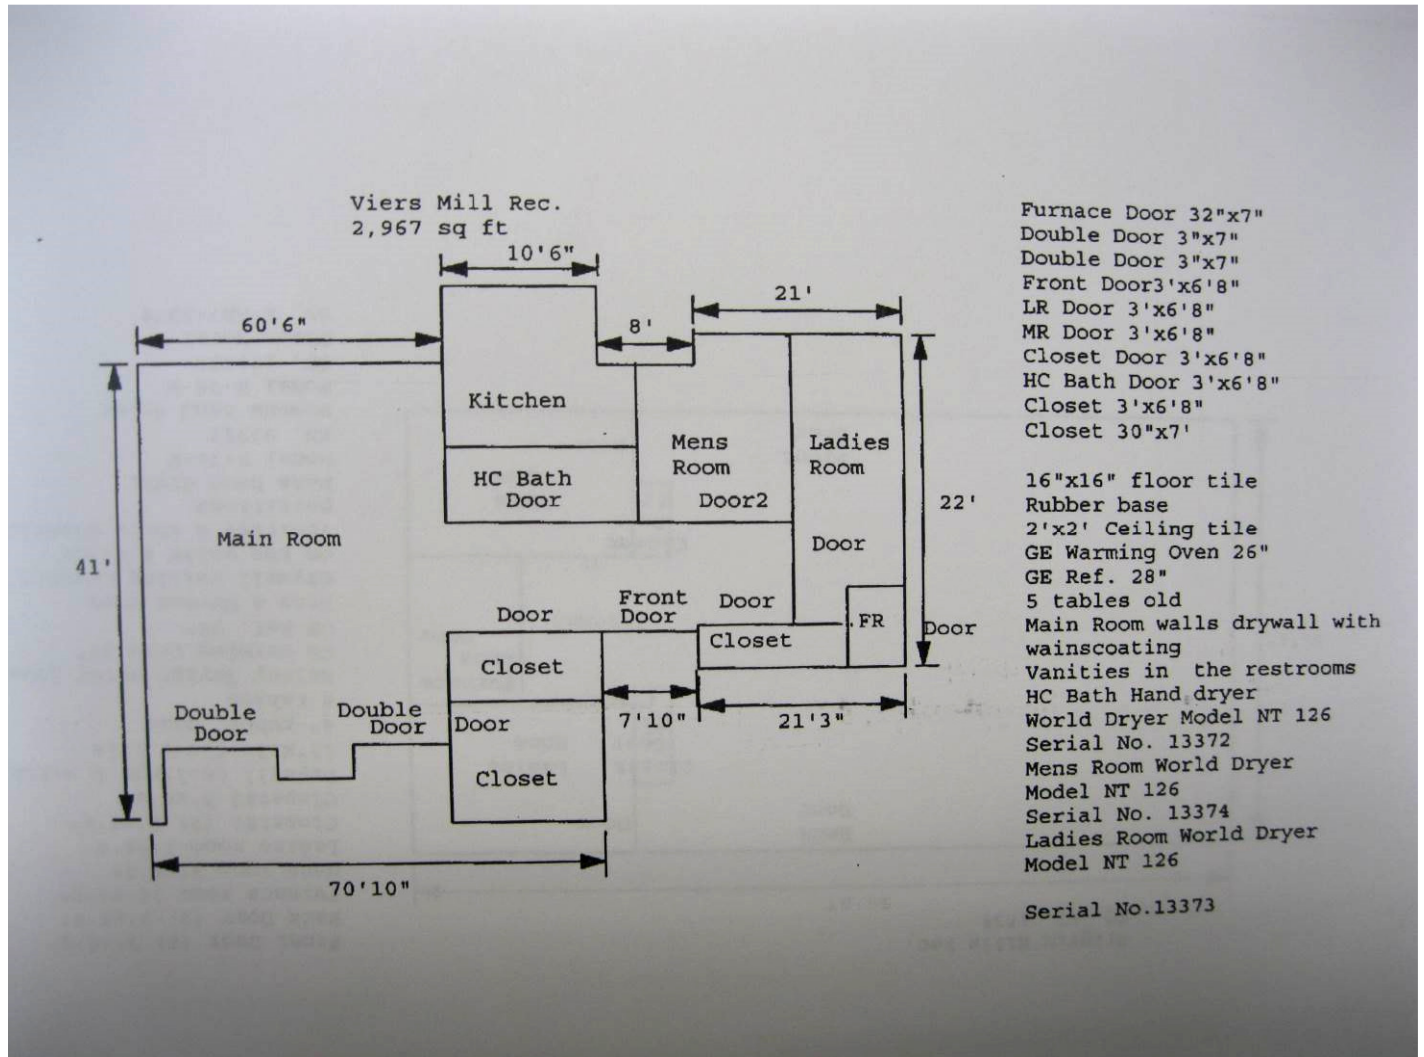
Facilities Management Floor Plan of Viers Mill Recreation Center, 2002. Courtesy: M-NCPPC

The interior of the main block has a large, open room finished in newer materials. Floors are vinyl tile. The ceiling is made of acoustic drop-in tiles with a regular pattern of infill fluorescent lighting. The facility has a kitchen, bathrooms, and ample storage.

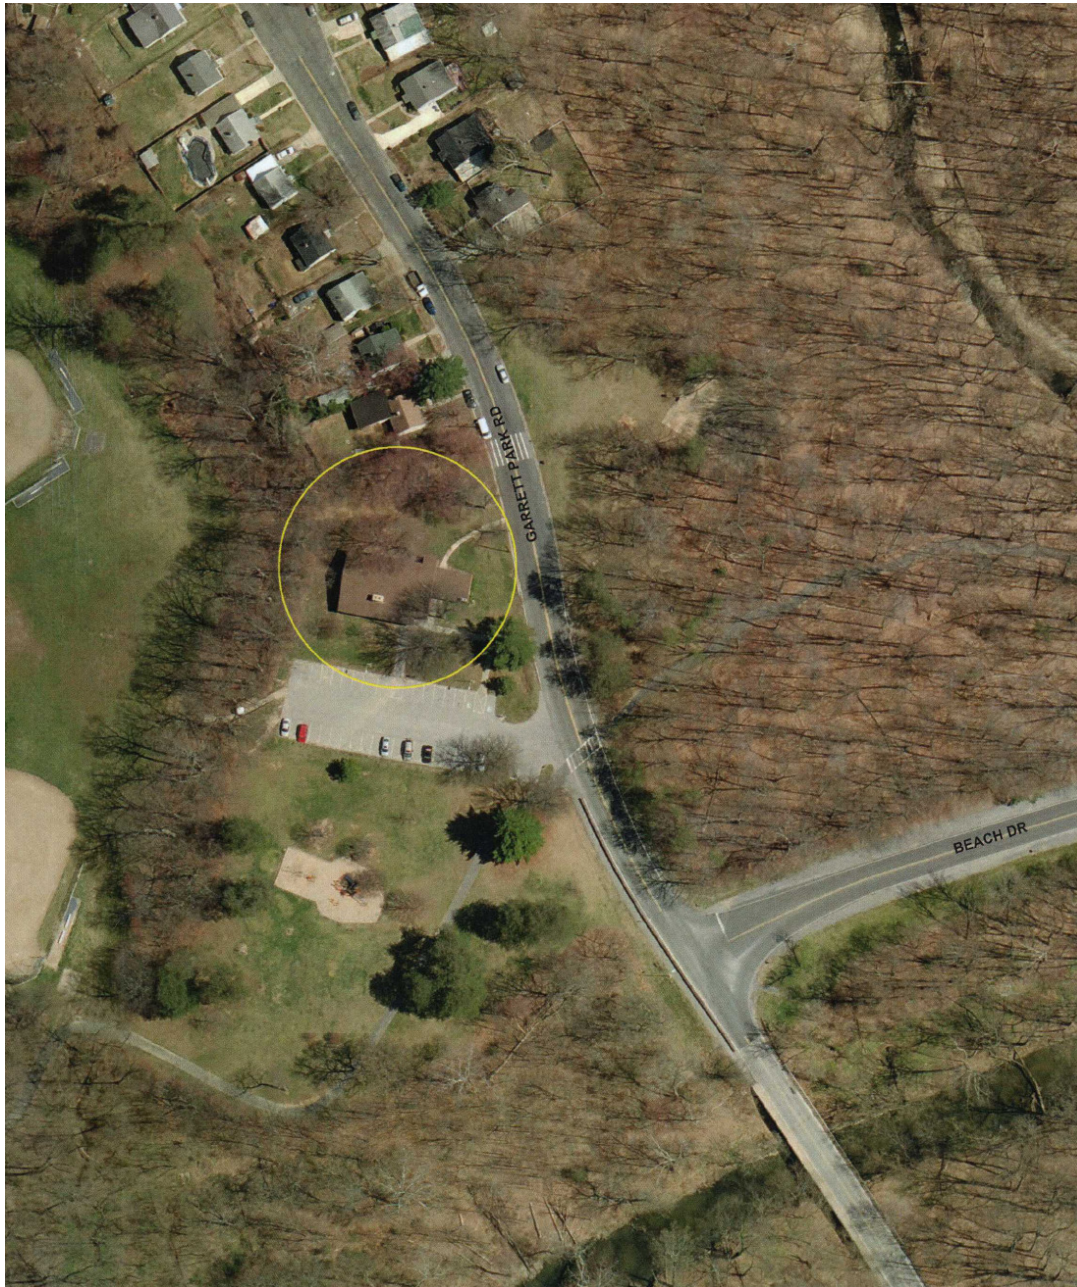
Figure 3. Aerial view of Veirs Mill Recreation Center, 2008. Courtesy: M-NCPPC.

Viers Mill Recreation Building is located on 17.52 acres at Garrett Park Road. The building is still surrounded to the west by an open lawn that includes playground equipment. The site has a rectangular, paved parking area in front of the building. The area to the north of the building that was originally designated for picnicking amid woodland is now made up of recreational fields, accessed via a series of descending steps. Basketball courts sit at the edge of the wooded trail that threads along Beach Drive in Rock Creek Park.

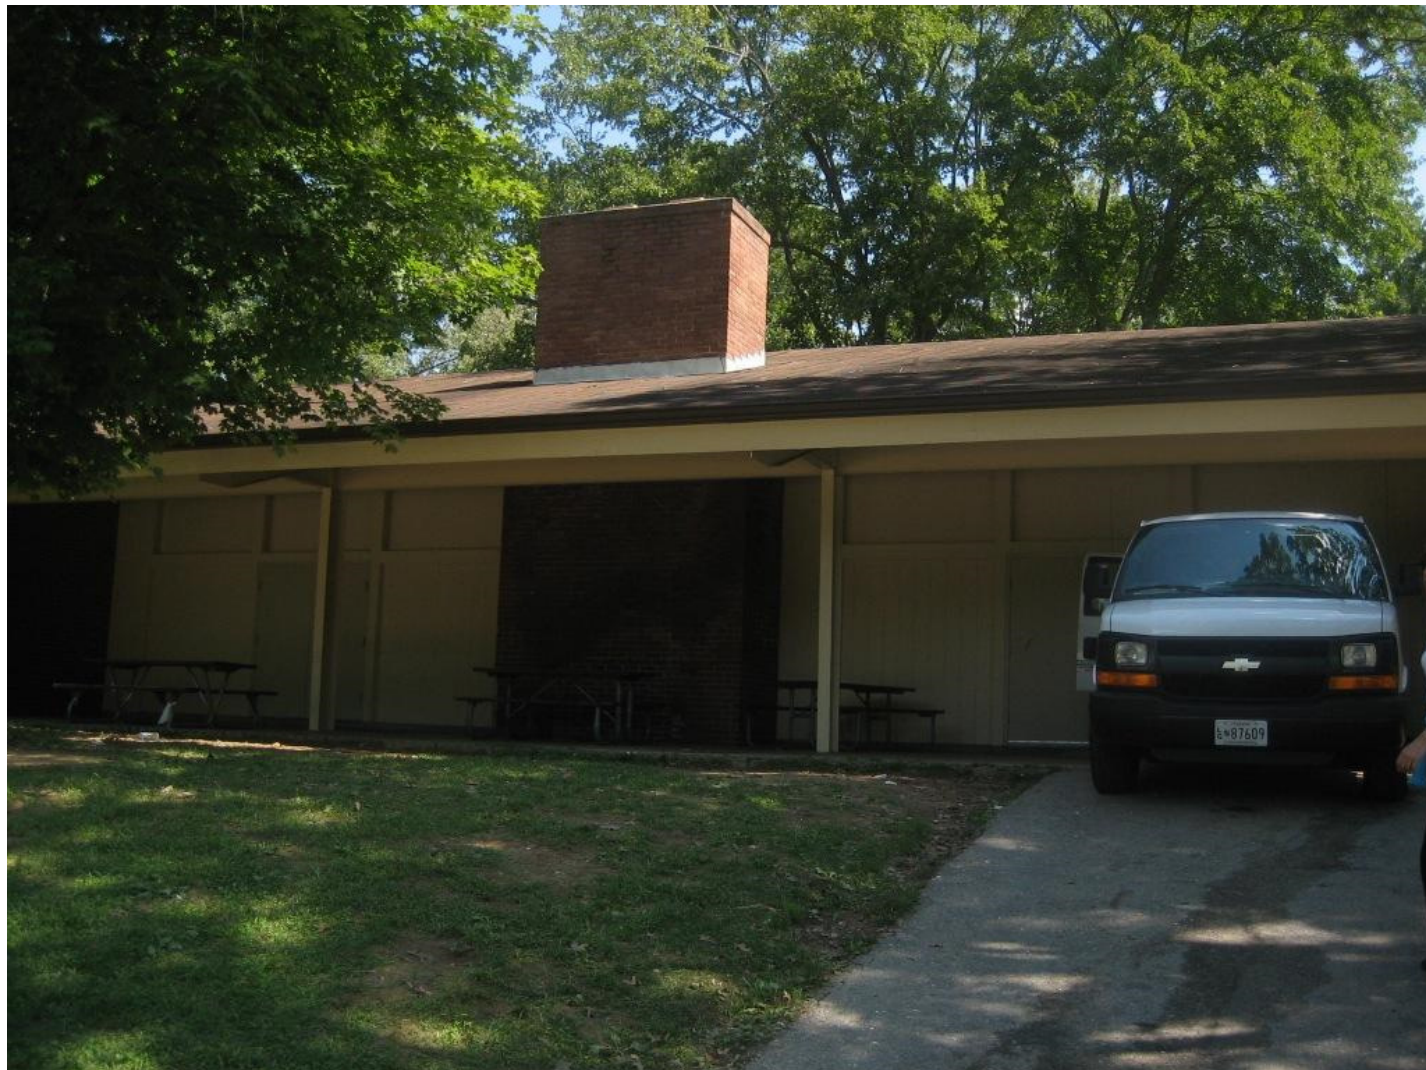
Figure 8. Veirs Mill Recreation Building, west (front) elevation.

The main, or west, façade is composed of two identical wall sections that frame a massive red-brick chimney that used to have a working exterior fireplace (now bricked in). The wall sections to either side of the chimney feature a pair of solid double doors flanked by a wall that follows the modular rhythm of two by fours. The two by fours define areas of wallboard versus doors and also define a series of transoms overhead, now enclosed with wooden boards. The open terrace covering that runs the length of the façade is supported on exposed steel I-beams and the underside of its covering is tongue-and-groove board. The outdoor deck flooring is a simple concrete slab on grade, and picnic tables are situated on it. A short driveway off the parking lot leads right up to

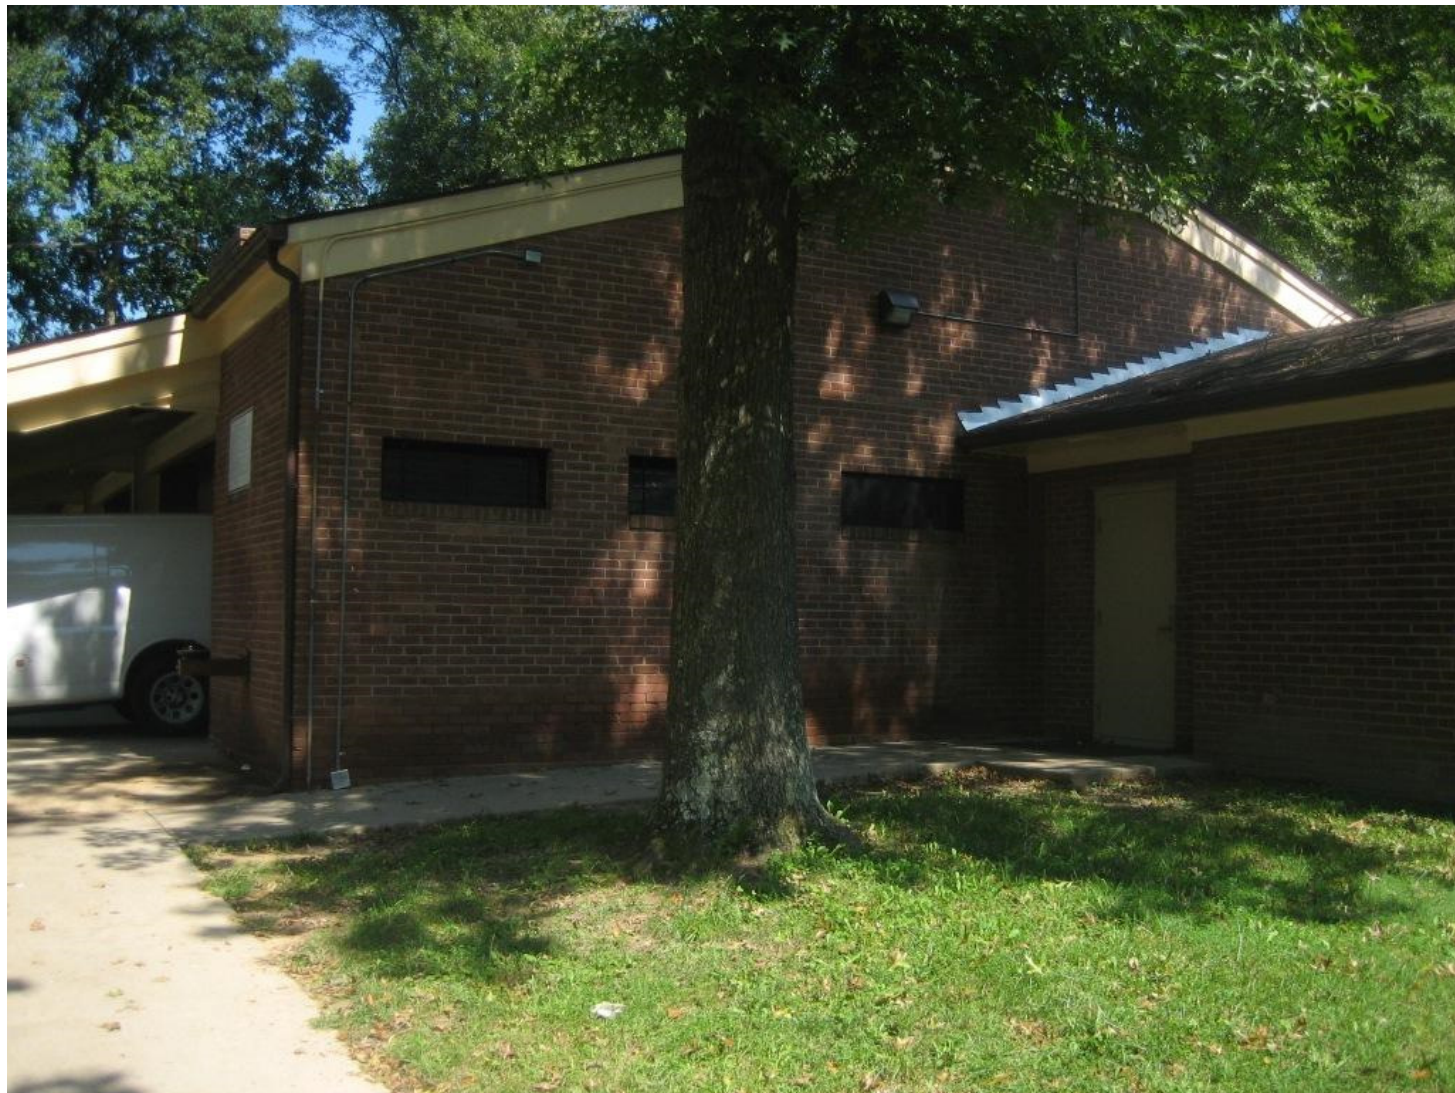
Figure 9. View of Viers Mill Recreation Building, northwest corner.

The north elevation is all brick since one very large window has been enclosed. The change in brickwork makes this alteration obvious.

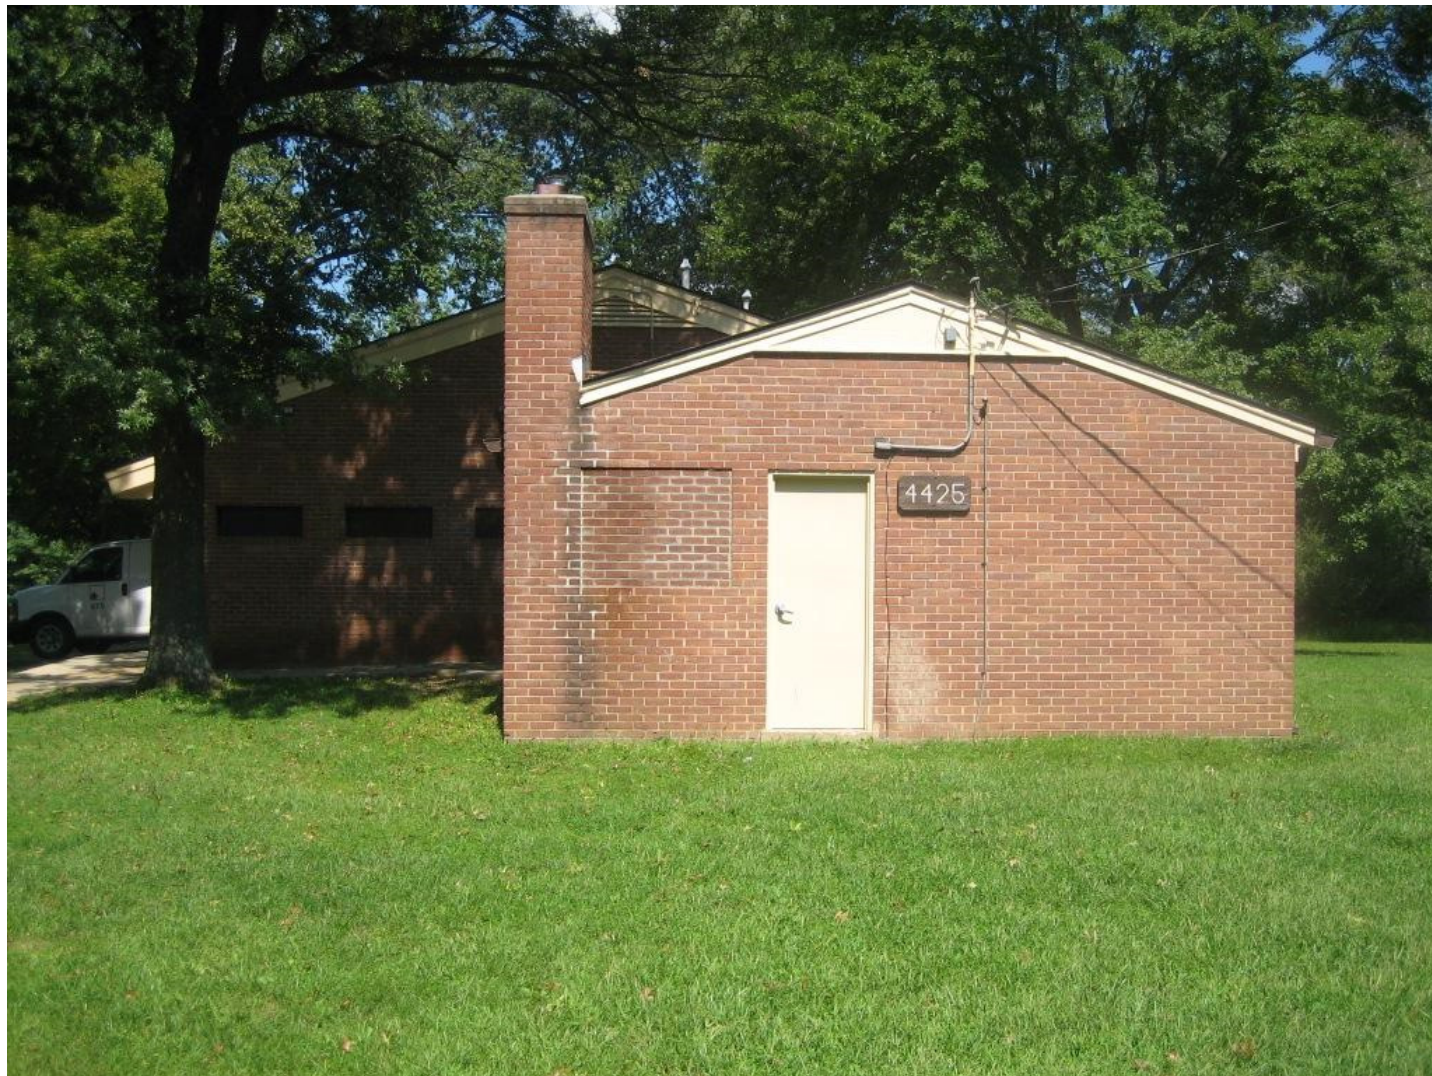
Figure 10. View of Veirs Mill Recreation Building, south elevation.

The south side elevation contains small, privacy-type windows, midway up the wall which defines the restroom. These have brick sills defined by a soldier course and are currently covered in metal grilles.

Windows and doors on the restroom wing have been closed up or altered over time, apparent in the different brickwork and wider mortar joints. A single door leads into the bathroom wing on the gable end.

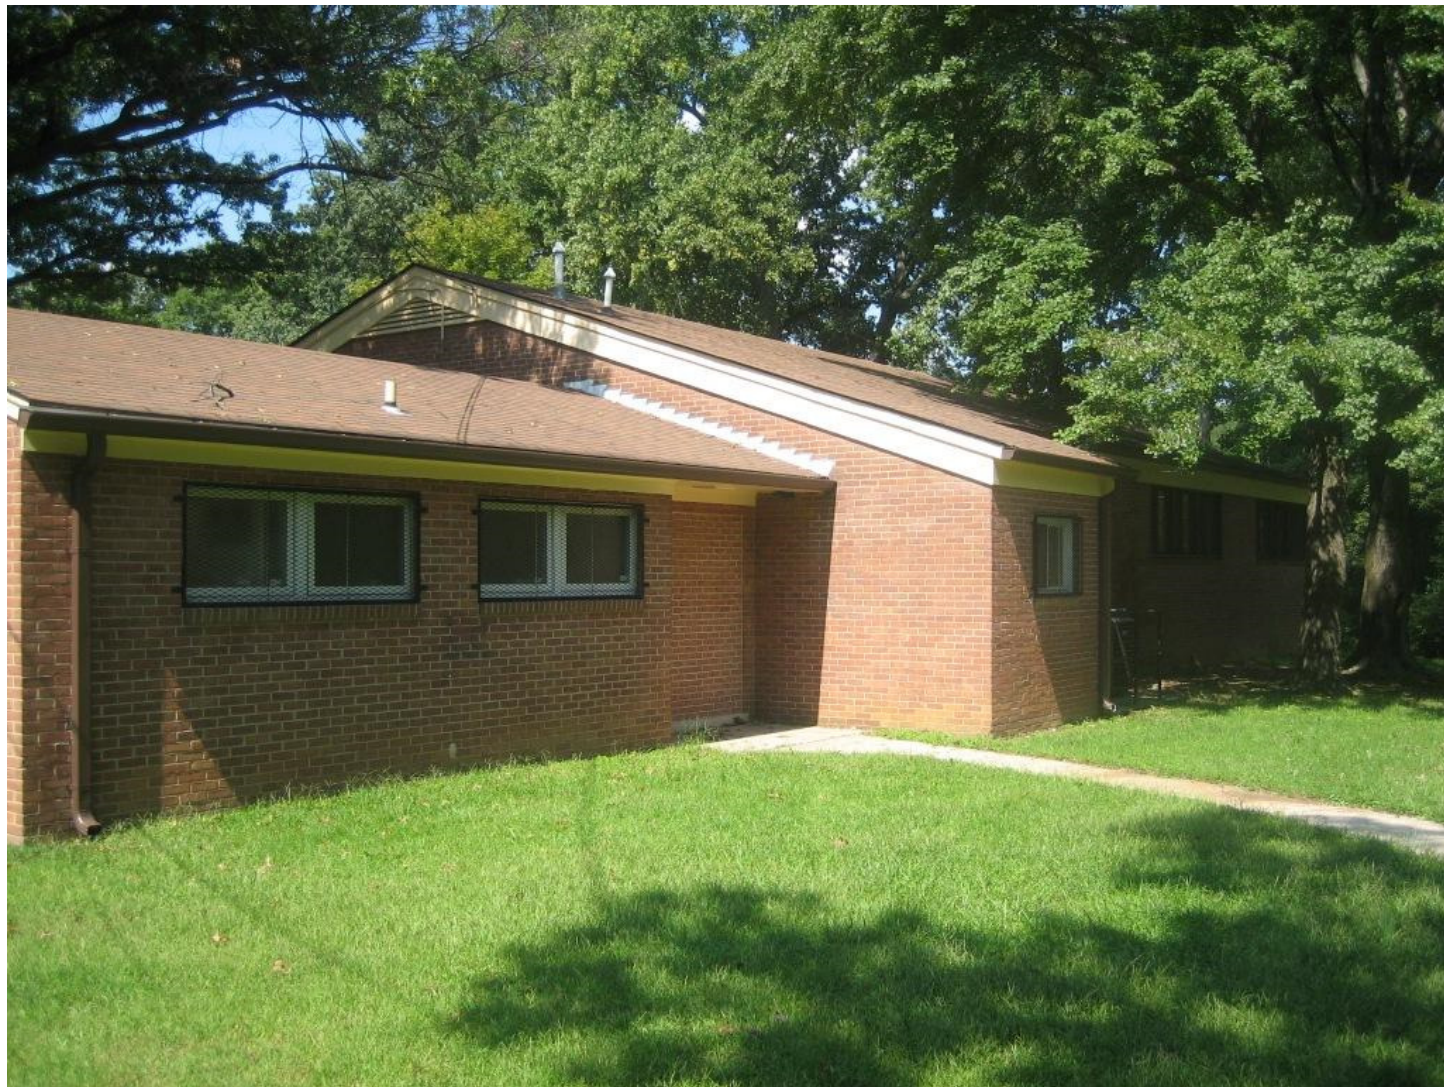
Figure 11. View of Veirs Mill Recreation Building, east (rear) elevation.

The east elevation contains banded windows composed of three pairs of casements. These windows are not original to the period of construction. They pierce the wall at a height slightly higher than midway and extend up to the eave line, defined only by brick sills.

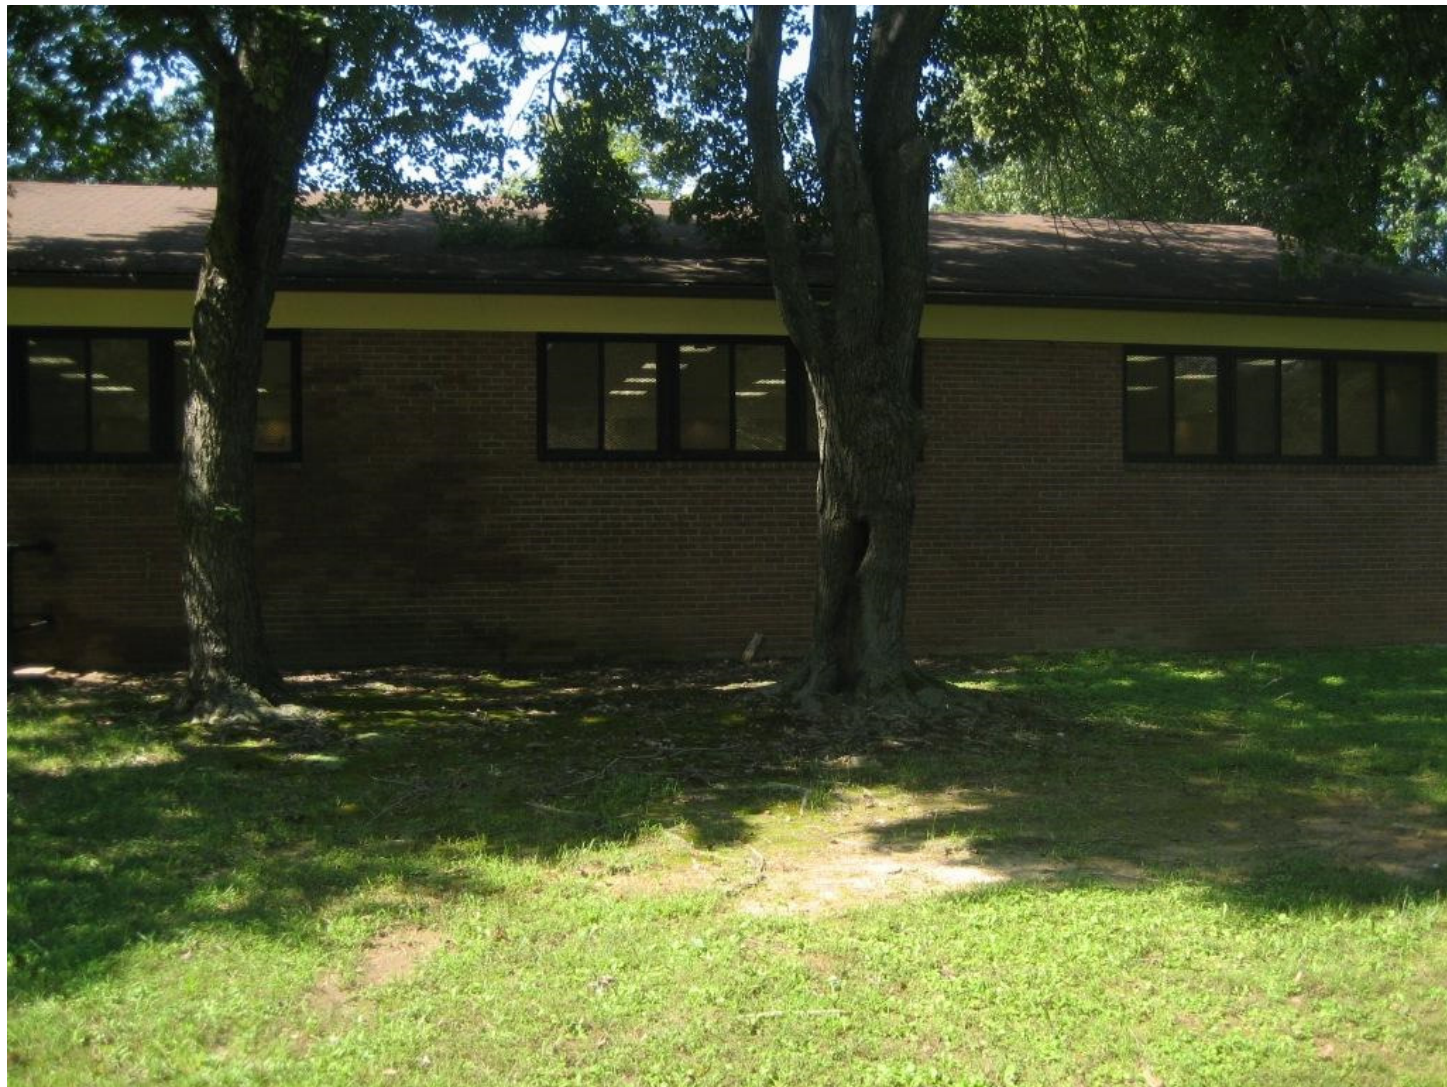
Figure 12. View of Veirs Mill Recreation building, east (rear) elevation.

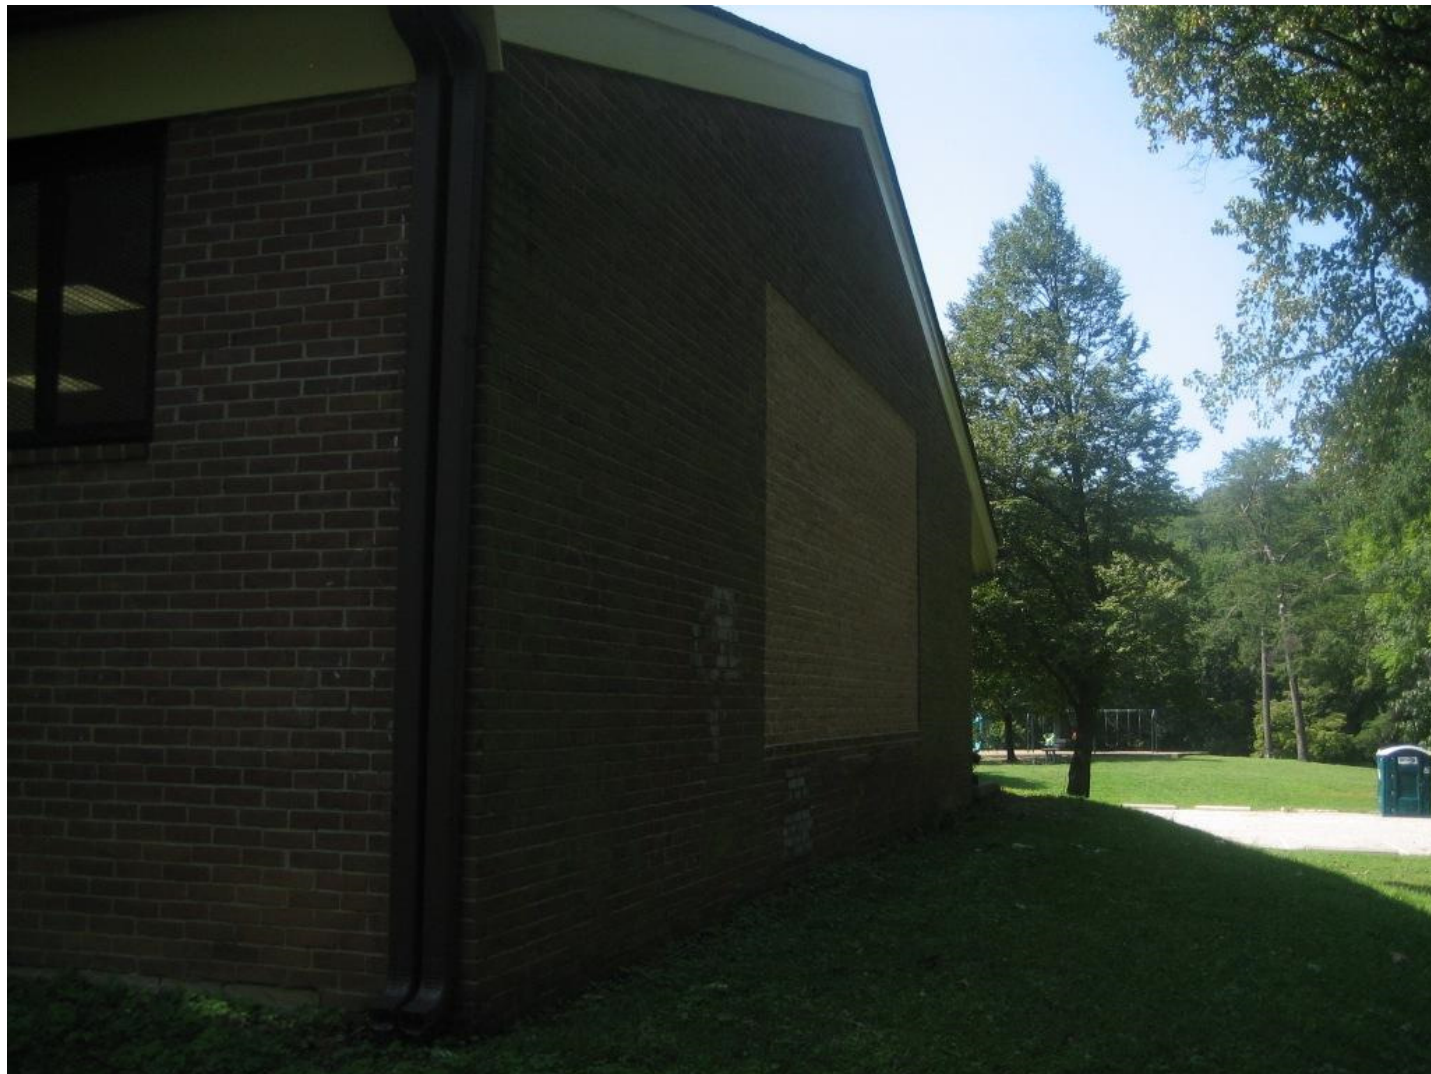
Figure 13. View of Veirs Mill Recreation Building, north elevation.

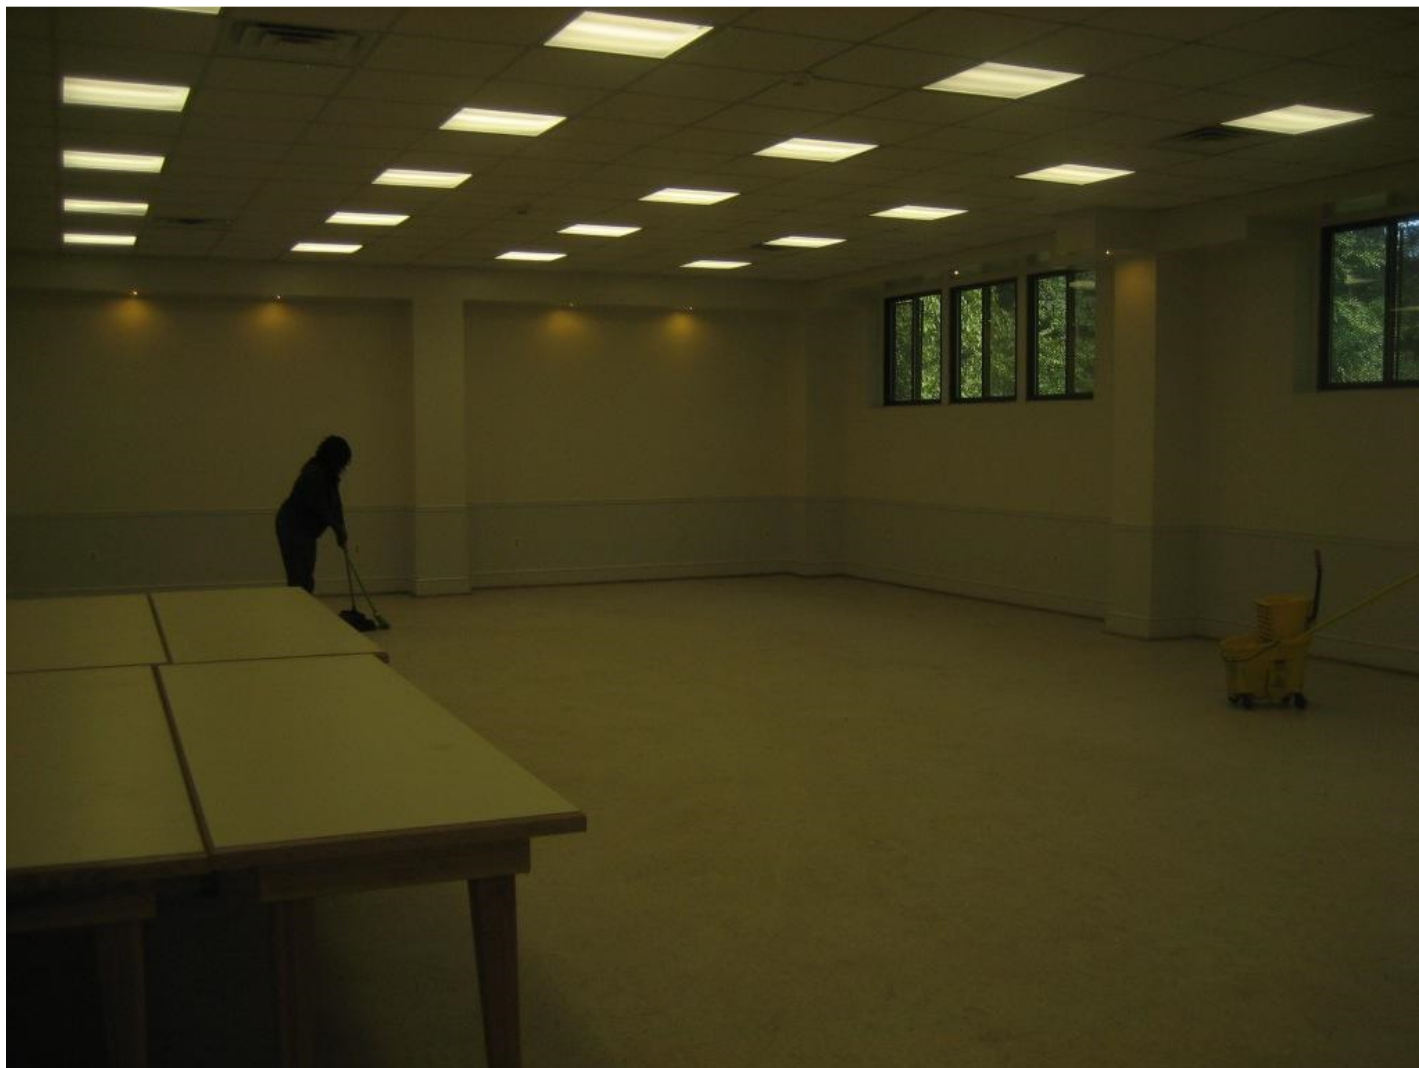
Figure 14. Interior detail of open space, Veirs Mill Recreation Building.
