MONTGOMERY COUNTY HISTORIC PRESERVATION COMMISSION
STAFF REPORT

Address:	5 Columbia Ave., Takoma Park	Meeting Date:	7/10/2019
Resource:	Contributing Resource Takoma Park Historic District	Report Date:	7/3/2019
Applicant:	Annie Kneedler & Sam Bryson	Public Notice:	6/26/2019
Review:	HAWP	Tax Credit:	partial
Case Number:	37/03-19A (REVISION)	Staff:	Dan Bruechert
Proposal:	Window Replacement

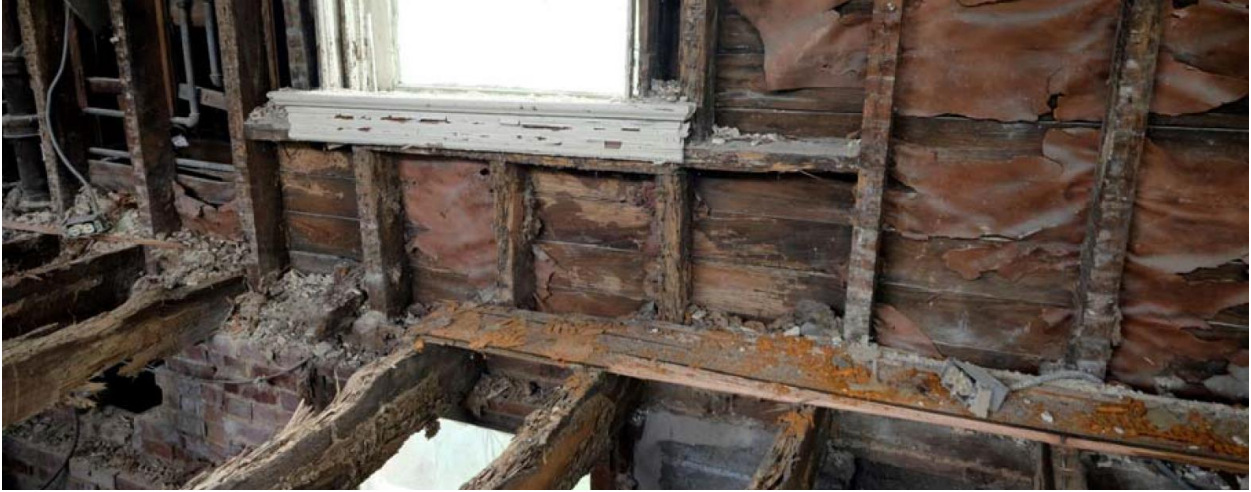
Figure 2: Detail of the termite damage done to the house framing and window frames.

In addition to the interior structure and the clapboards, the windows also showed extensive signs of termite damage. In addition to the termite damage, there is additional damage caused by deferred house maintenance caused largely by water infiltration. The applicant has conducted a full examination of the windows and Staff can confirm the photos submitted accurately portray the typical damage caused to the windows sills, jambs, and frames. Upon viewing the extent of the damage to the windows and the estimate from a well-known window restorer, Staff determined that a full window survey was unnecessary in this instance.

The applicant proposes to replace 21 damaged historic wood windows, their frames, and sills with new wood windows and wood sills to match the appearance of the historic.

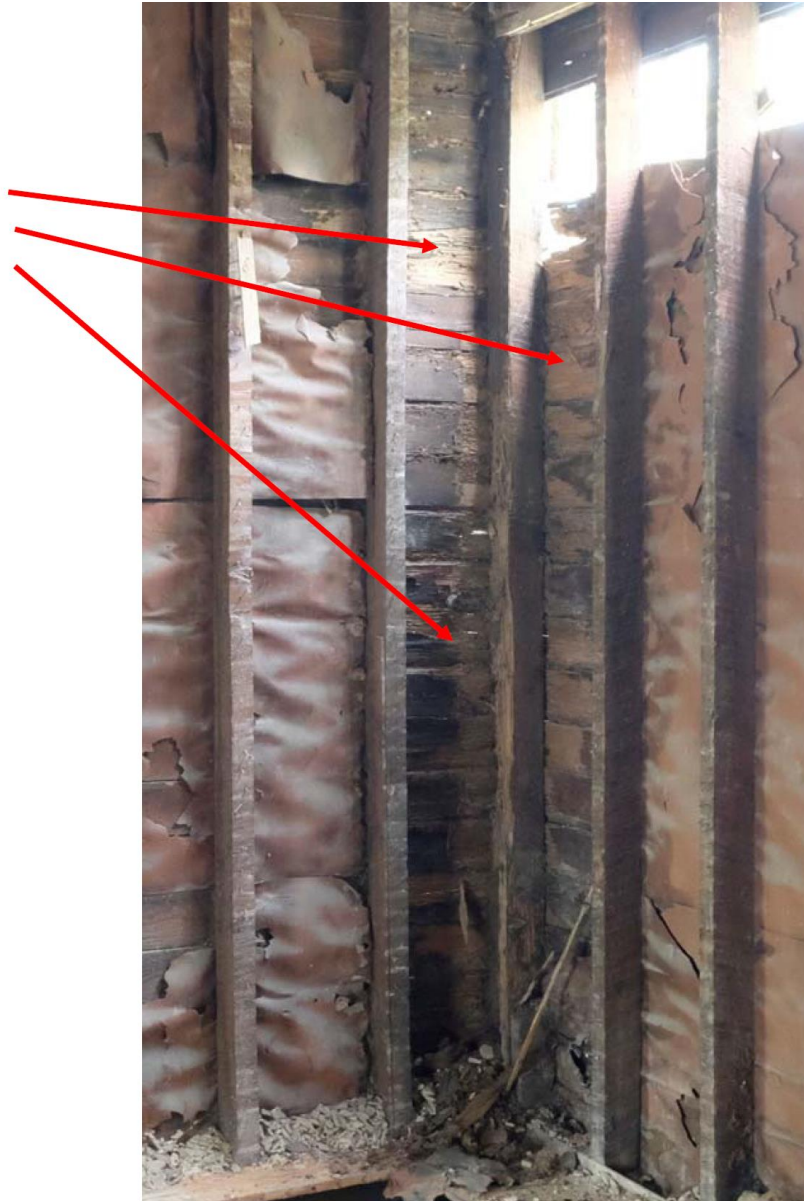
Typical corner showing extensive termite damage to corner framing as well as siding.

Figure 3: Termite damage at the exterior corner of the house showing the termite damage.
