Montgomery County Planning Board Public Hearing, Worksession and Action on Locational Atlas Listing of the Worthmiller House (M:35-211), 8104 Woodhaven Boulevard, Bethesda

WORTHMILLER HOUSE

LOCATIONAL ATLAS & INDEX OF HISTORIC SITES

DESIGNATION FORM

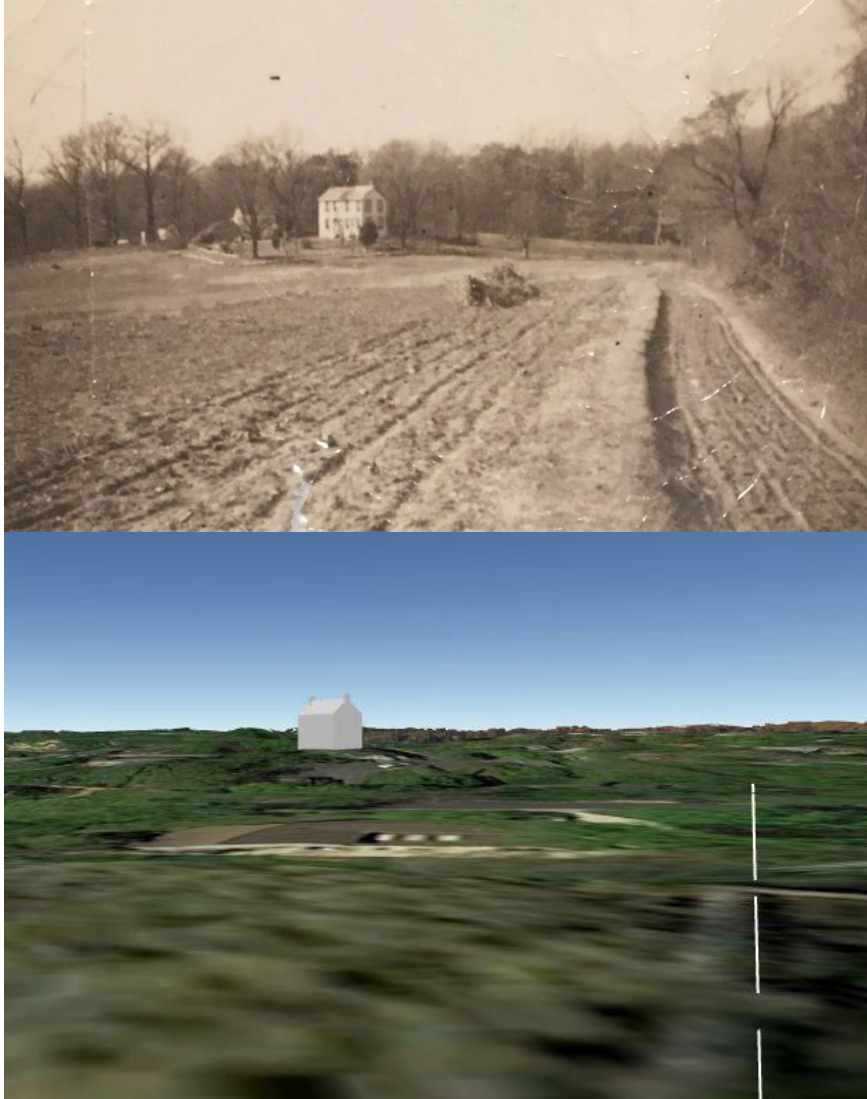
Figure 2: View of 8104 Woodhaven Boulevard looking northwest from the driveway off Wilson Lane, ca. 1937, and model of the original side-gable section of the present-day dwelling geolocated in Google Earth. The white line on the model shows the location of the no longer extant driveway (dirt path) recorded on historic maps. The similarities between the location, form, and orientation of the dwelling in these two views supports that the historic photograph shows the original house prior to the 1937 renovation.

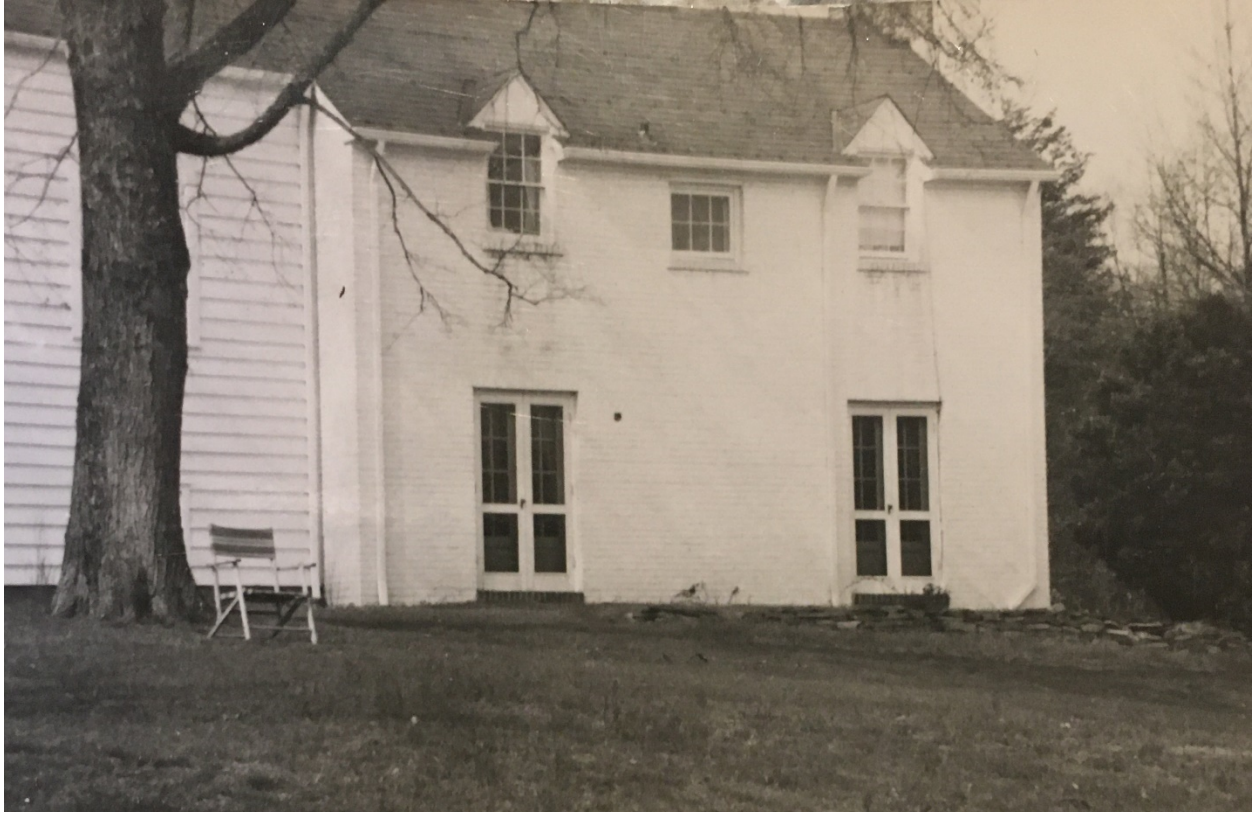
Figure 4: View of the ca. 1937 addition, looking north from the yard. Date of the photograph is unknown.
Source: Donald M. Wight, Jr.

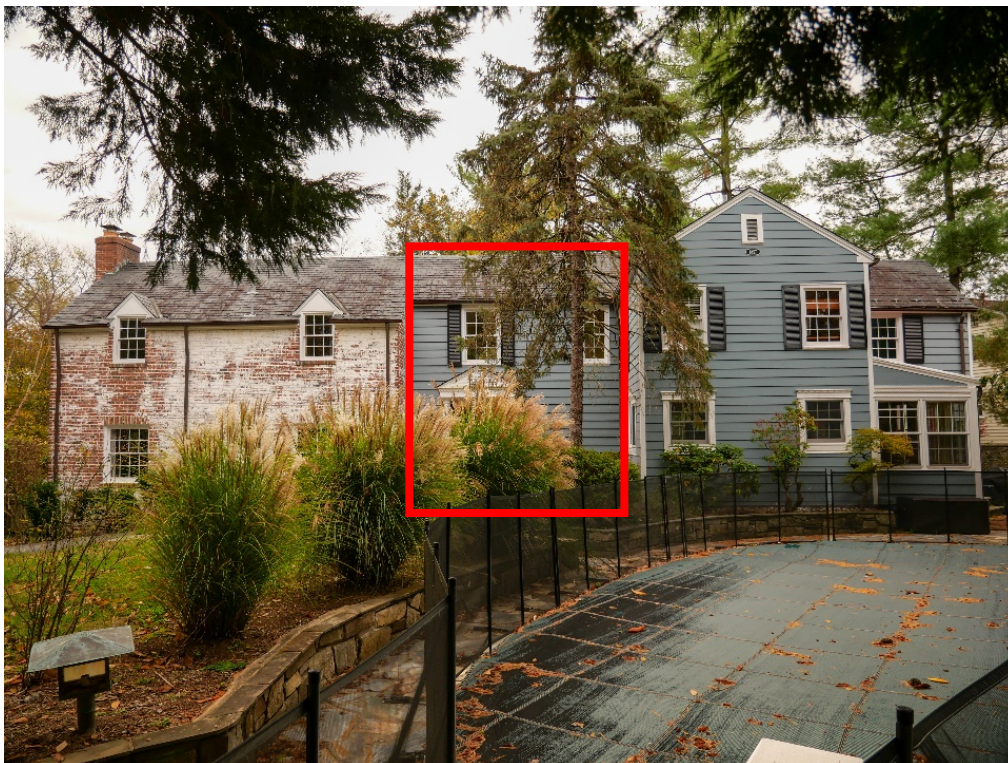
Figure 1A: Annotated view of the façade (north elevation). The red box shows the remaining visible part of the ca. 1857 house.

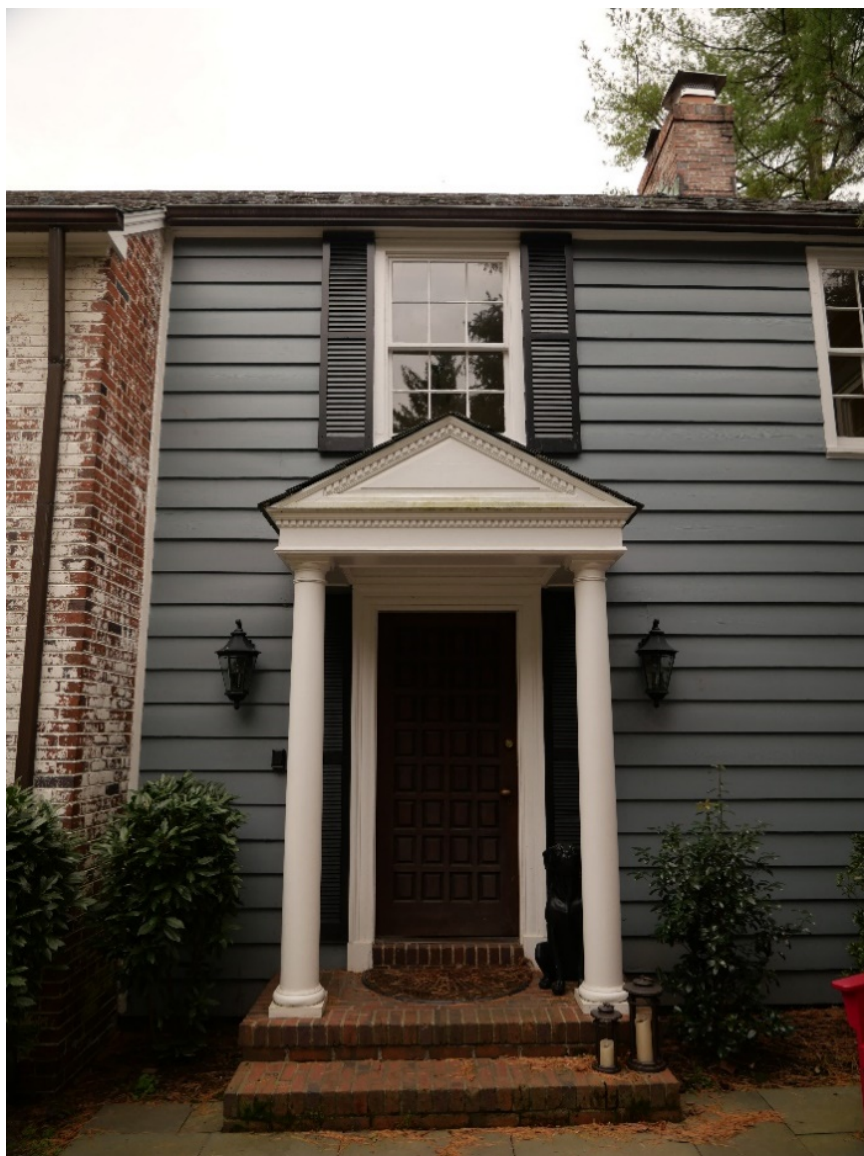
Figure 2: View of the current principal entrance, located in the easternmost bay of the north elevation of the original dwelling. The door and porch are twentieth-century alterations.

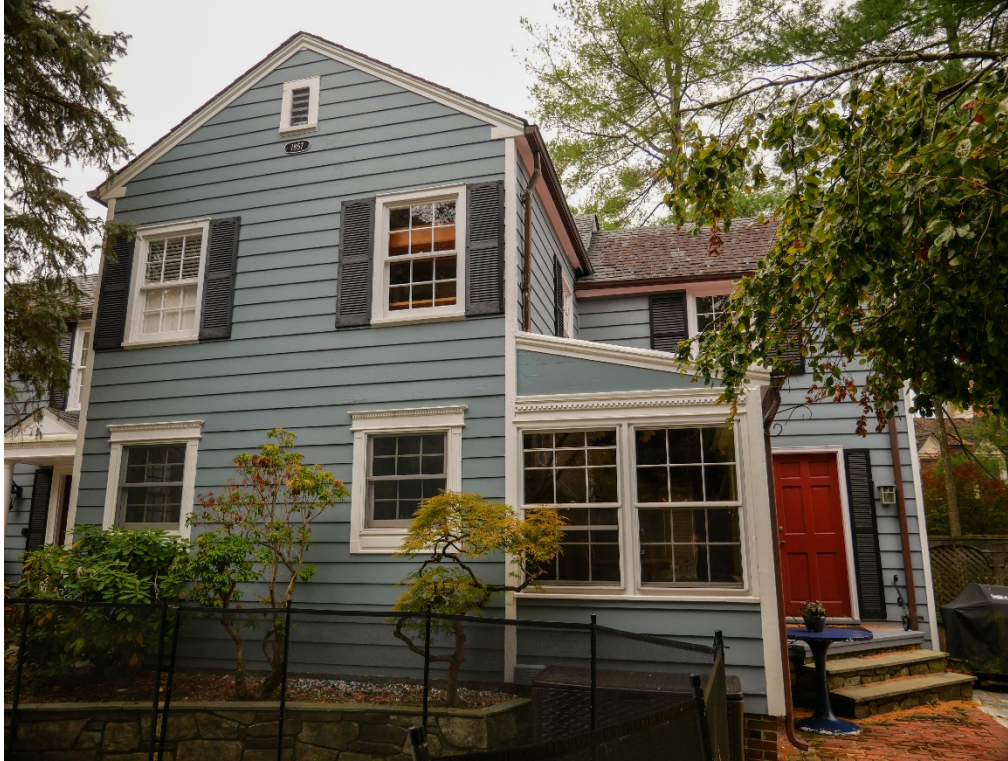
Figure 3: View of the north elevation of the ca. 1937 gable-ell addition with one-story, shed-roofed porch (now enclosed). The two-story, wood-frame, gable addition to the west with a screened-in, first-story porch (now enclosed) is set back to the right with visible red door.

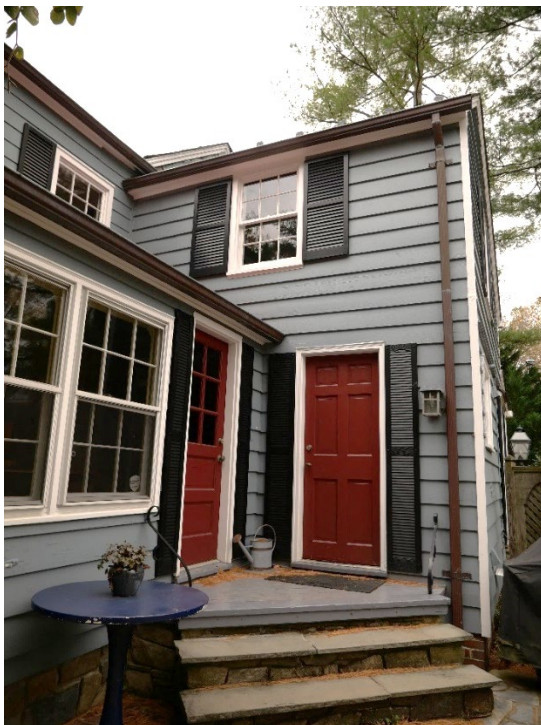
Figure 4: View from the northwest corner of the one-story shed roofed porch, now enclosed as a breakfast nook, (left) and the two-story, gable addition to the west, with first-story porch now enclosed.

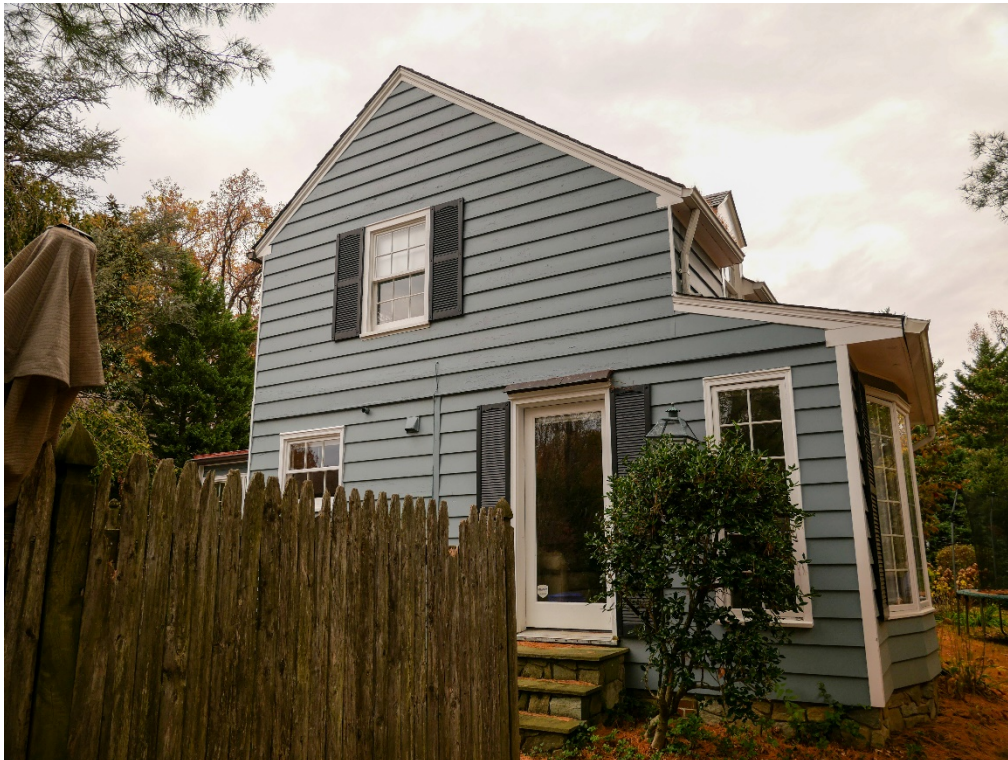
Figure 6: View of the west elevation, showing enclosed first-story porch with projecting bay to the rear.

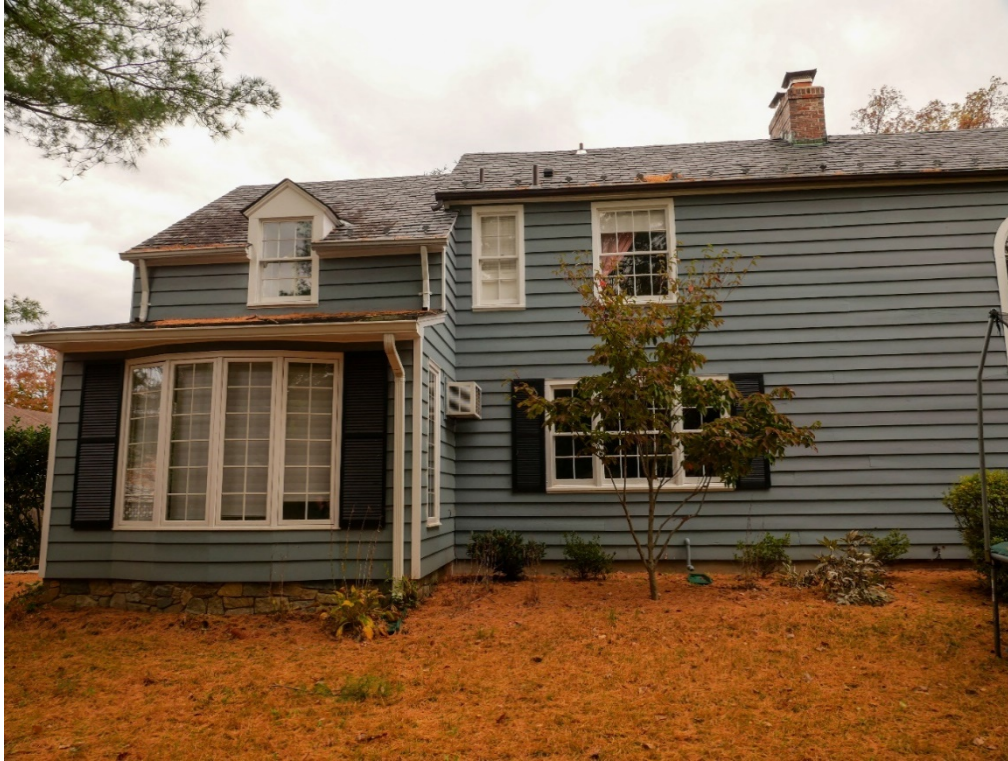
Figure 7: Partial view of the south elevation. The gable addition to the west, with late twentieth-century bay, is to the left and the original ca. 1857 dwelling is to the right.

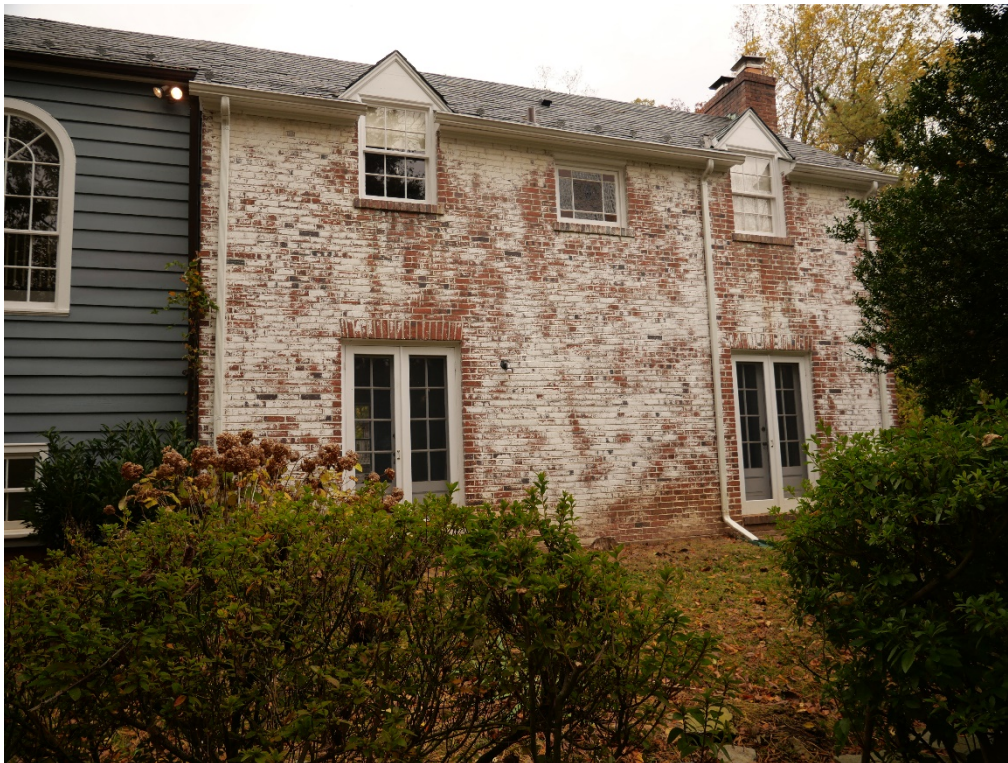
Figure 8: Partial view of the eastern end of the south elevation. The original dwelling is to the left and the ca. 1937 brick veneered addition is to the right.

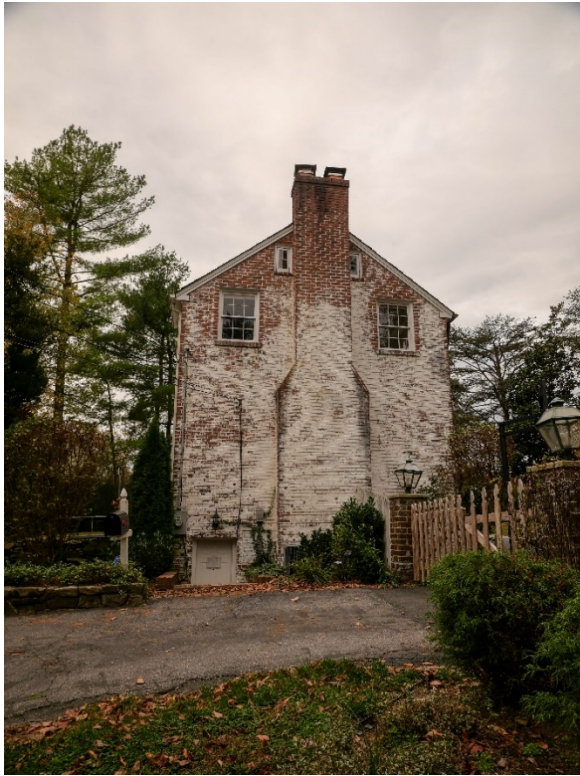
Figure 9: View of the east elevation of the ca. 1937 brick veneered addition.

The substantial brick veneered addition to the eastern end of the home projects approximately three feet south of the original home's south wall. Fenestration in this addition is symmetrical, with two double-leaf, wood-frame, eight-light glass doors shielded behind wood-framed, glass storm doors. Centered above each door is an inset, gabled, dormer with a six-over-six, double-hung, wood-sash window. Between the dormer windows, a non-original, nine-light stained-glass window abuts the cornice. Three metal downspouts provide drainage.

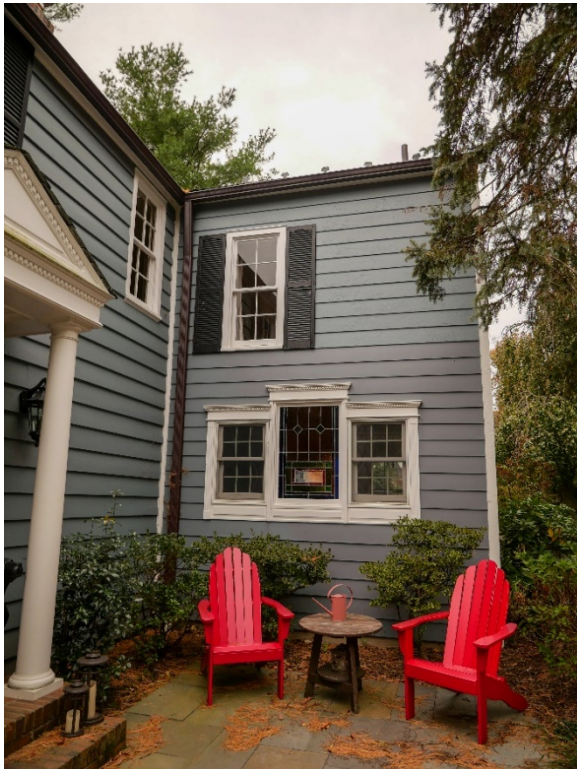
Figure 10: View of the east elevation of the ca. 1937 gable-ell addition to the north.

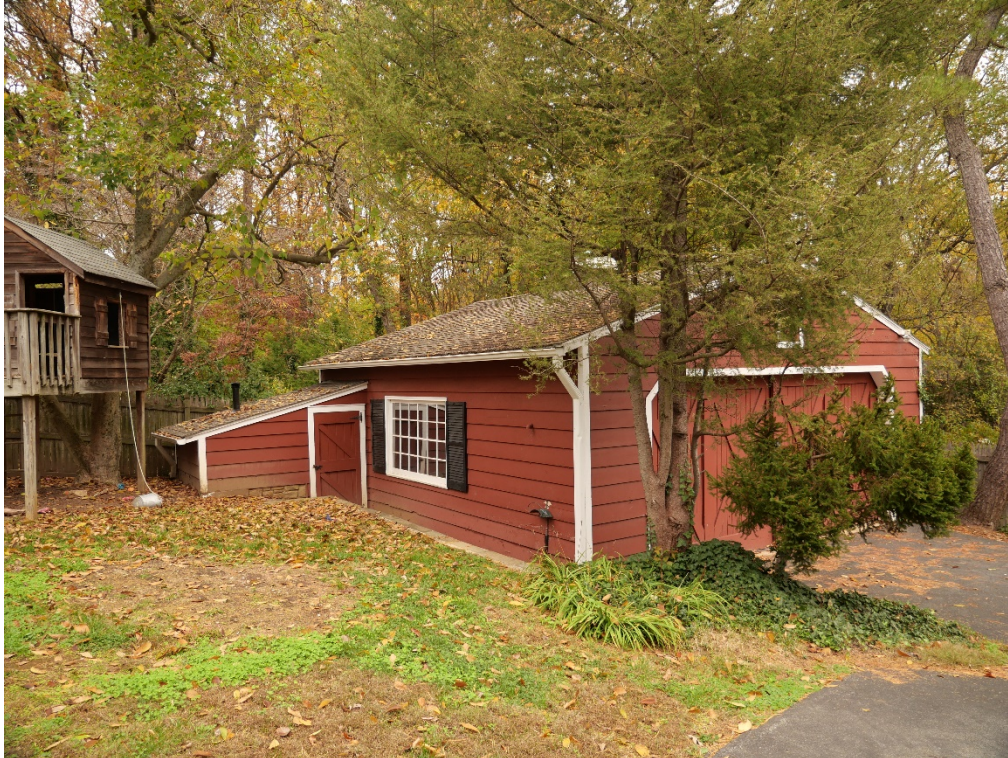
Figure 12: View of the ca. 1964 garage.

Also located on the property are several outbuildings that likely date to the latter half of the twentieth century. A ca. 1964 wood-framed, front-gabled two car-garage sits on a brick foundation at the northeastern corner of the lot, at the terminus of the paved drive. At the southeastern corner of the lot, a small, square shed rests on a masonry foundation clad in brick veneer. The wood-frame structural system is clad in cedar shingles and is capped with a pyramidal, cedar-shingled roof and copper roof cap.

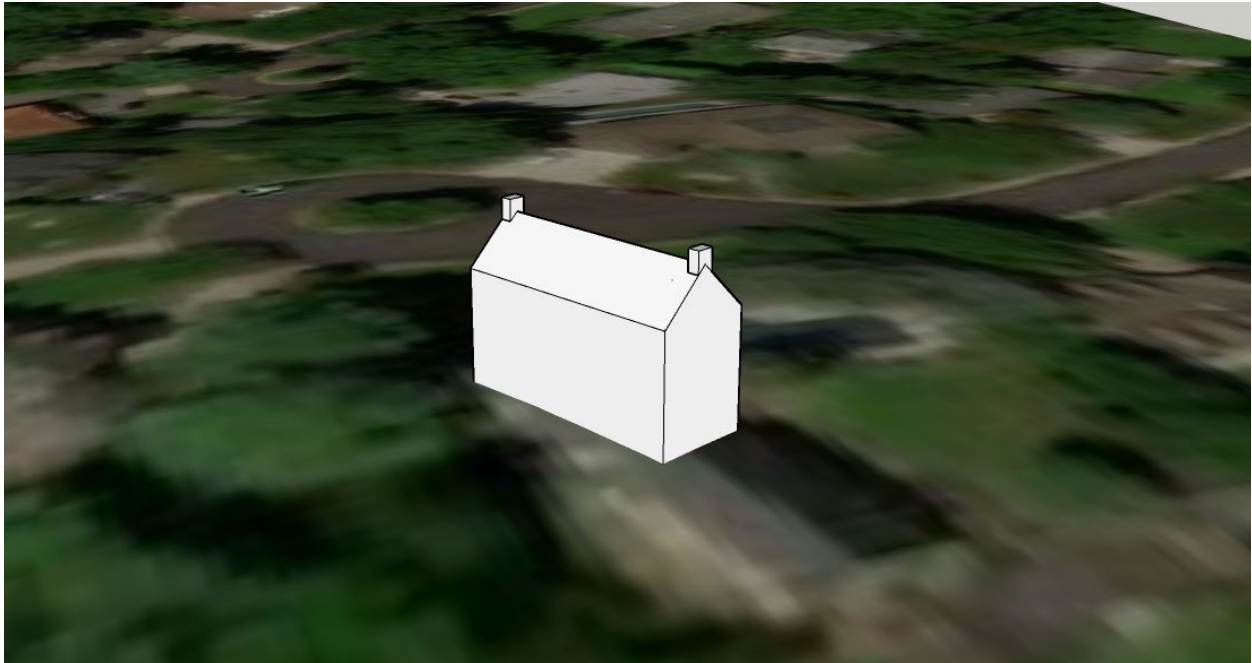
Figure 1: View of the south and east elevations of the original side-gable house, ca. 1857.

Built ca. 1857, the original dwelling consisted of a four-bay, single-pile, side-gable, wood-frame dwelling with internal paired end chimneys, which have since been removed (App. 4, Fig. 1 and 3). This section presently rests on a continuous brick foundation that is partially parged with concrete. The foundation supports a wood-frame structural system that is clad with twentieth-century wood siding and capped with a slate-shingled roof. A non-historic, central brick chimney was added concurrent with the construction of the 1937 additions. Fenestration primarily consists of a mid-twentieth-century, single-leaf, wood door with pedimented entry porch; non-historic, double-hung, wood-sash windows; a non-historic, arched window; and two four-over-four, double-hung, wood-sash windows. The original four-bay fenestration pattern is no longer apparent due to significant reconfiguration of window and door openings and the likely reorientation of the façade from the south to the north elevation.

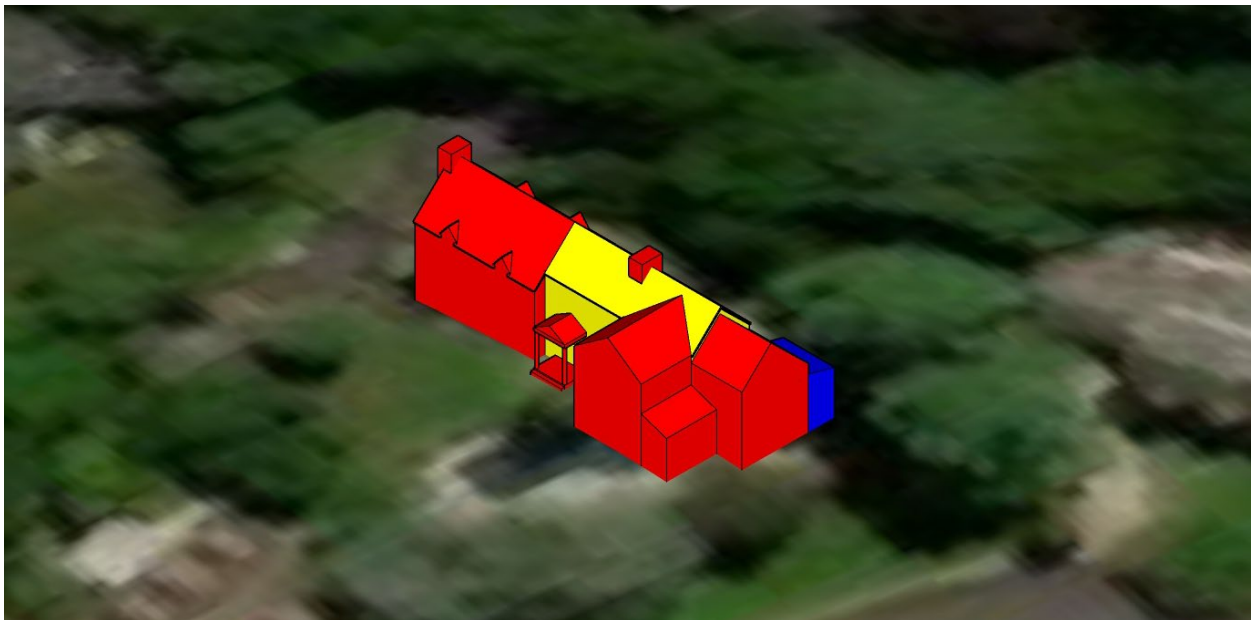
Figure 6: View of the north (present-day front) and west elevations, 2019. The section shaded yellow is the ca. 1857 side-gable house, the sections shaded red are the ca. 1937 additions, and the section shaded blue is the late-twentieth-century addition.

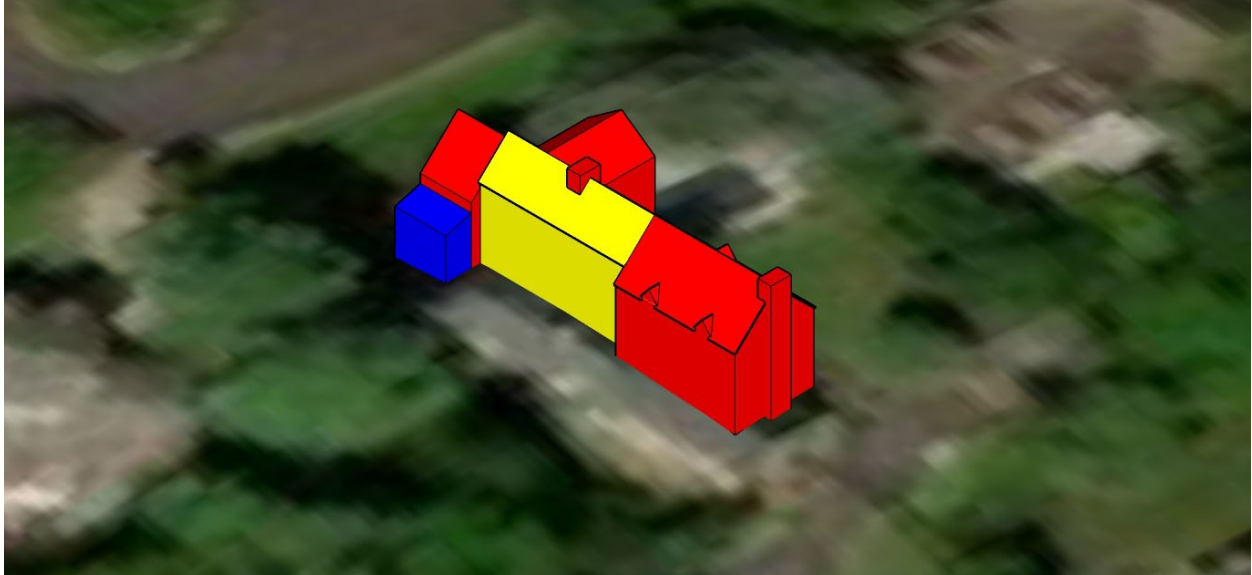
Figure 7: View of the south (present-day rear) and east elevations, 2019. The section shaded yellow is the ca. 1857 side-gable house, the sections shaded red are the ca. 1937 additions, and the section shaded blue is the late-twentieth-century addition.

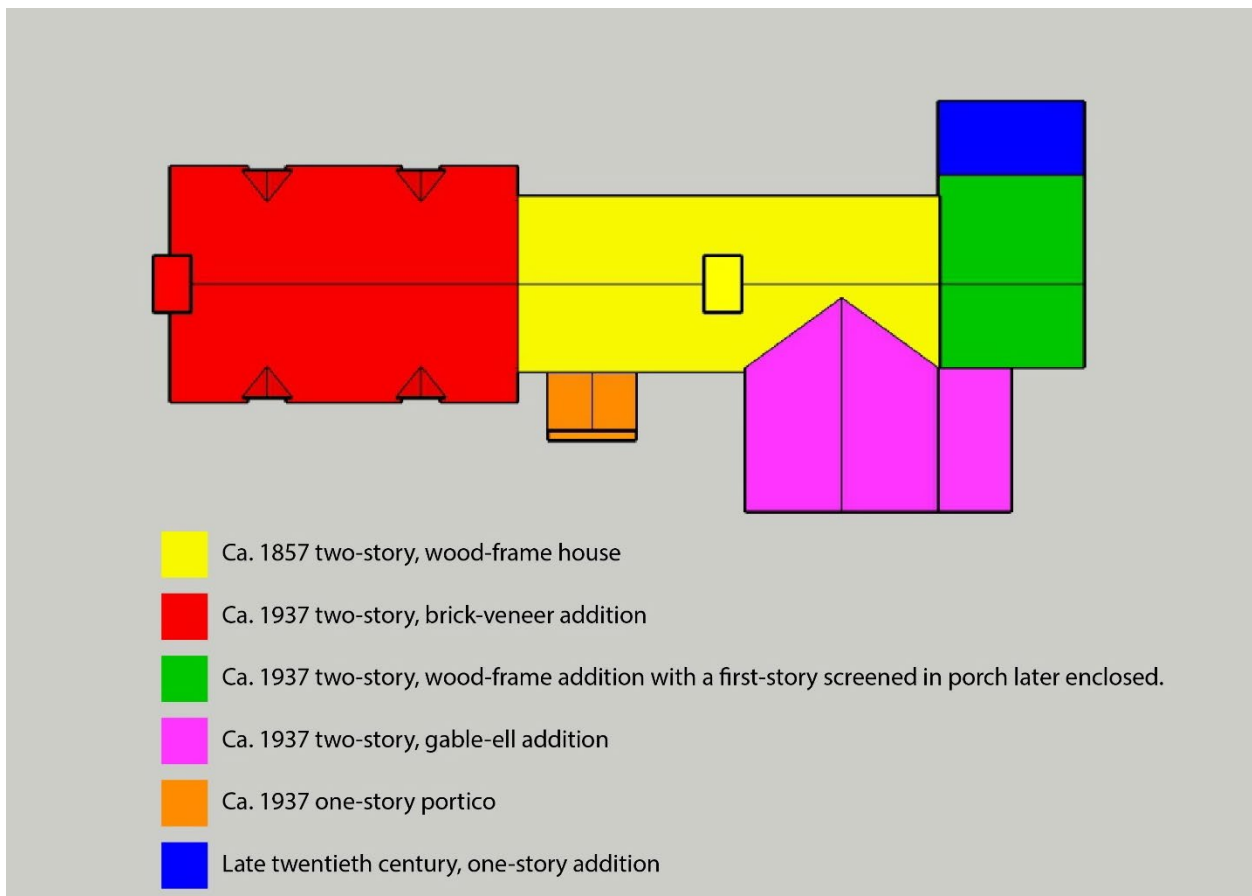
Figure 8: The plan view shows the different sections of the dwelling as described in the architectural description.
