#### **MONTGOMERY COUNTY HISTORIC PRESERVATION COMMISSION**

Address: 9925 Sutherland Rd., Silver Spring Meeting Date: 8/17/2022

**Polychrome Historic District**

**Proposal:** RETROACTIVE window and door replacement

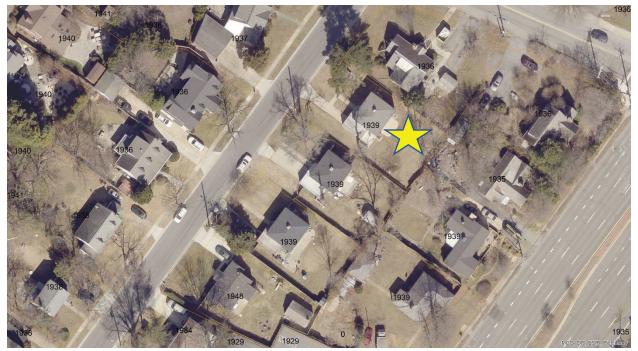
Figure 1: The subject property is the northernmost of the three two-story Polychrome houses.

The subject property is a two-story Art Deco styled house with a low-pitched pyramidal roof and concrete walls.

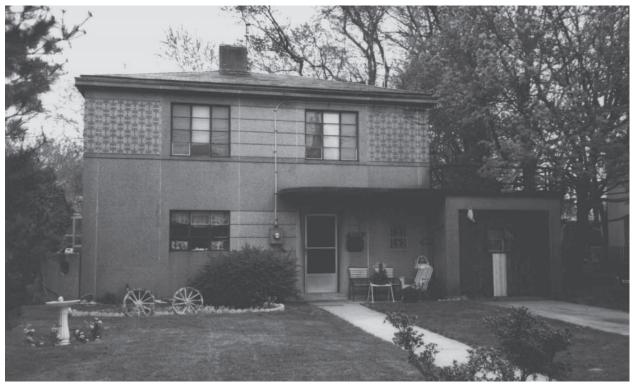
The historic windows were steel casements with divisions that aligned with the decorative concrete banding (see Fig. 2 and 3 below). Based on images from Google StreetView, it appears that some of the exterior doors may have been replaced, however, we do not have clear photographs that detail the materials and configuration of those doors. The rear first-floor doors were replaced, however, we don't know if the historic French doors (see Fig 3.) were still extant or if other doors had been installed in the historic openings.

Figure 2: Front elevation of 9925 Sutherland (c.1993) before the window replacement.

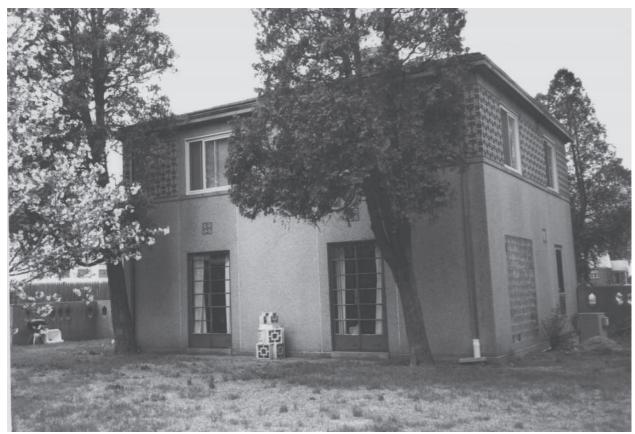
Figure 3: Rear of 9919 Sutherland (not the subject property), showing the historic steel doors. (photo c.1993).

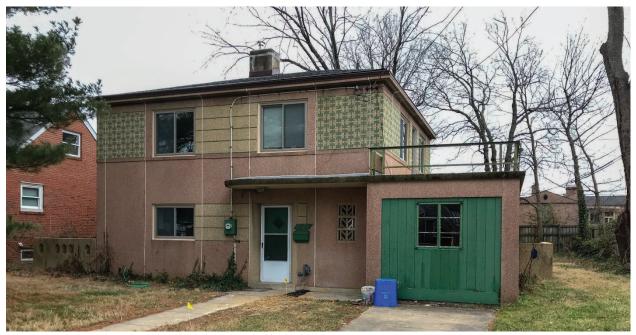
Figure 4: Front elevation showing the new vinyl windows.

Staff finds the new windows and doors are incompatible in their materials and design. The historic window design is integrated with the exterior decorative banding and single-lite sliding windows are an inappropriate replacement. Additionally, the vinyl frames and casements lack the profile depth of the historic windows. The fiberglass doors are also an incompatible replacement for the steel rear doors and

wood first and second-floor side doors. Staff finds this proposal is inconsistent with 24A-8(b)(2).

Staff recommends the HPC add a condition to the approval of this HAWP for the record, that states the vinyl windows and fiberglass doors do not qualify for the general in-kind replacement provision of Chapter 24A that would allow these features to be replaced without HAWP. All window and door work at the subject property needs a full HAWP review.

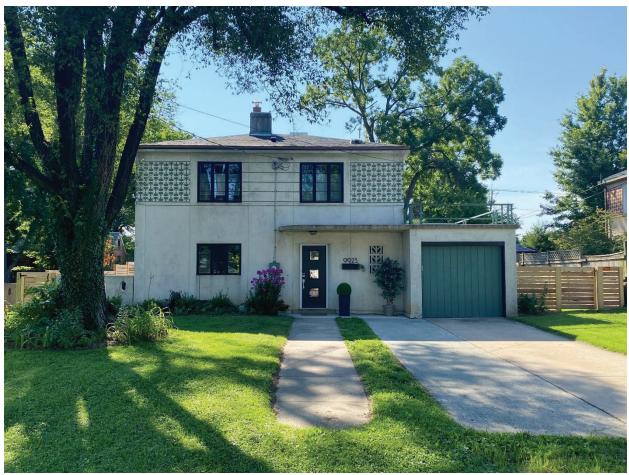
As stated above, Staff does not find that the new windows and doors are compatible with the architectural character of the historic house. The neighboring property, 9923 Sutherland, was able to find a replacement window the HPC found to be compatible, thereby demonstrating that it is possible to replace the unique windows when they have degraded beyond repair.

Figure 5: 2022 photo of 9923 Sutherland with the replacement windows.
