MONTGOMERY COUNTY HISTORIC PRESERVATION COMMISSION STAFF REPORT

Address: 6 High Street, Brookeville **Meeting Date:** 6/11/2025

Case No.: 1117972 Staff: Devon Murtha

Proposal: Retroactive approval for basement window installation, masonry painting, shutter

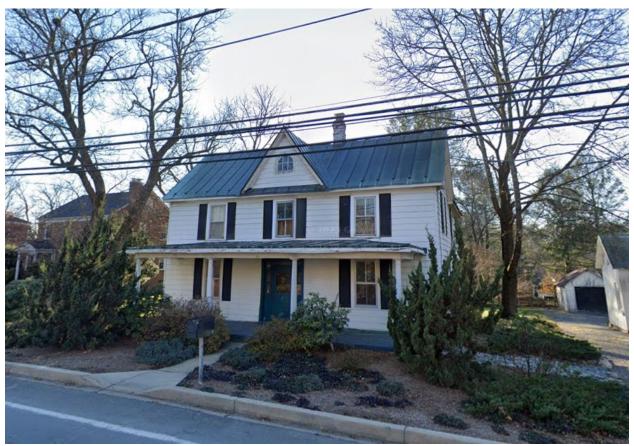
Facing east on Georgia Avenue is a 2 1/2 story frame 3 bay by 2 bay center gable house with a standing seam tin roof. There is a one-story front porch with ionic columns across the full width of house. The windows are 2 over 2 with a small six pane arched window in the center gable. The front door is surmounted by a transom and side lights.¹

Figure 2: Photo of subject property along High Street, prior to scope of work (Google Images, 2022).

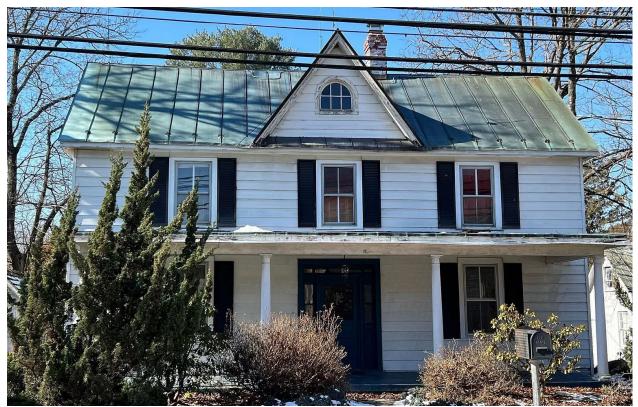
Figure 3: Before shutter removal (2022)

The shutters that were removed were made of aluminum and not original to the building. Like many of the residences in Brookeville, the building may historically have had wood louvered shutters; however, Staff has not been able to find any documentary evidence of this. The removal of non-historic aluminum

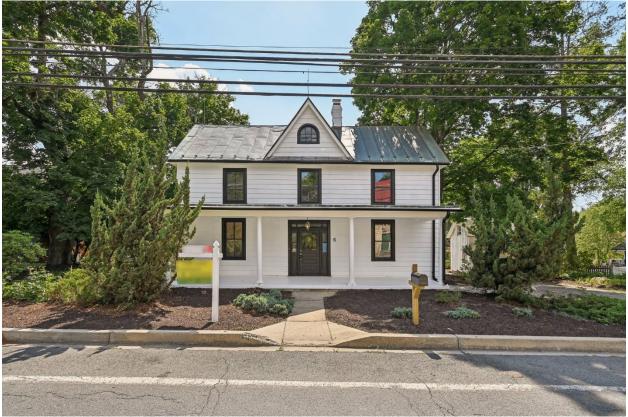
Figure 4: After shutter removal (2024)

shutters does not constitute a loss of historic material, per *Standard 2* and *Chapter 24A-8(b)*, and is generally appropriate.

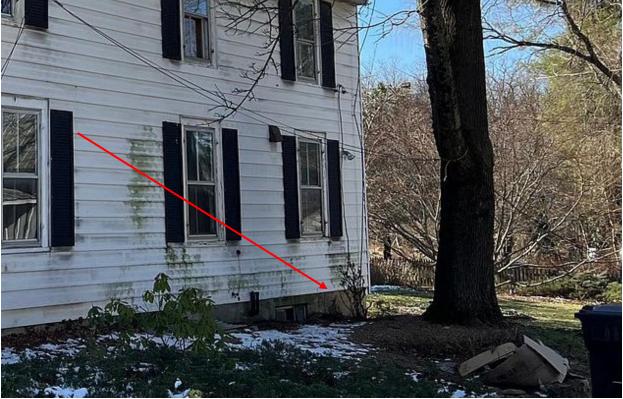
Figure 5: Before painting foundation (2024).

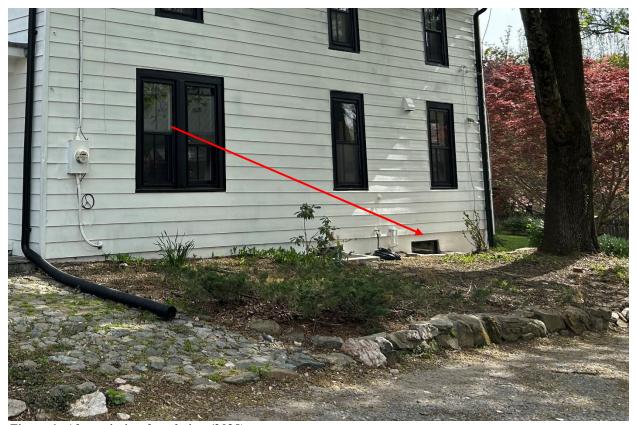
Figure 6: After painting foundation (2025).

The applicant painted sections of previously unpainted parged stone foundation.

The HPC does not generally support painting previously unfinished masonry foundations. Painting masonry can cause moisture retention and damage to the material. Additionally, painting unpainted surfaces alters the overall character of the resource and is incompatible with the district contravening 24A-8(b).

Staff finds that the painting of unfinished masonry is *generally* not appropriate on historic foundations in Brookville. However, in this particular case, painting the foundation does not meaningfully impact the character of the district. The foundation is minimally visible from the right-of-way and, more importantly, has been altered by the addition of non-historic parging on top of the stone foundation. The actual historic material remains unaltered by the addition of paint. The sections of foundation that were painted are on the side (south) and rear (west) elevations and have little impact on the character of the district from the right-of-way along High Street.

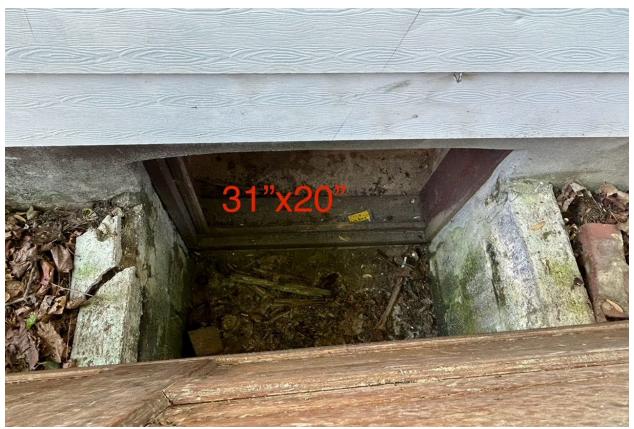
Figure 7: Before basement window installation (2024).

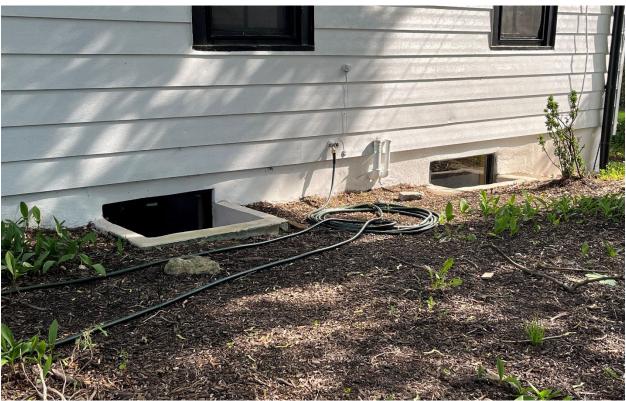
Figure 8: After basement installation (2025).

The applicant stated that they replaced broken wood windows on the foundation level with new wood windows that matched the profile of the existing. They were not able to provide photos of the windows that were removed. The new windows are wood sash casement windows and are not readily visible from the right-of-way. Although Staff is not able to verify that the new windows are an in-kind replacement due to a lack of photographic evidence, wood is a historically appropriate material for these windows. Staff notes that installation of foundation-level windows not visible from the right-of-way, as is the case in this proposal, is routinely administratively approved. The replacement does not impact the character of the historic district or the resource, per 24A-8(b).

Only the window replacement is eligible for the Montgomery County Historic Preservation tax credit program.

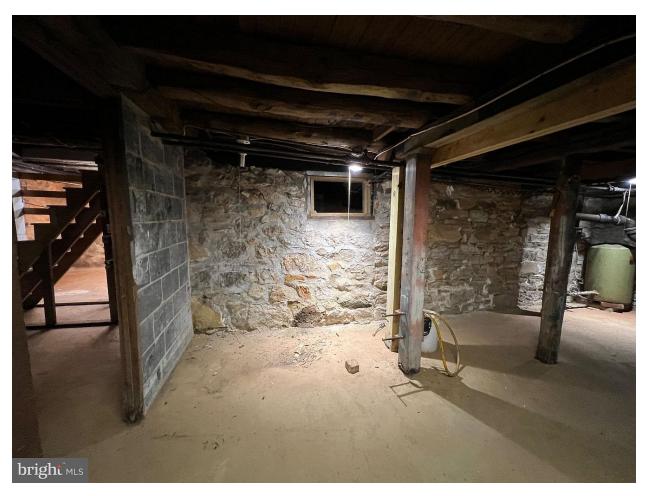
Figure 9: Interior photo of the basement showing stone foundation.

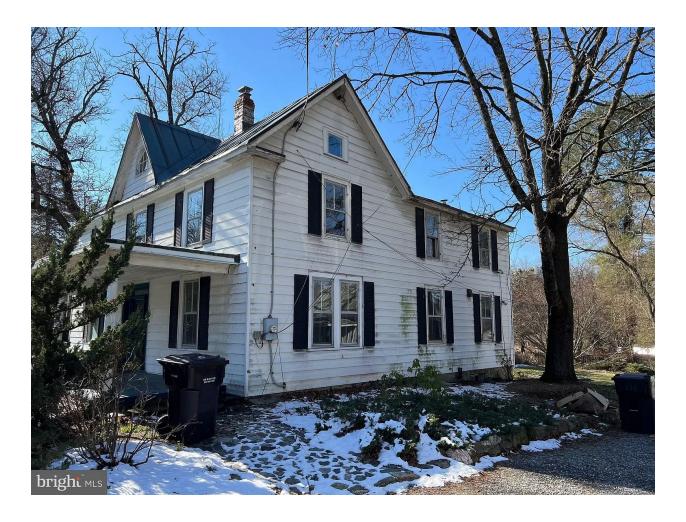
Side of the house. Gutter repair. Window restoration.

- b. This is a complete renovation. The house was not in livable condition.
- c. Bathroom not usable. Painting failing in all the outbuildings. Leaking pipe in the old kitchen. Gutter issue. Water in the basement. All windows have peeling paint and not closing thus leaking air.
- g. (Optional Question) Did this approach solve the rehabilitation problem?

We were not approved for wood window replacement. We looked for many wood window restoration companies but neither one can do the job. The general contractor did painting and restoration of the wood windows above grade and replace the windows in the basement with new windows.
