*Preliminary Consultation*  
**MONTGOMERY COUNTY HISTORIC PRESERVATION COMMISSION**  
**STAFF REPORT**

<b>Address:</b>	900 Jessup Blair Dr., Takoma Park	<b>Meeting Date:</b>	6/27/18
<b>Resource:</b>	Individually Listed Master Plan Site <b>The Moorings/Jessup Blair House</b>	<b>Report Date:</b>	6/20/18
<b>Applicant:</b>	M-NCPPC	<b>Public Notice:</b>	6/13/18
<b>Review:</b>	Preliminary Consultation	<b>Staff:</b>	Dan Bruechert
<b>Proposal:</b>	Building Rehabilitation

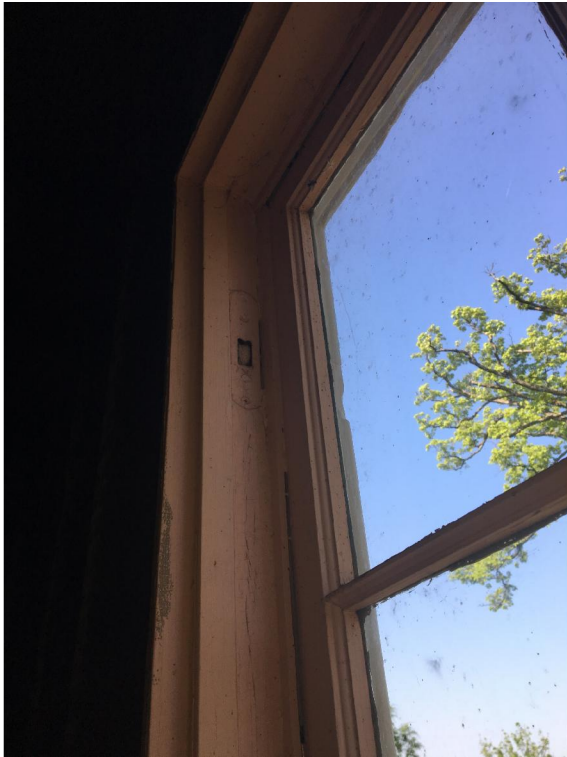
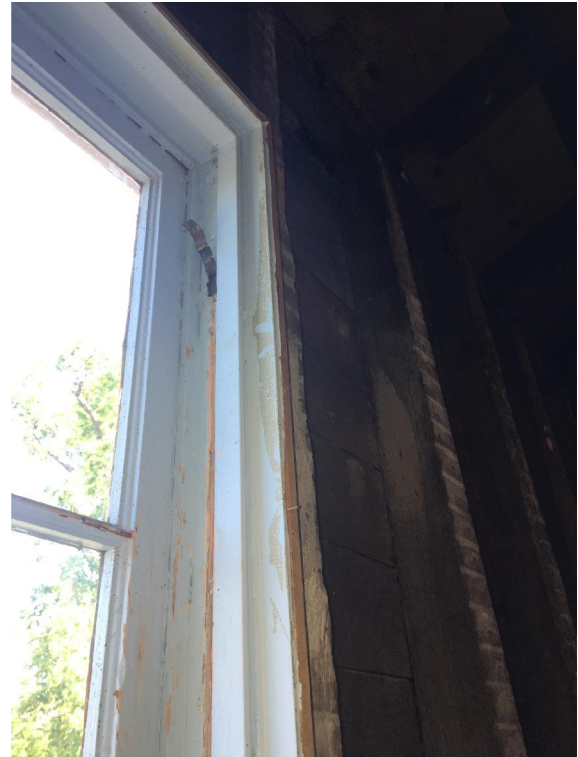
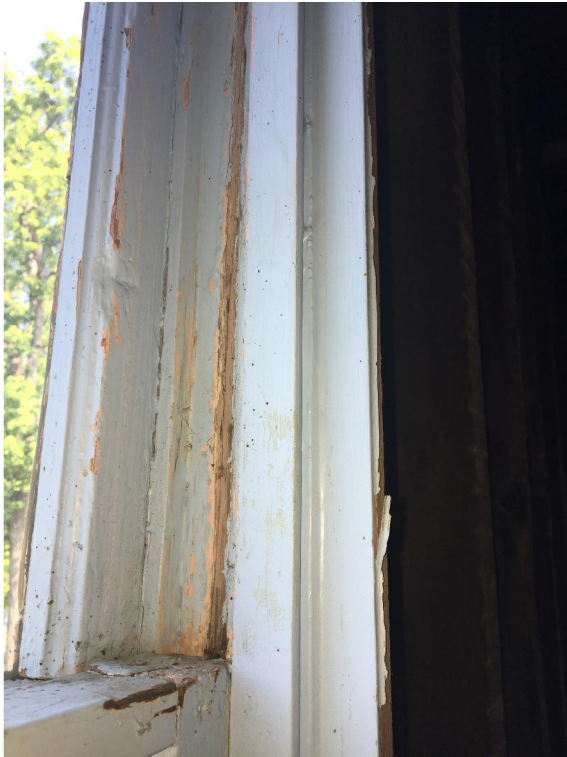
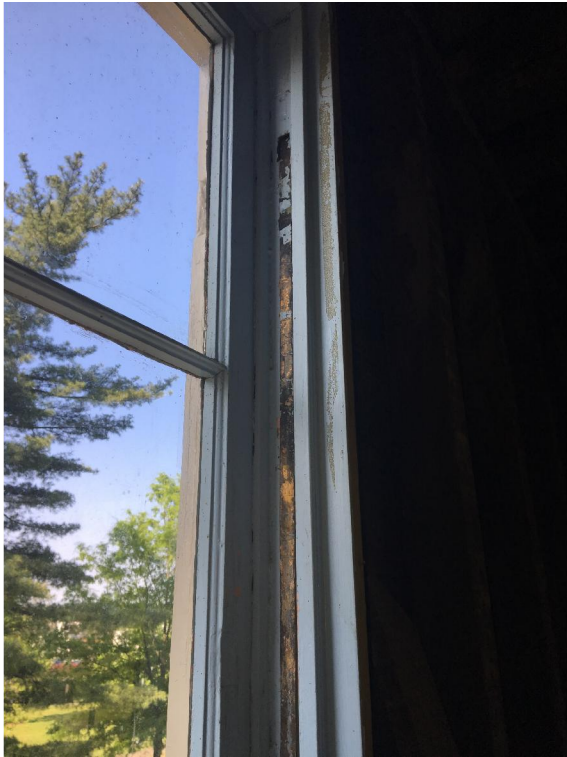
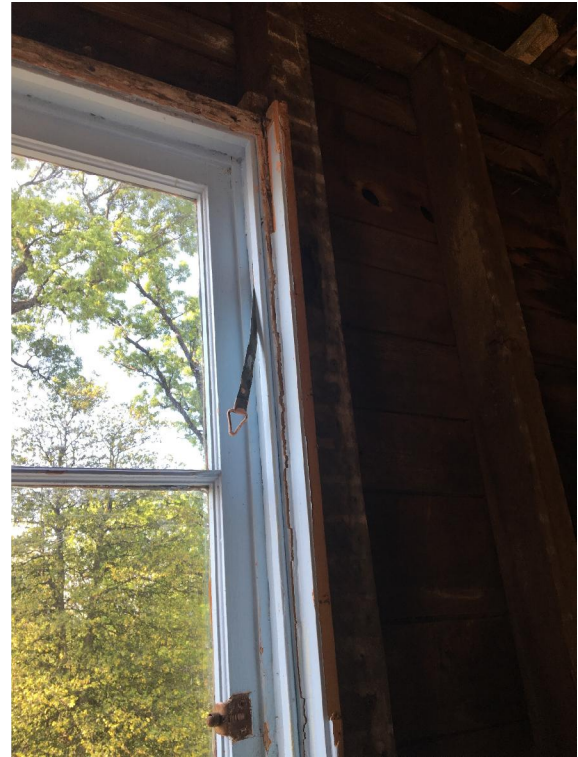
- 18 windows
- Located in the main historic mass and second floor of rear ell.

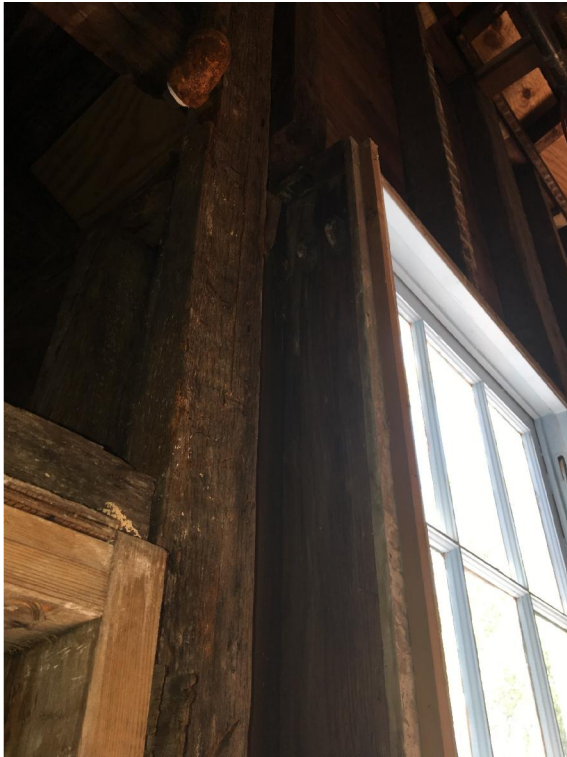
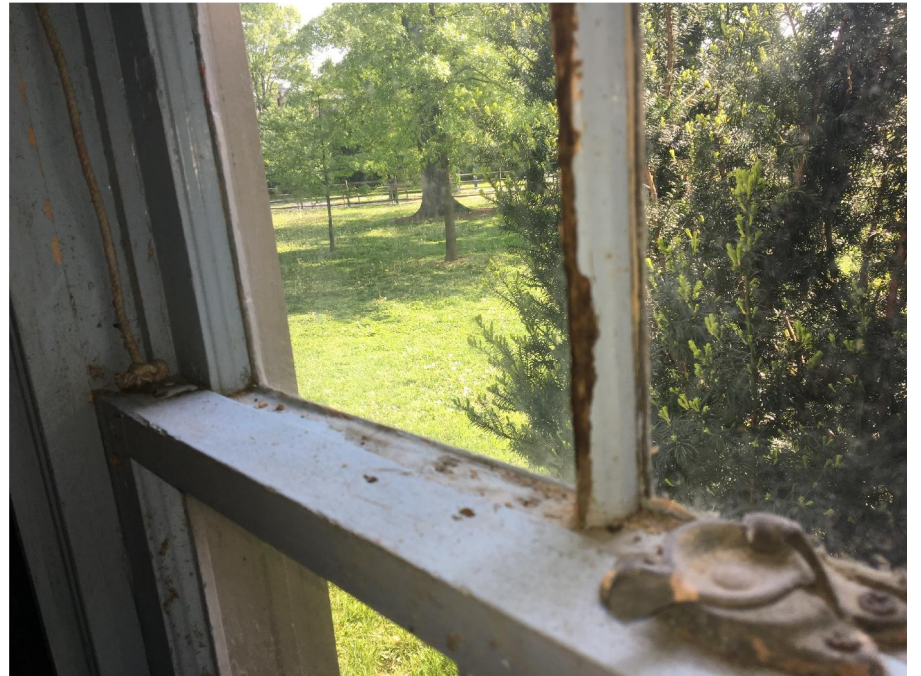
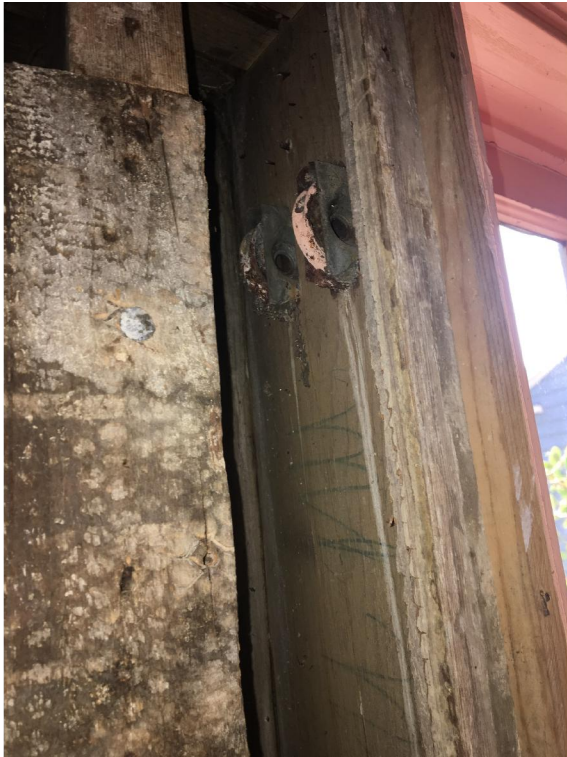
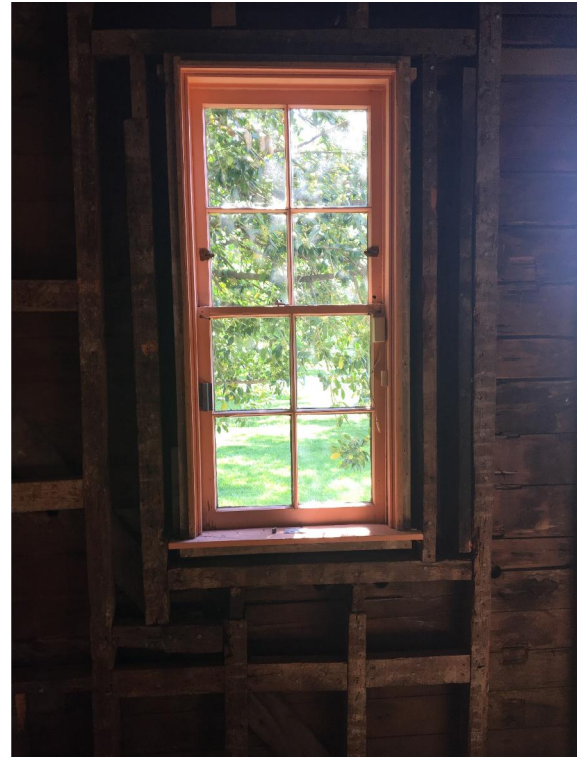
- One 6/6 and six 4/4 windows
- Located in the rear (east) elevation of the main mass and the rear (east) and left (north) elevation of the rear ell.

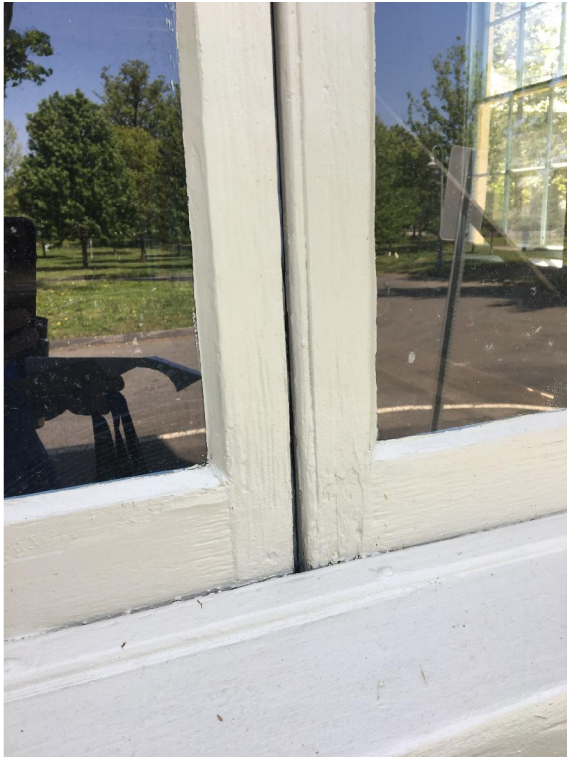
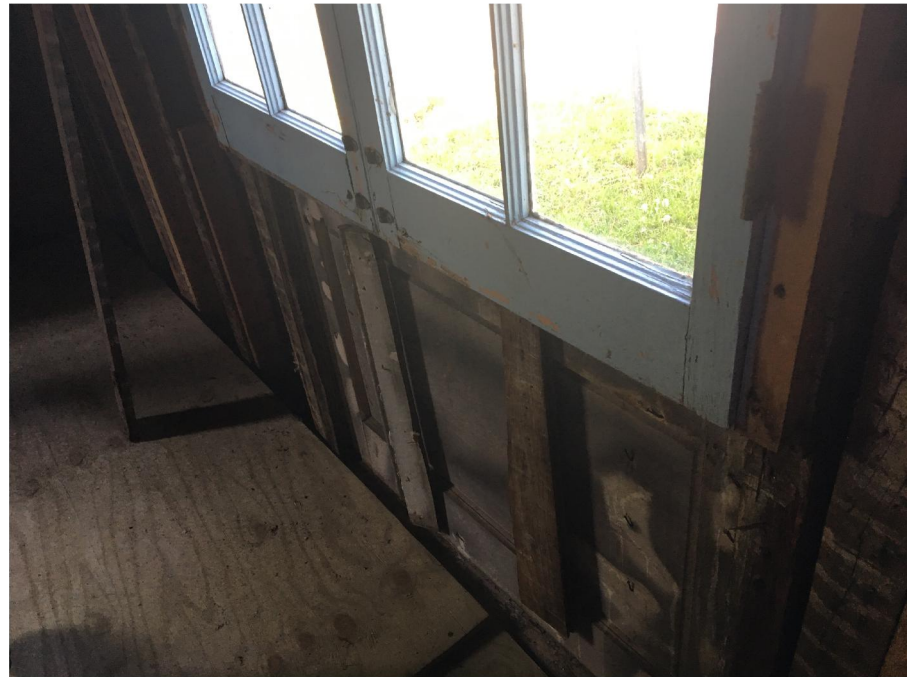
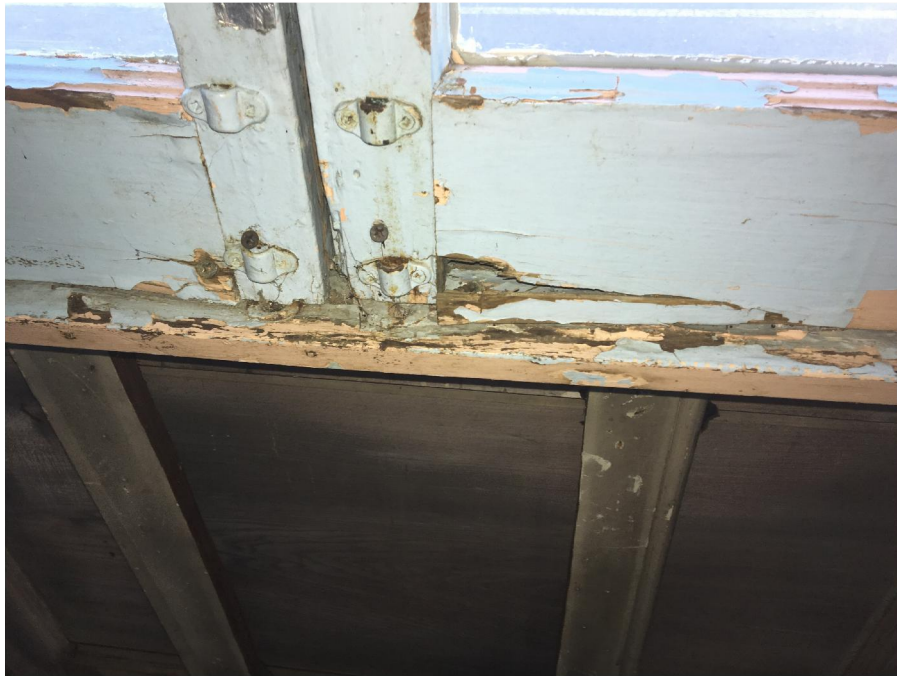
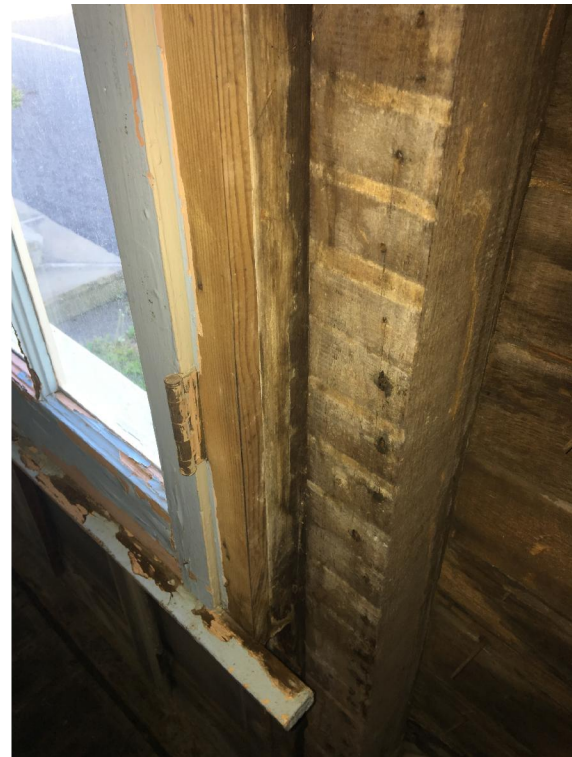
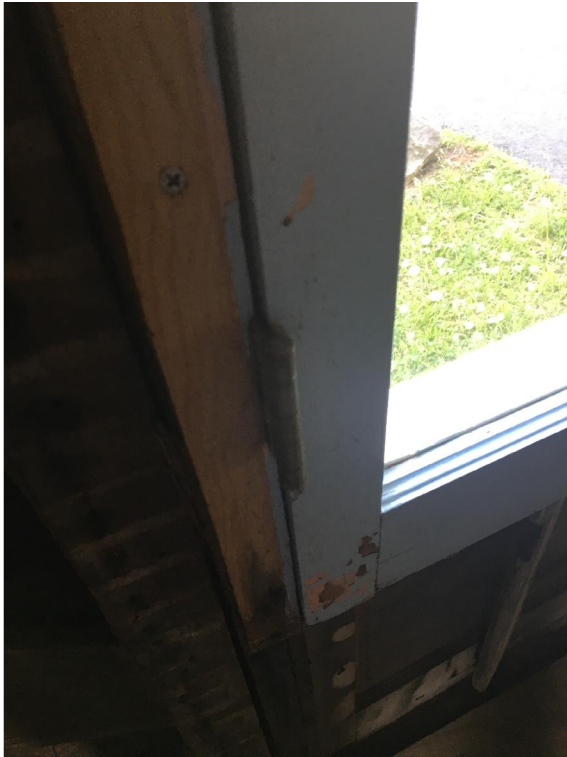
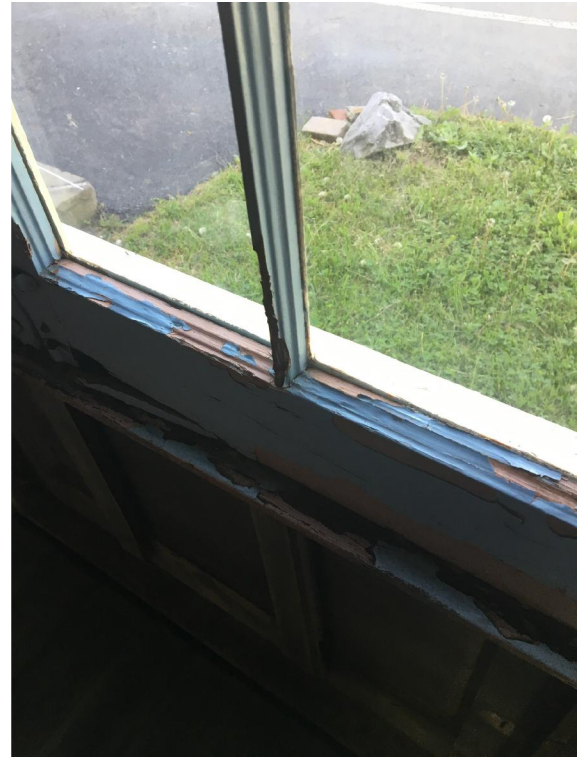
- Two paired eight-light casements
- First floor of the front (west) elevation.

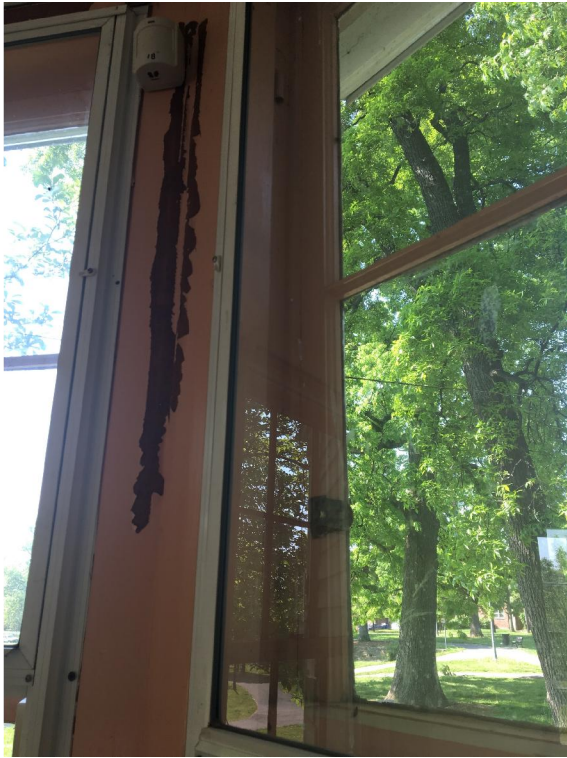
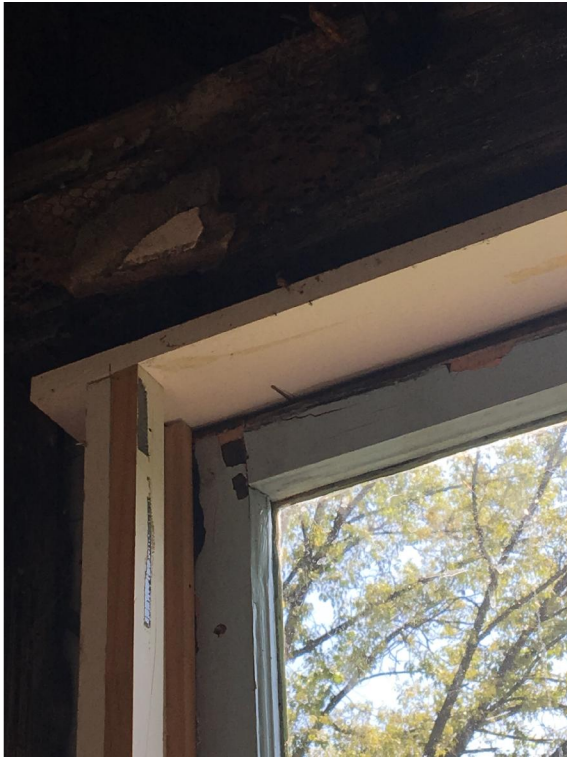
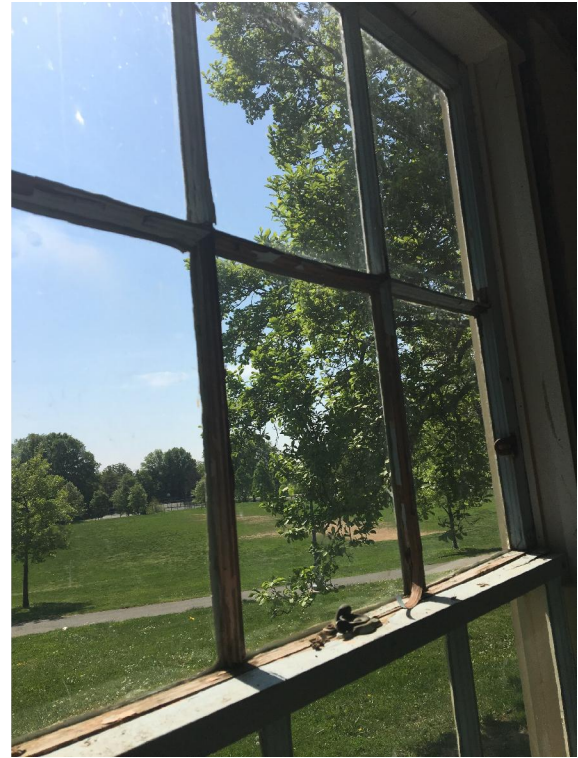
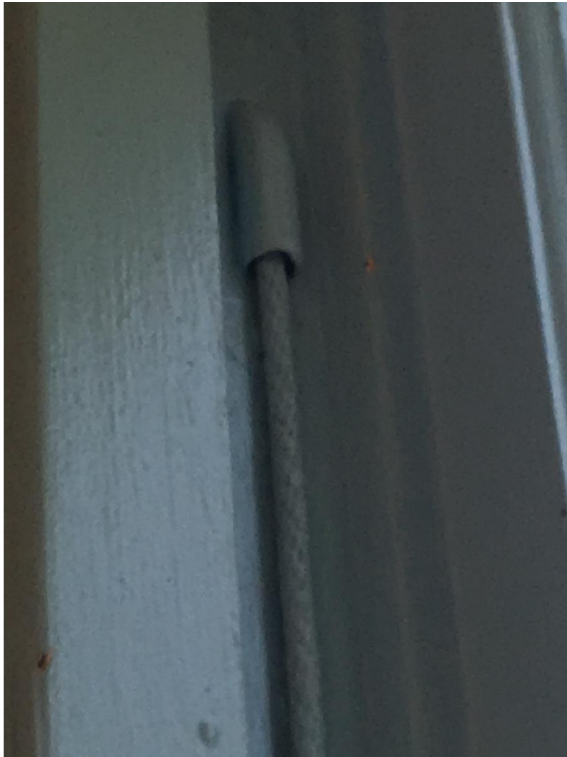
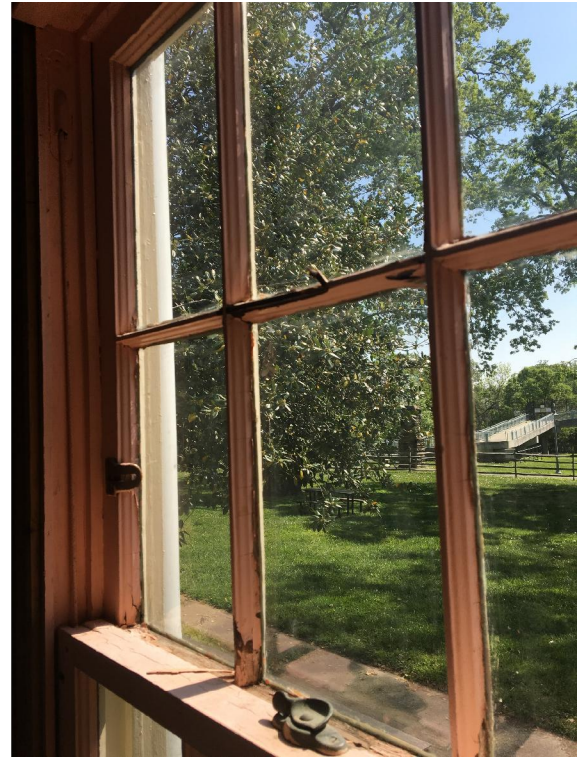
- Thirteen 6/6 windows
- Located in the library addition, constructed in 1942, and rear (east) elevation of the 'library connector'.

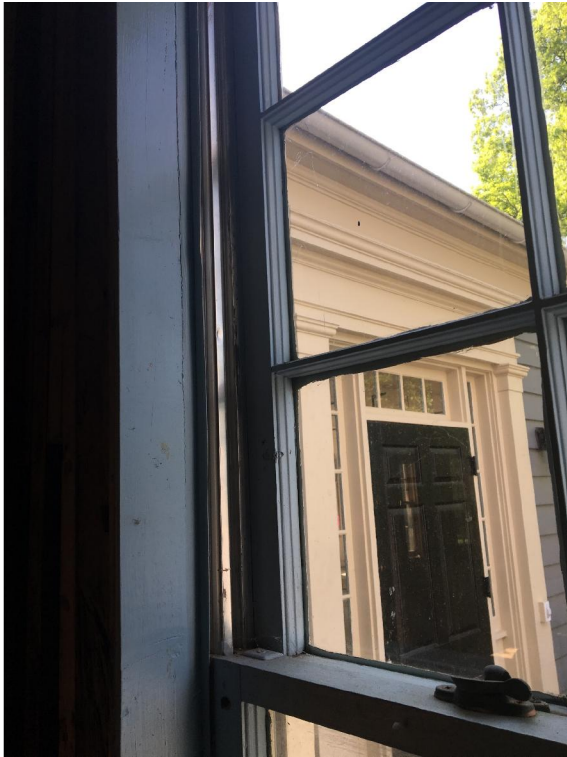
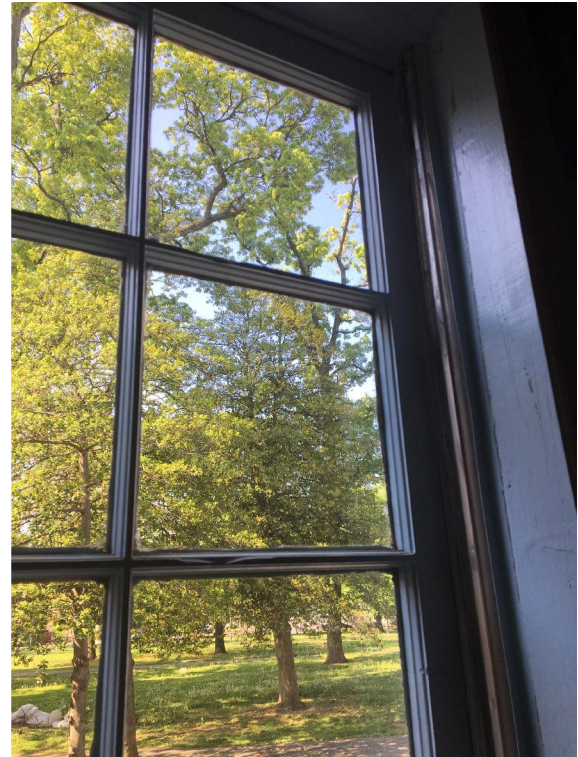
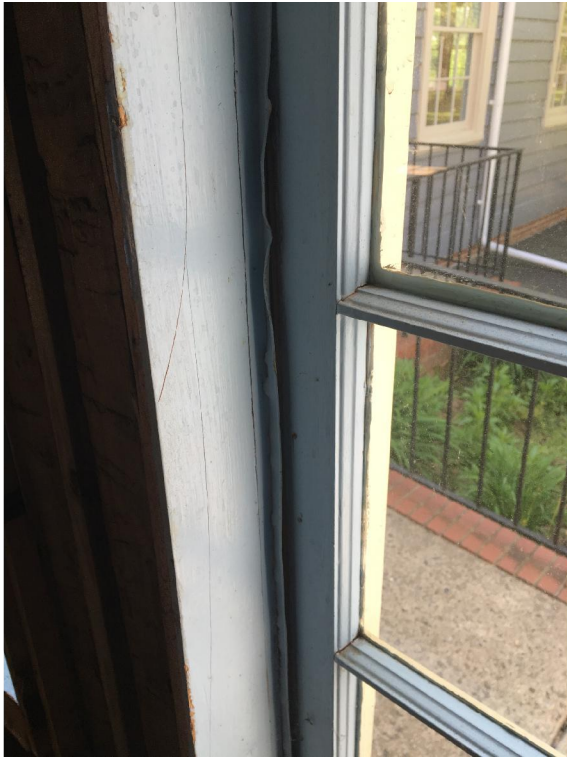
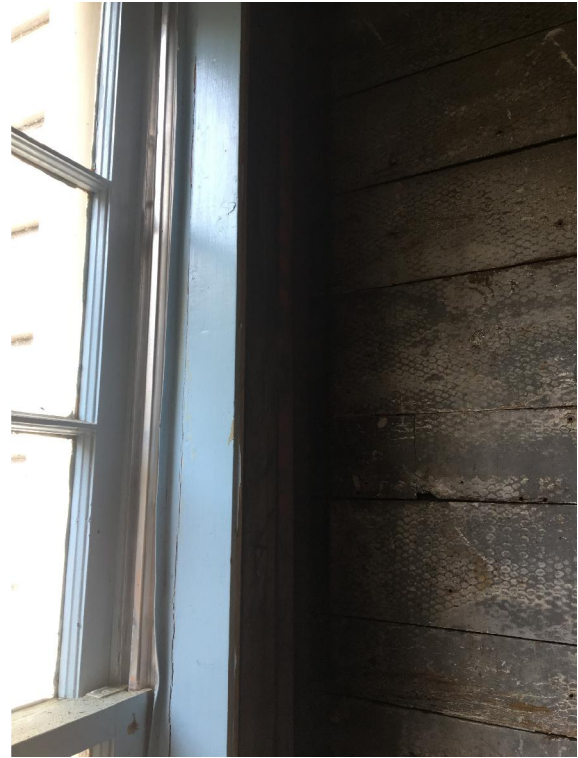
- Two 12/12 sash windows
- First floor of the right (south) elevation of the 'library connector'.

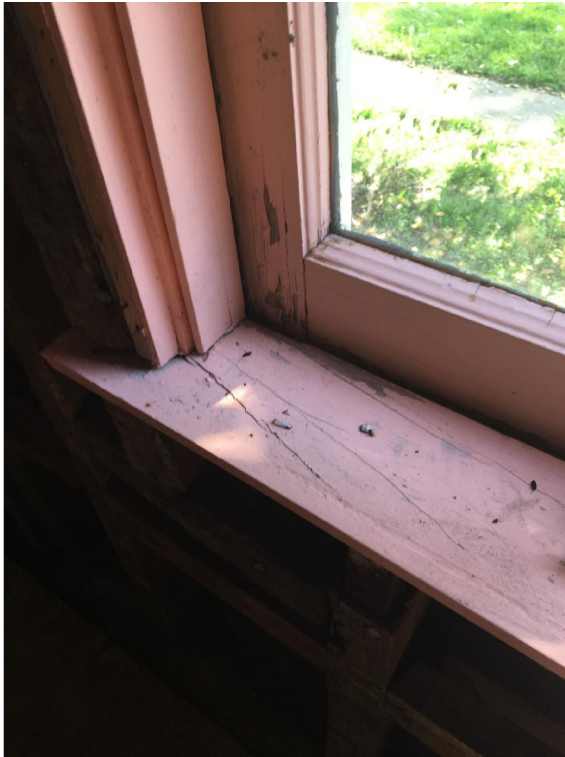
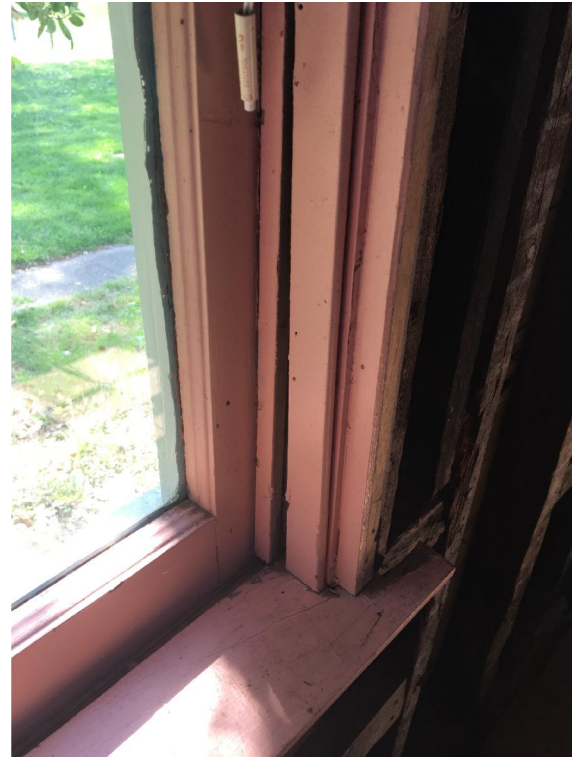
<26>

Currently a window; proposed for replacement with door for egress

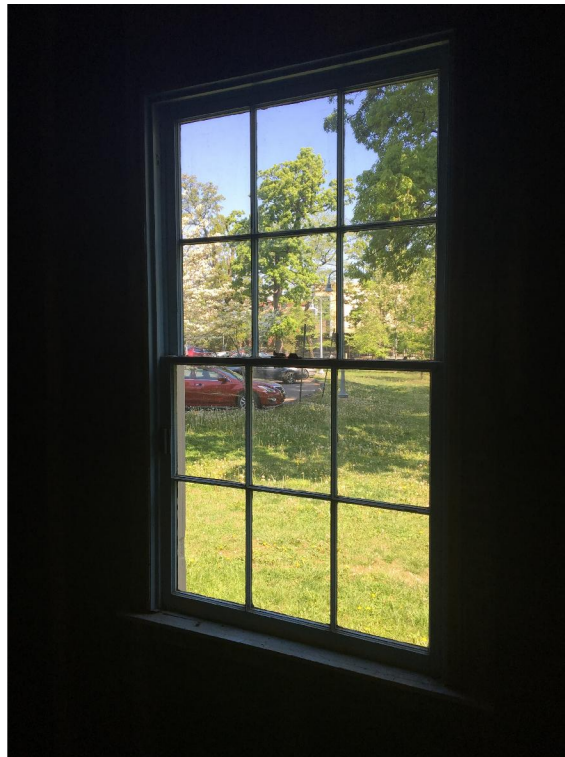
33	North elevation, lower, east	Tape Pulley, 6/6	Damaged muntins in top and bottom sash, meeting rail damaged, sill broken

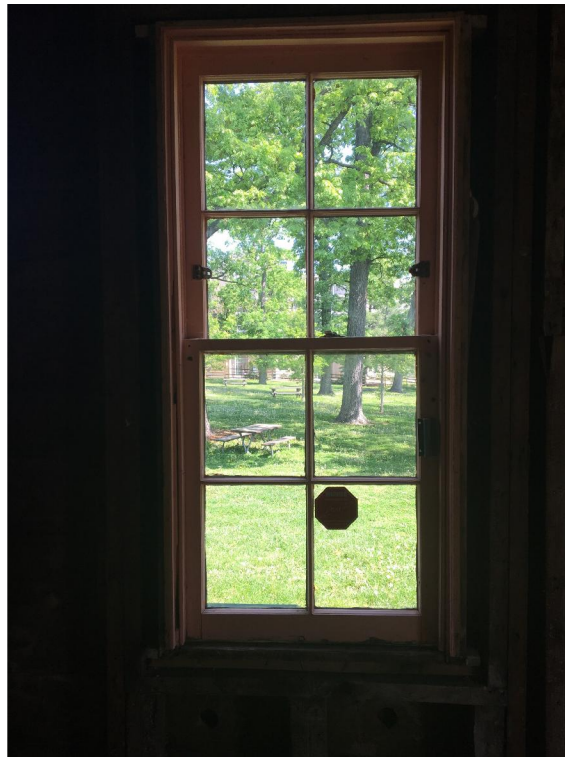
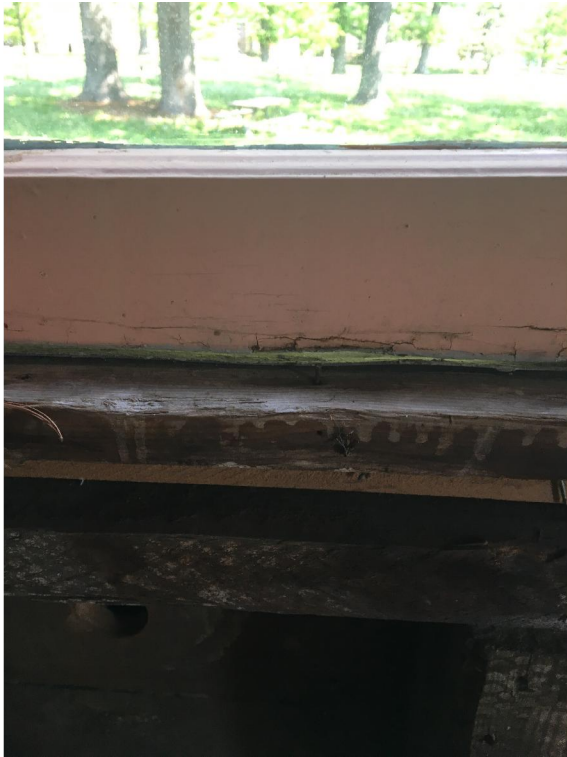
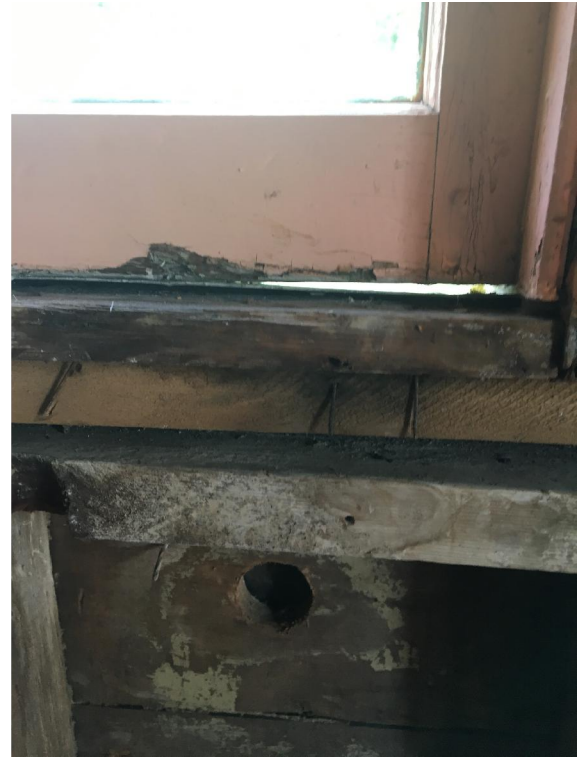
<38>

38	North elevation, ell, lower, east	4/4, double hung	Damaged muntins rebuilt with putty, rotten bottom rail, sill missing

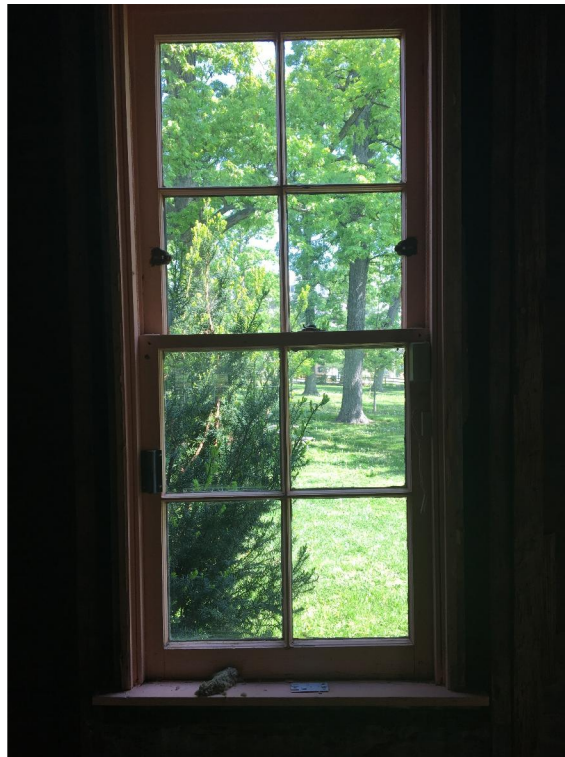
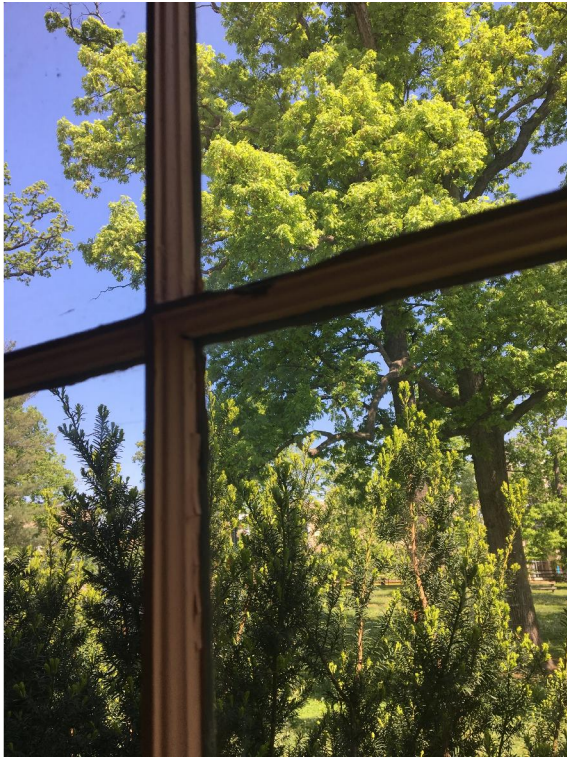
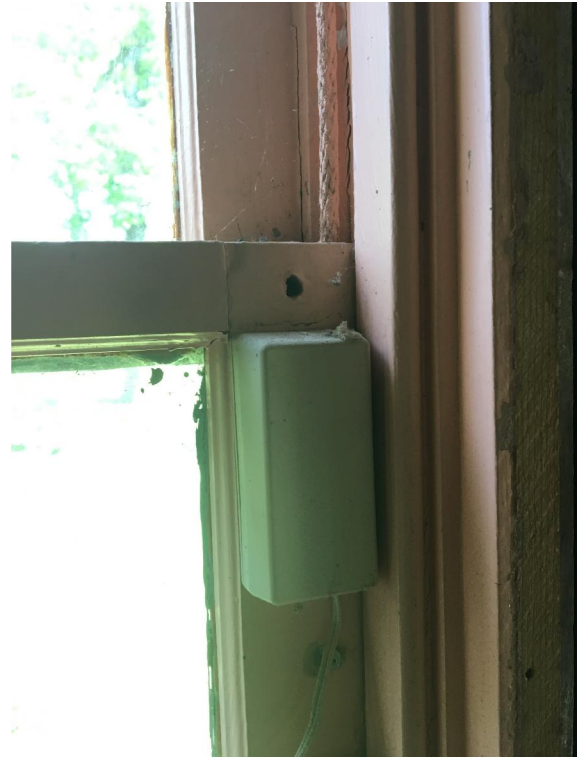
<39>

39	North elevation, ell, lower, center	4/4, double hung	Damaged muntin in top sash, damaged stiles

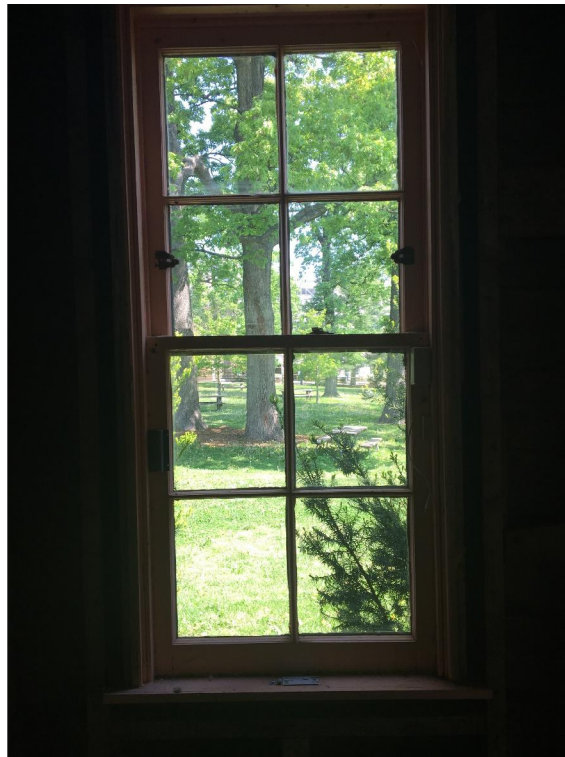
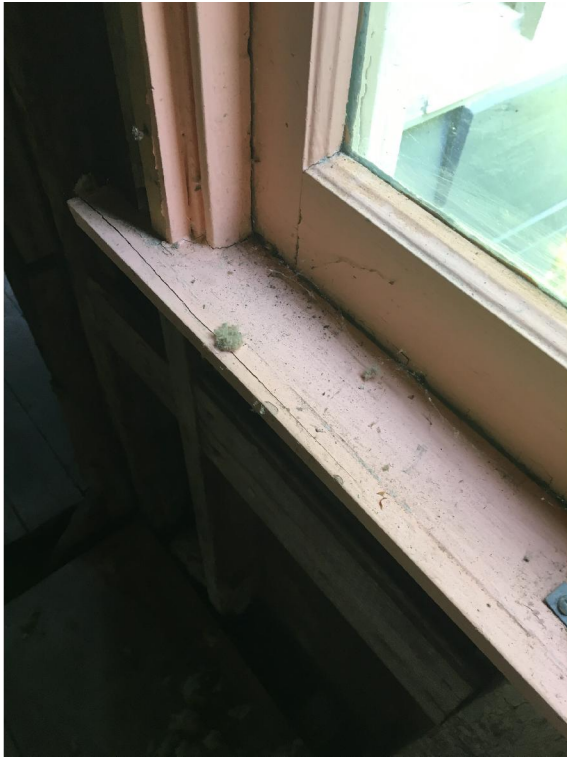
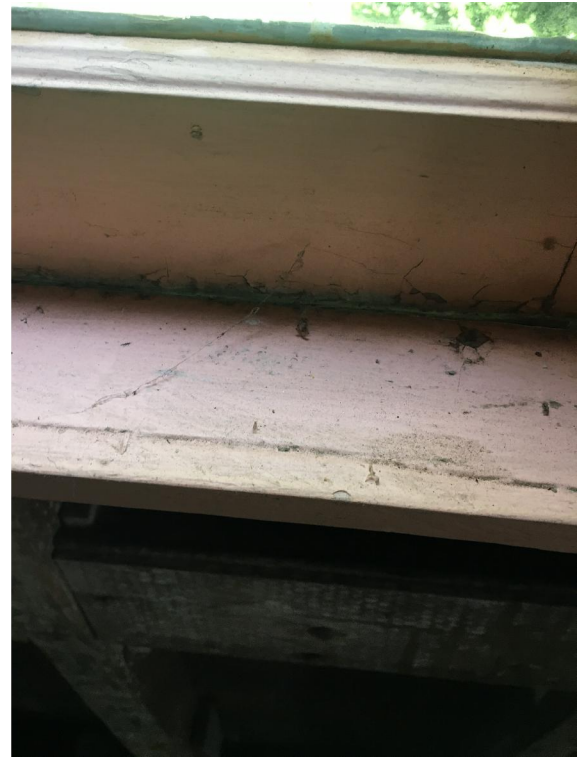
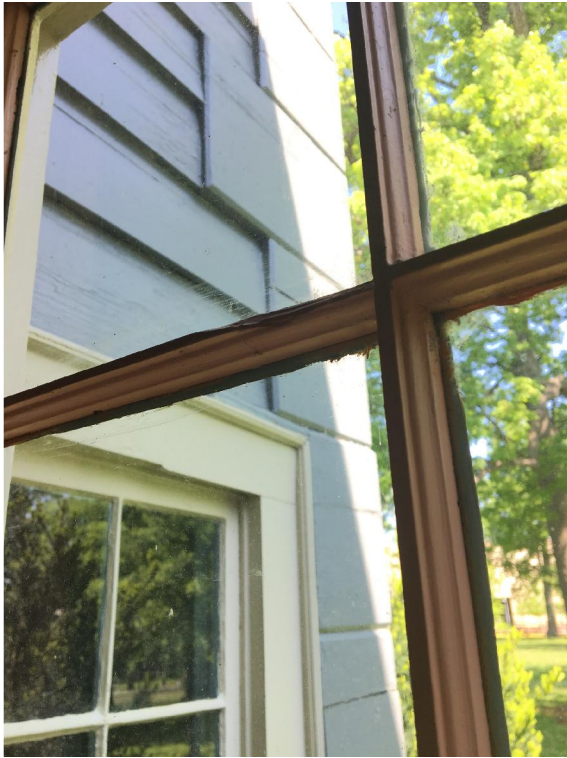
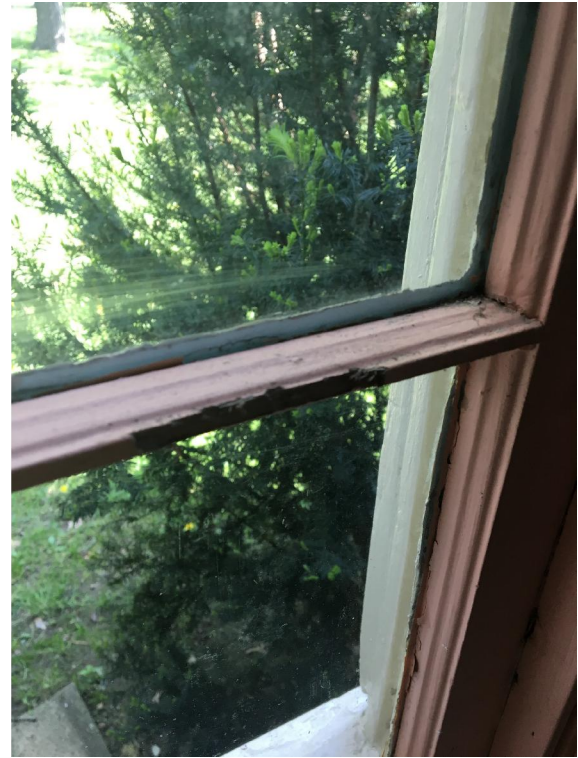
<40>

40	North elevation, ell, lower, west	4/4, double hung	Damaged muntins in top and bottom sash, damaged stiles, rot in bottom rail, broken sill

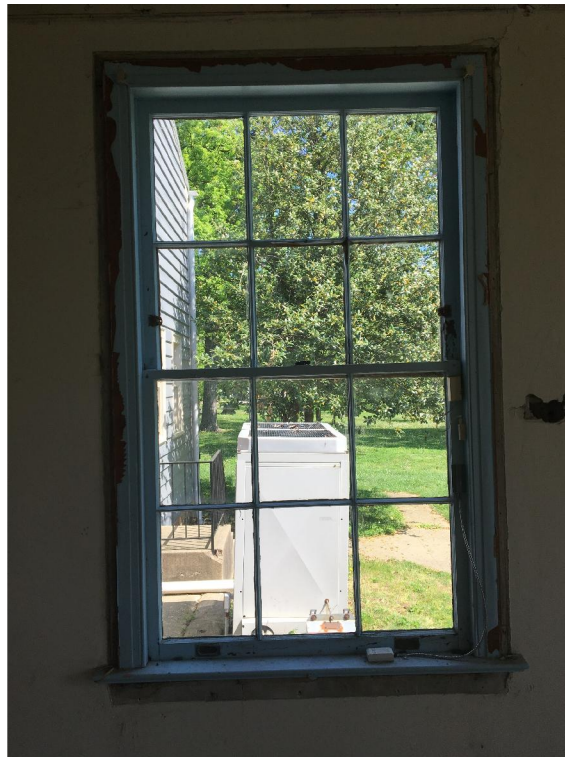
42	North elevation, library, west	6/6 (likely) single hung	Damaged muntin in top sash, racking
