# APPLICATION FOR HISTORIC AREA WORK PERMIT

House Number: 10500 & 10520 Street: ST. PAUL STREET  
Town/City: KENSINGTON Nearest Cross Street: METROPOLITAN AVE  
Lot: P6 Block: \_\_\_\_\_ Subdivision: \_\_\_\_\_  
Liber: \_\_\_\_\_ Folio: \_\_\_\_\_ Parcel: \_\_\_\_\_

## **INTRODUCTION**

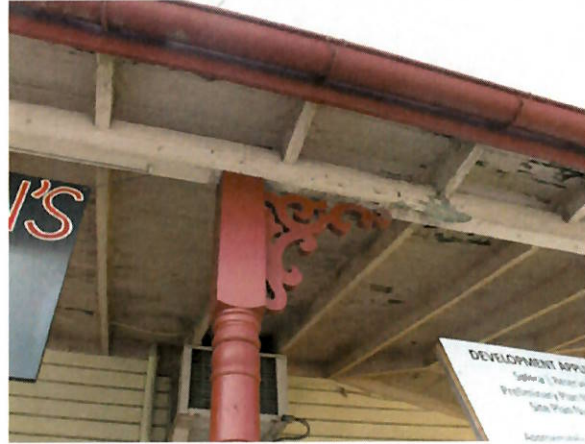
FIGURE 18 Non-original decorative Queen Anne-style brackets.

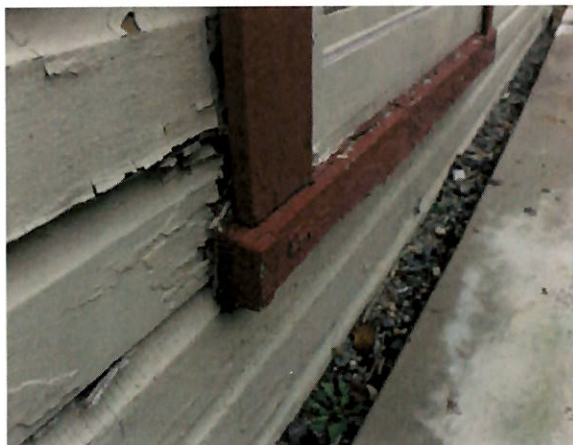
FIGURE 32 North elevation, intermediary space between low concrete wall and wall filled with gravel.

On the north elevation where the low concrete wall has been added, ongoing water issues are visible. Damage includes wood rot, missing siding, evidence of termite damage or other wood-destroying insect damage.

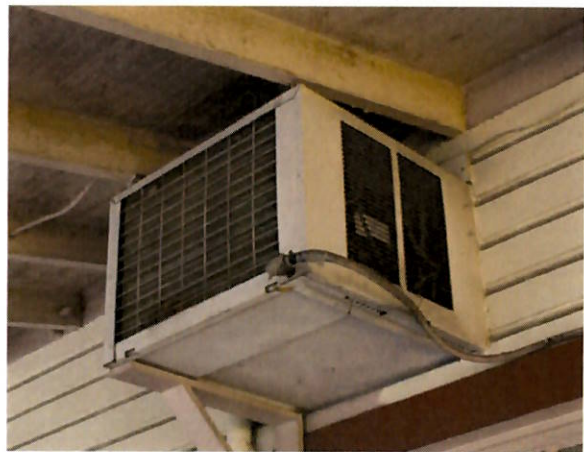
The wood cladding has been cut and modified to accommodate equipment including through-wall air-conditioning units on the facade and south elevation and electrical panels and conduit on the facade.

FIGURE 36 Through wall AC unit at front facade.

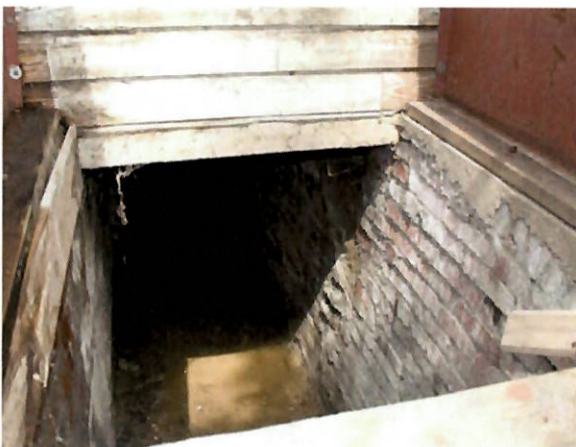
*Brick* - Brick foundation walls exhibit damage and deterioration. Efflorescence and moisture damaging mortar. On the south side the foundation is not visible and the wood siding is set directly touching the ground.

FIGURE 37 Brick foundation walls visible at basement access hatch.

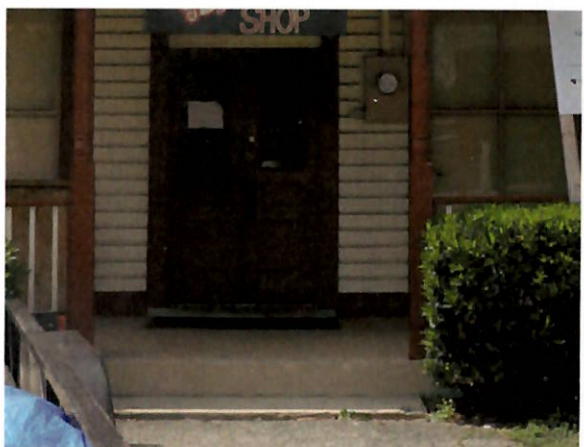
*Concrete* - Contemporary concrete at the rear west elevation is generally in fair condition. The original concrete at the front porch, however, is in fair to poor condition showing signs of cracking and settlement.

FIGURE 38 Painted concrete porch and step.

The original components of the front porch include the roof, roof framing, and concrete slab. The concrete slab is painted and in fair condition, showing some signs of cracking and settlement. When constructed the porch was reached by a concrete ramp or walkway from St. Paul Street and a single concrete step. Today asphalt has covered all of the walkway and much of the step. The painted wood framing of the porch roof is deteriorated, and several boards exhibit termite damage and rot. The metal roofing appears to be original and is extremely worn. The columns, railing, and decorative elements were added between the 1990s-2000s. While the posts appear to be in fair condition, the balusters and railing are extremely deteriorated.

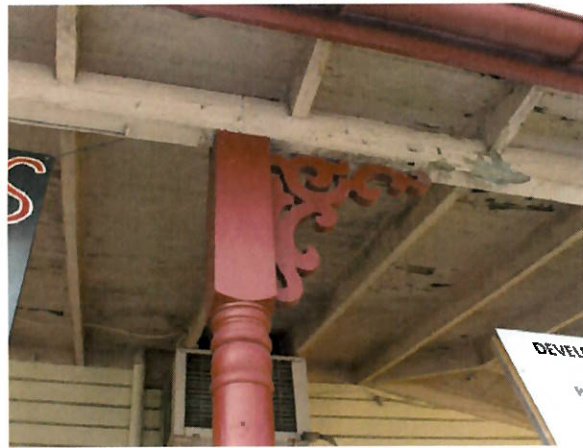
FIGURE 40 Non-original porch posts and decorative brackets.

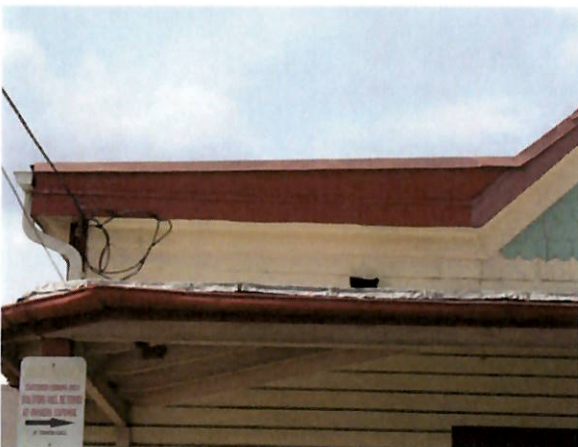
FIGURE 45 Side wing condition.

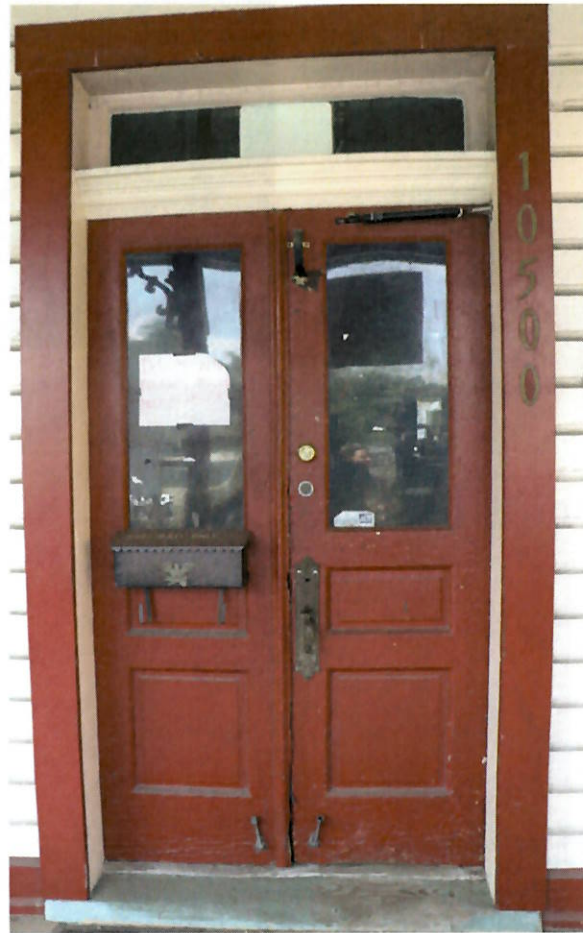
The main entry door is worn and is in fair to poor condition but is operable. The bottom rails have worn unevenly. The bead or astragal has worn and chipped. The wood threshold is also worn and very uneven. The frame appears to be original, though given the multiple layers of wood cladding, the wood trim and exterior surround appear to be replacements.

FIGURE 55 Double-leaf doors with two raised wood panels.

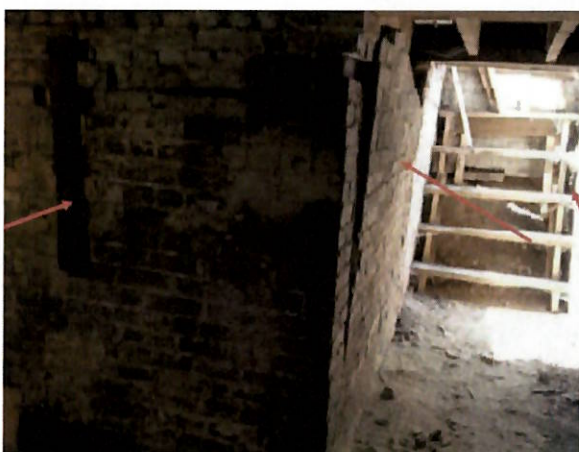
FIGURE 57 Brick foundation wall. Structura, Inc., 2018.

Overall, the interior foundations appear to be in poor condition. Structura observed deteriorated mortar joints throughout the foundation wall construction that appear to be the result of significant water intrusion. The soil in the basement was also observed to be saturated with water. A section of the foundation wall has rotated and displaced laterally. It appears that some retrofit work was performed in the past to help stabilize adjacent foundation walls. This retrofit work consisted of steel bars with tie rods. Some of the foundation walls for the original construction had been modified and demolished to provide access to adjacent crawl space below later construction. In the shallow crawl space, there are some areas of the foundation, including below the access hatch on the south elevation, that have been undermined.

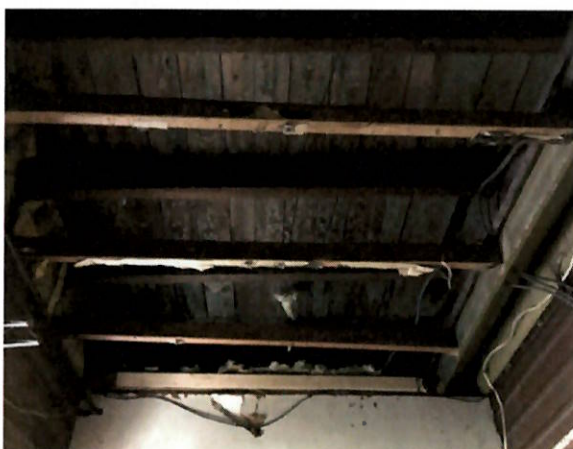
FIGURE 60 Roof framing above the north wing. Structura, Inc., 2019.

The north wing roof framing is supported by the exterior wood stud wall and what appears to be the original exterior wall that remained in place after the north wing was added. A significant amount of mold was observed on the underside of the north wing roof framing.

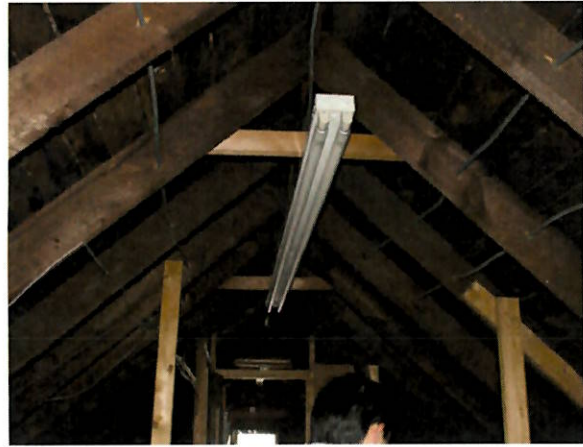
The cross-gable roof framing consists of wood rafters with attic floor joists. Several members of the framing have been sistered with modern dimensional lumber. The flat roof framing above the wings consists of wood joists supported on the exterior wood stud walls and interior structure that also support the gable roof framing. The roof over the south wing is supported on the interior by a wood beam supported by interior columns. The beam is deteriorated and as a result the roof of the wing slopes towards its connection with front facing gable. The roof over the north wing is supported on the interior by the original north elevation wall and remains essentially flat. The roofs over the wings have been recently built up and the slope has been modified to improve drainage and halt water damage. The roofs are covered in roofing membrane.

FIGURE 62 Gable roof framing.

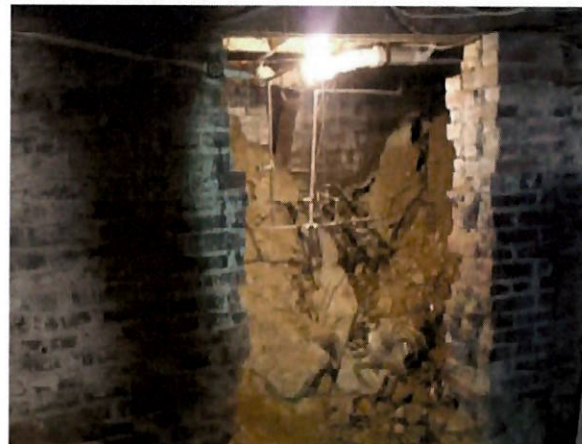
FIGURE 64 Opening demolished in section of foundation wall. Structura, Inc., 2018.

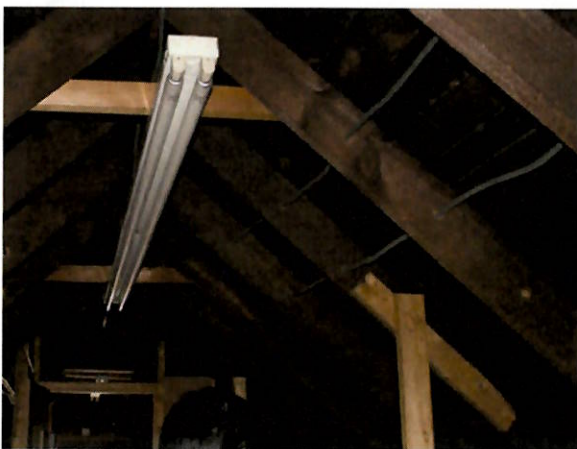
FIGURE 70 Sistered roof framing.

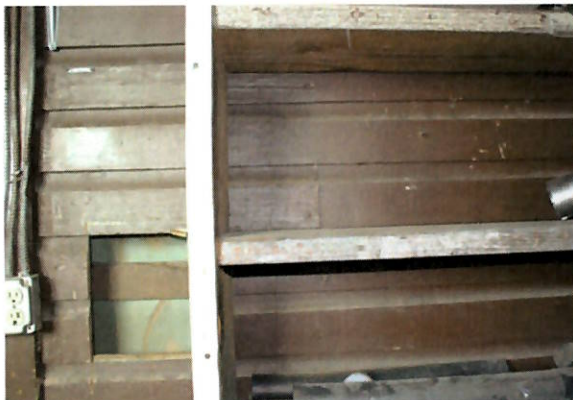
FIGURE 76 Interior, original exterior painted wood siding, extant within north wing storage space.

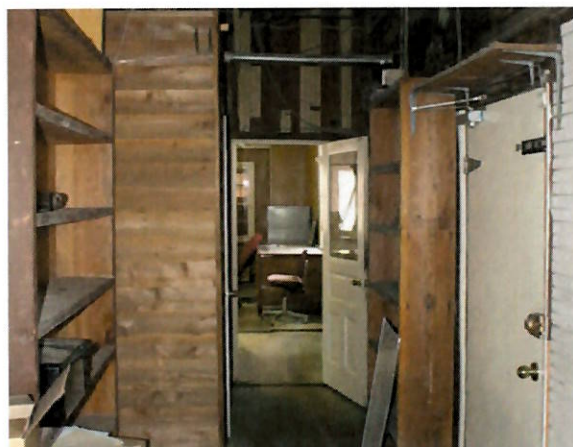
FIGURE 77 Interior, north wing storage space, looking west.

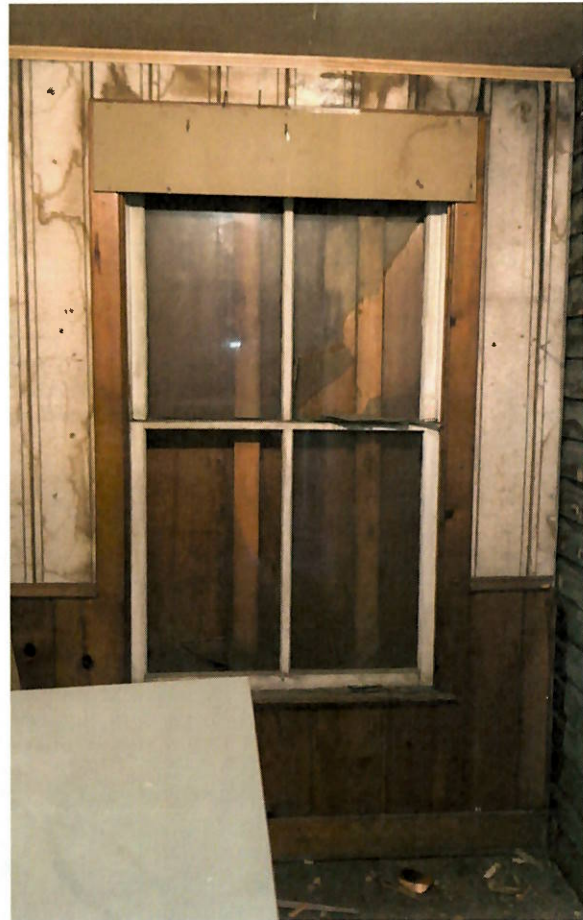
FIGURE 78 Interior, uncovered window in closet. Structura, Inc., 2019.

At the front of the building is a small storage space approximately 11'-10" deep reached by a wood door with two inset panels and a glass doorknob. The walls are clad in vertical wood panels that appear to date from the 1960s and 1970s and a dropped ceiling is covered in gypsum board. Floors contemporary wood. A two-over-two double-hung wood window on the front façade in this closet was covered on both the interior and exterior but was located during exploratory demolition. The window is extant and in fair condition.

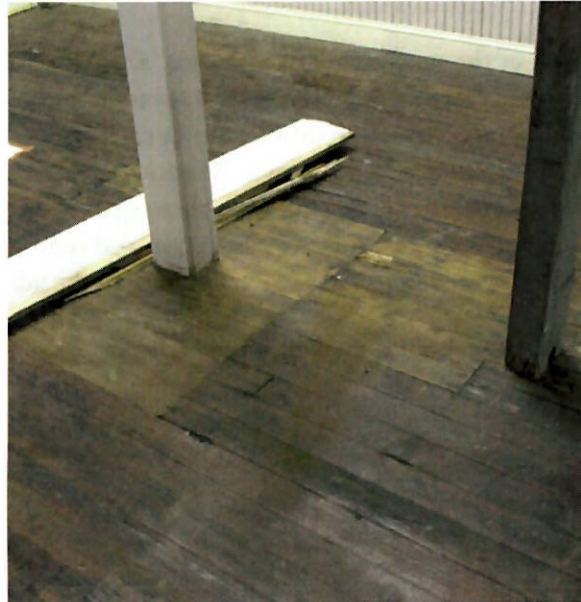
FIGURE 84 Interior, wood plank flooring transition from original construction to south wing.

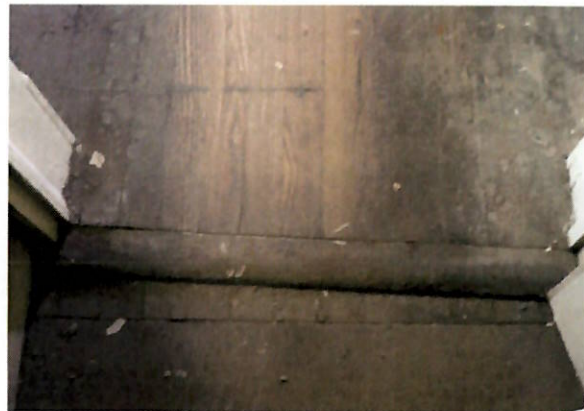
FIGURE 85 Interior, plywood flooring in north wing at transition to wood plank in office.

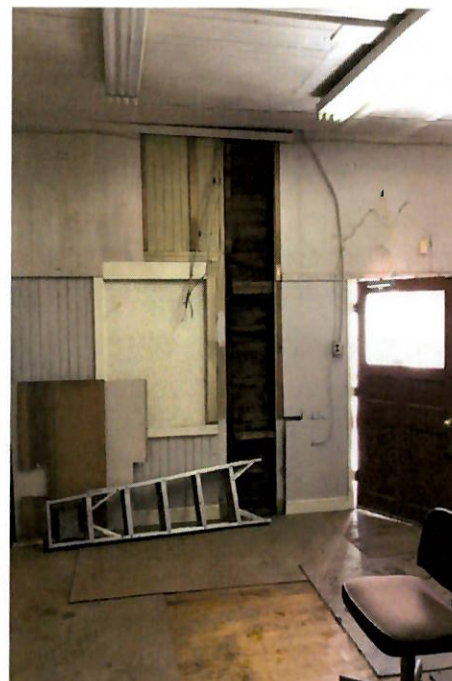
FIGURE 87 Interior, various layers of wall cladding materials revealed during exploratory demolition.
