CONDITION ASSESSMENT REPORT

EXPLORATORY WORK FIELD NOTES

HISTORIC PRESERVATION REPORT

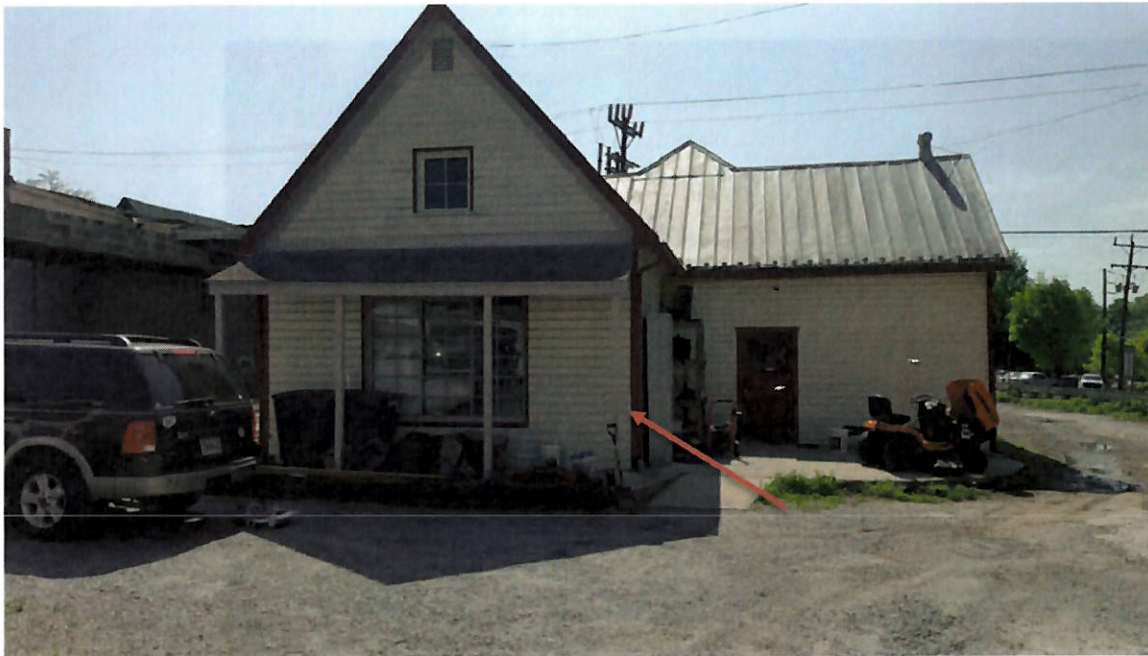
3. West Elevation (Note addition built in 1980s)

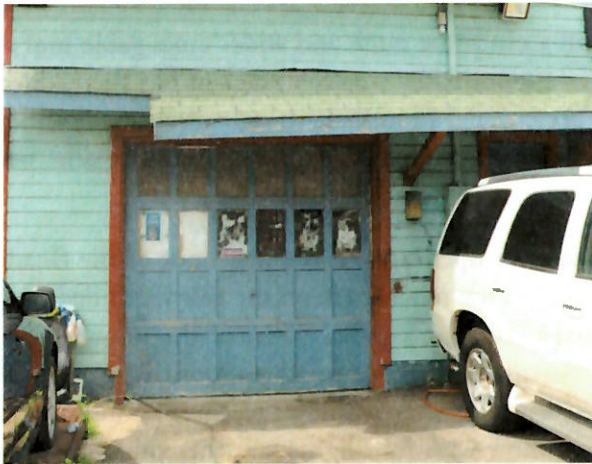
FIGURE 15 Garage door, east elevation.

The two entry doors do not appear to be original and are in good condition. The wood garage door is in fair condition exhibiting some deterioration including peeling and flaking paint.

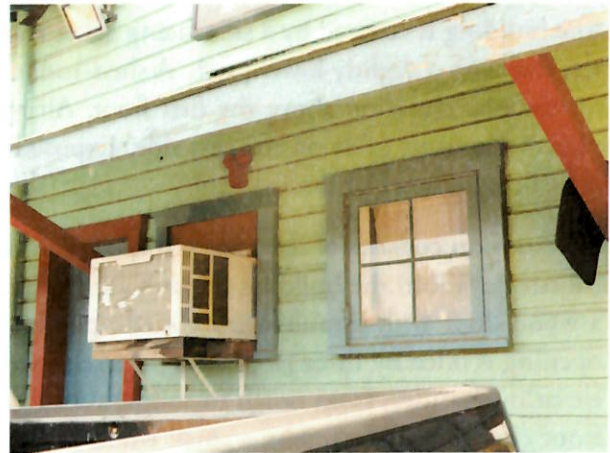
FIGURE 18 Casement windows, east elevation.

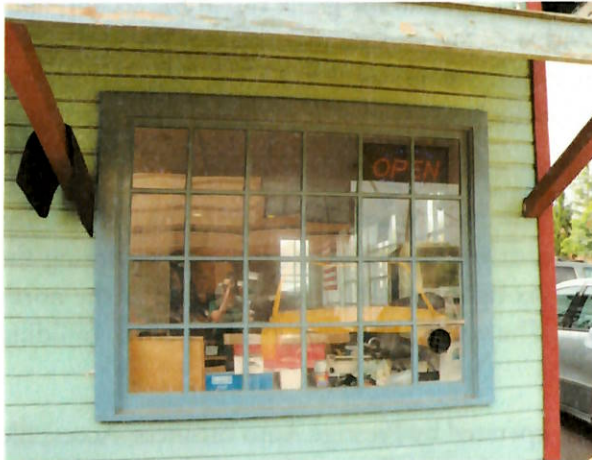
FIGURE 16 Non-original multi-light window, east elevation.

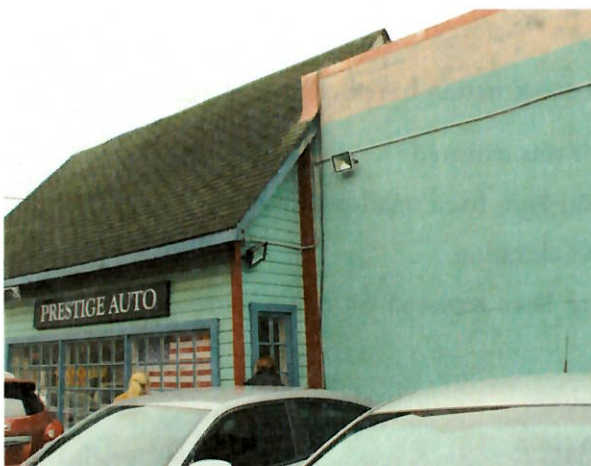
FIGURE 17 Partial and obstructed view with non-contributing concrete block shed, looking southeast.

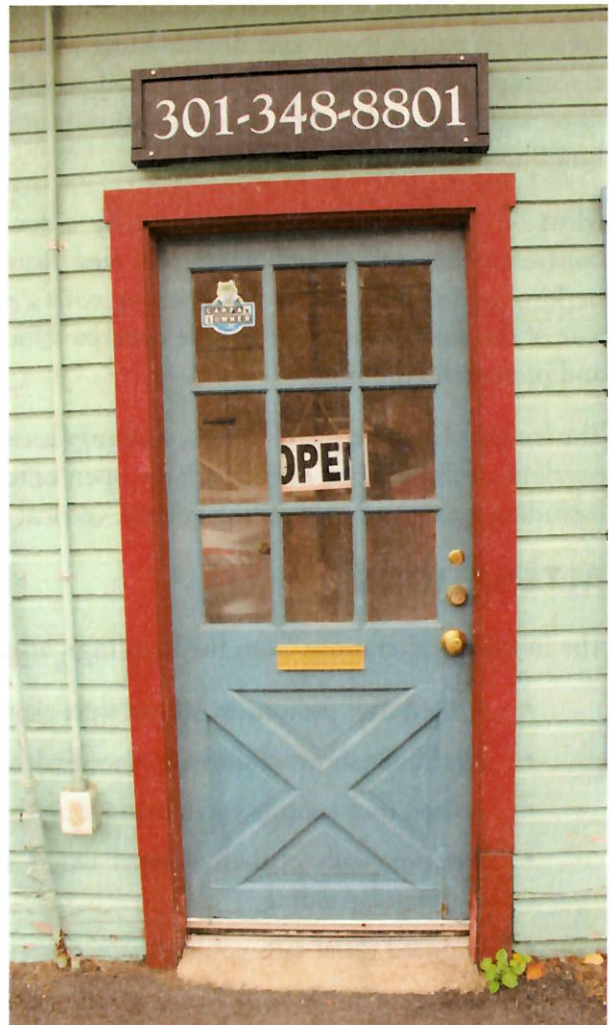
FIGURE 19 Primary entrance, north elevation.
