PHYSICAL DESCRIPTION AND ASSESSMENT OF EXISTING CONDITIONS

EHT Tracerics conducted site visits and surveyed the building's exterior and interior in August and November 2018 in order to identify and photograph existing conditions. Supplementary survey was conducted by Structura, Inc. Structural Engineers to assess the structural conditions of framing members and the foundation in May 2018. At that time, observations were limited to components and structures that were readily accessible and observable without the use of destructive probes. Additional assessment and limited exploratory demolition was performed in January 2019 to provide greater insight into the building's existing conditions. Structura's findings can be found in the report included as Appendix A.

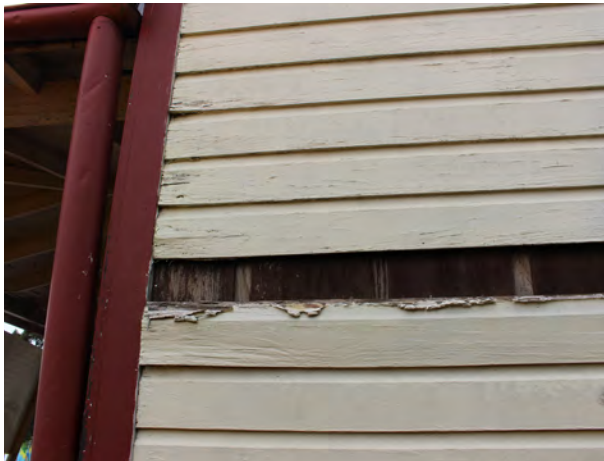
Wood Siding and Shingles- The painted exterior wood cladding, including the siding and shingles, exhibit some deterioration caused by moisture and insects. Visible deterioration includes peeling and flaking paint, areas of wood rot, and termite damage. The painted wood shingles within the gable roofs are worn and some of the shingles appear to have split. Painted wood trim is in fair to good condition.

FIGURE 31 Missing German lap siding that reveals the extant vertical siding.

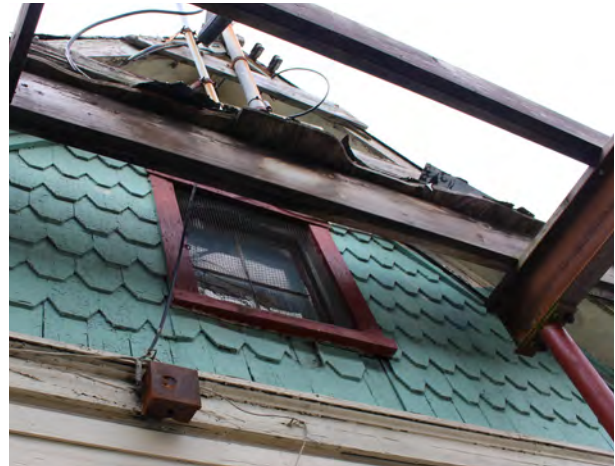
FIGURE 35 Trapezoidal-cut shingles on north gable.

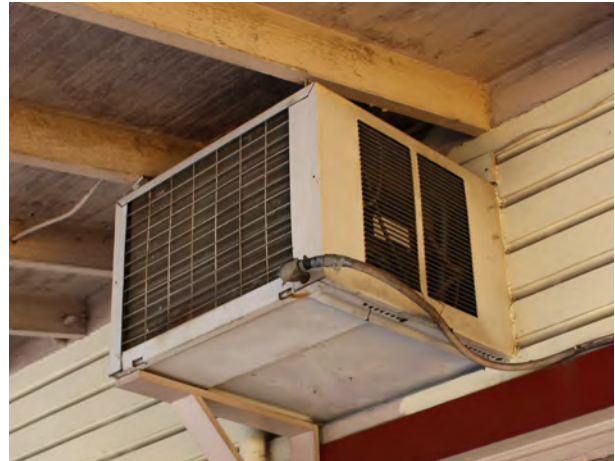
The wood cladding has been cut and modified to accommodate equipment including through-wall air-conditioning units on the facade and south elevation and electrical panels and conduit on the facade.

FIGURE 36 Through wall AC unit at front facade.

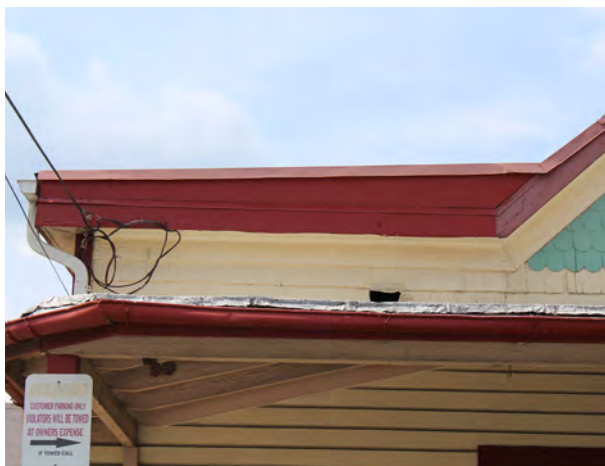
A standing seam metal roof remains extant on the building. The roof appears generally worn and past its useful life. Water infiltration on the interior suggests damage and deterioration. The wings are covered in membrane roofing which was recently added on top of what was likely a standing seam metal roof. The rear roof slope and new addition are covered in contemporary metal roofing.

FIGURE 45 Side wing condition.

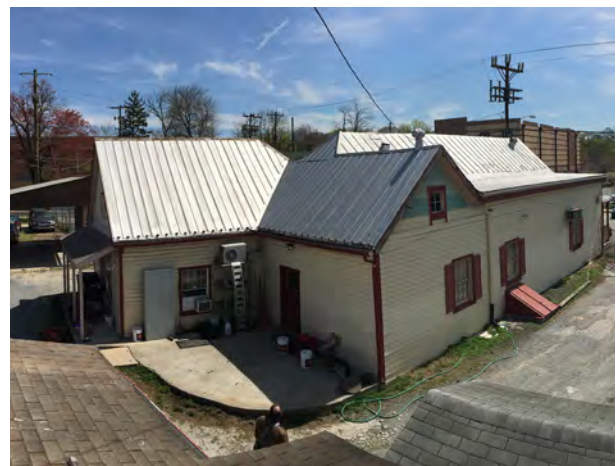
FIGURE 46 Contemporary metal roofing visible on rear addition.

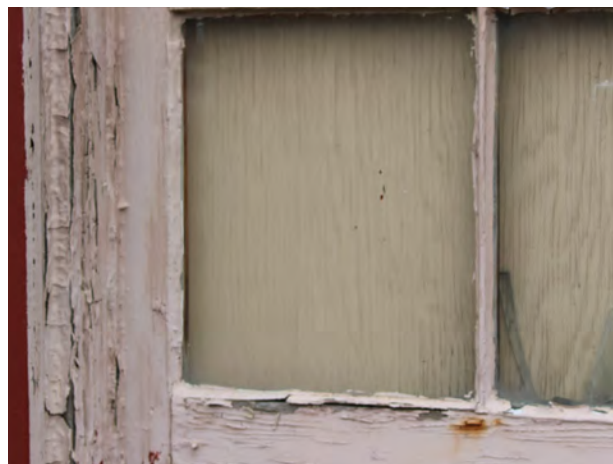
Side elevations feature wood-sash, double-hung windows with six-over-six and six-over-one-light configurations. These windows are in fair to poor condition. The windows were not a part of the original construction, thus the differing light configuration. They likely originally featured a six-over-six light configuration, but the lower sashes appear to have been damaged or replaced over time. The windows have broken glass, missing glazing putty, deteriorated and peeling paint, and deteriorated and replacement muntins.

FIGURE 49 Window detail.

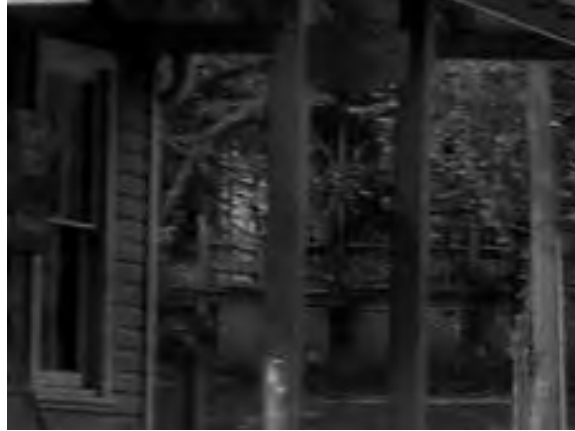
Windows at the wings of the facade are currently covered on the interior with plywood and covered on the exterior by multiple layers of wood siding. During limited exploratory demolition in early 2019, the original window at the northern wing on the façade was revealed. Like the other extant windows on the facade, the window is wood double-hung with a two-over-two configuration. The window appears to be in good condition with the exception of the glazing which is broken. The south wing also featured a window at the façade. The opening appears extant, but the sash is no longer extant.

FIGURE 50 Approximate location of covered north-wing facade opening.

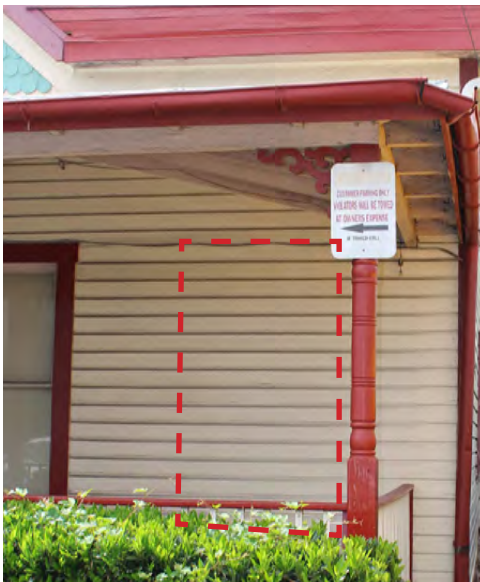
FIGURE 51 Approximate location of covered north wing window opening.

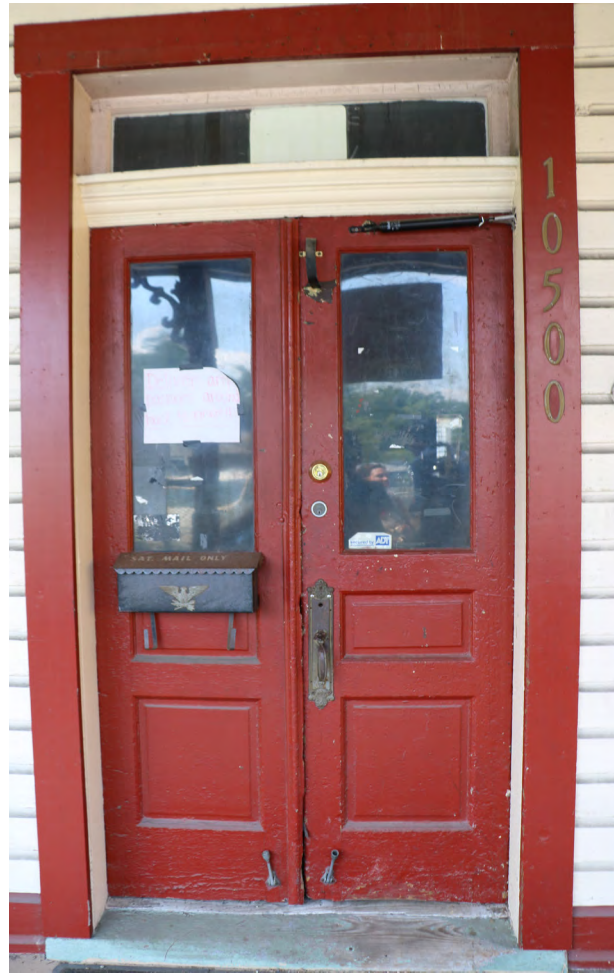
The main entry door is worn and is in fair to poor condition but is operable. The bottom rails have worn unevenly. The bead or astragal has worn and chipped. The wood threshold is also worn and very uneven. The frame appears to be original, though given the multiple layers of wood cladding, the wood trim and exterior surround appear to be replacements.

FIGURE 55 Double-leaf doors with two raised wood panels.

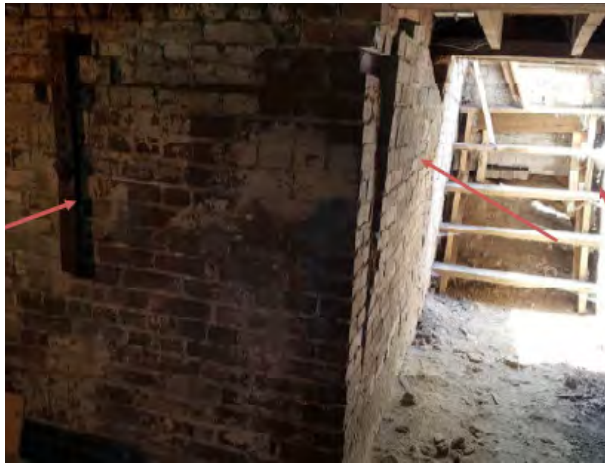
FIGURE 57 Brick foundation wall. Structura, Inc., 2018.

Overall, the interior foundations appear to be in poor condition. Structura observed deteriorated mortar joints throughout the foundation wall construction that appear to be the result of significant water intrusion. The soil in the basement was also observed to be saturated with water. A section of the foundation wall has rotated and displaced laterally. It appears that some retrofit work was performed in the past to help stabilize adjacent foundation walls. This retrofit work consisted of steel bars with tie rods. Some of the foundation walls for the original construction had been modified and demolished to provide access to adjacent crawl space below later construction. In the shallow crawl space, there are some areas of the foundation, including below the access hatch on the south elevation, that have been undermined.

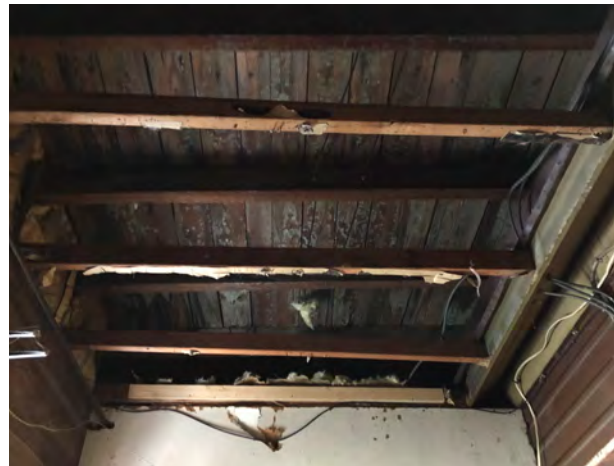
FIGURE 60 Roof framing above the north wing. Structura, Inc., 2019.

The north wing roof framing is supported by the exterior wood stud wall and what appears to be the original exterior wall that remained in place after the north wing was added. A significant amount of mold was observed on the underside of the north wing roof framing.

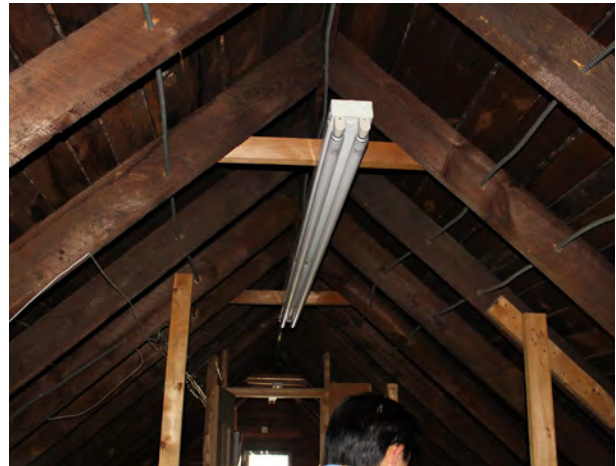
FIGURE 62 Gable roof framing.

The roof rafters are in good condition. However, the various additions and modifications made to the building appear to have left some areas of the roof without adequate support framing. In order to fully understand existing conditions of the roof framing, select areas of the interior ceiling finishes were removed in order to observe the roof framing over the wing additions. Wood joists appear to

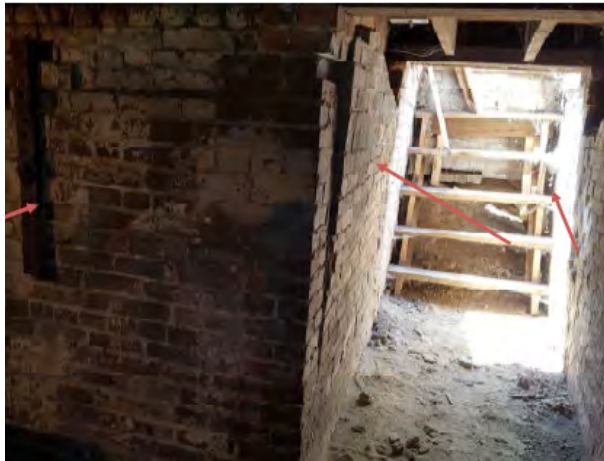
In early 2019, Structura excavated a test pit on the south side of the building. The test pit revealed that there was no footing below the foundation wall. The bottom of the foundation wall was measured to be approximately 32 inches below grade.

FIGURE 63 Laterally displaced foundation wall, undermined footing below access hatch and stair, and previous foundation wall retrofit. Structura, Inc., 2018.

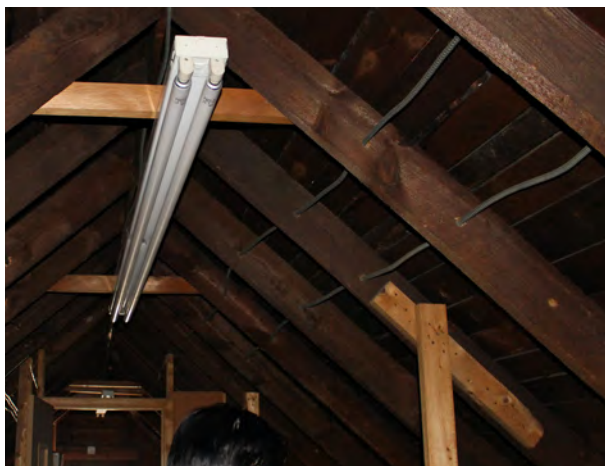
The cross-gable roof framing consists of wood rafters with attic floor joists. Several members of the framing have been sistered with modern dimensional lumber. The flat roof framing above the wings consists of wood joists supported on the exterior wood stud walls and interior structure that also support the gable roof framing. The roof over the south wing is supported on the interior by a wood beam supported by interior columns. The beam is deteriorated and as a result the roof of the wing slopes towards its connection with front facing gable. The roof over the north wing is supported on the interior by the original north elevation wall and remains essentially flat. The roofs over the wings have been recently built up and the slope has been modified to improve drainage and halt water damage. The roofs are covered in roofing membrane.

FIGURE 70 Sistered roof framing.

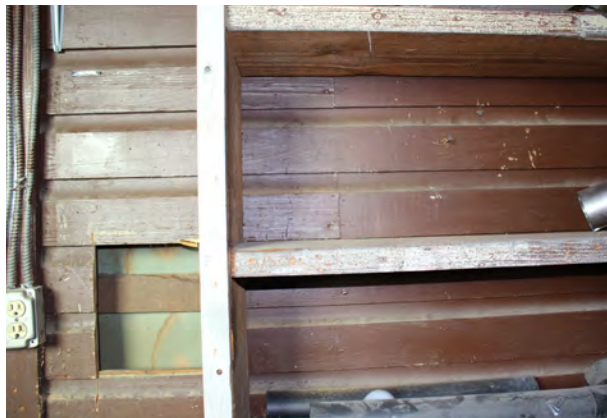
The north wing storage space is divided from the showroom by a solid wall which is actually the original construction north exterior wall. The original exterior painted wood siding and trim is extant within the space. The space is accessed by way of an opening in the wall behind the retail counter. Within the north wing storage space there is a front storage closet and a water closet.

FIGURE 76 Interior, original exterior painted wood siding, extant within north wing storage space.

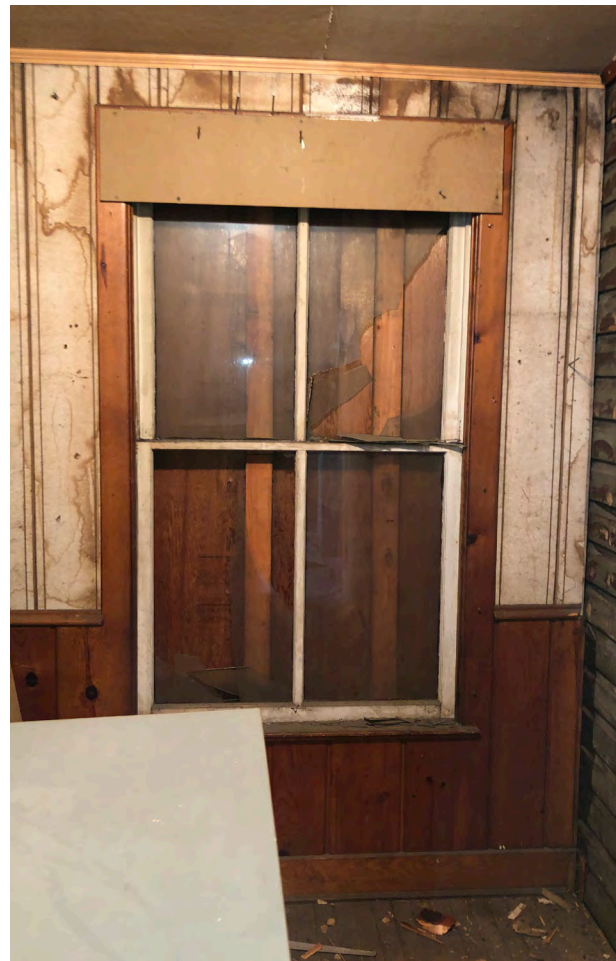
FIGURE 78 Interior, uncovered window in closet. Structura, Inc., 2019.

At the front of the building is a small storage space approximately 11'-10" deep reached by a wood door with two inset panels and a glass doorknob. The walls are clad in vertical wood panels that appear to date from the 1960s and 1970s and a dropped ceiling is covered in gypsum board. Floors contemporary wood. A two-over-two double-hung wood window on the front façade in this closet was covered on both the interior and exterior but was located during exploratory demolition. The window is extant and in fair condition.

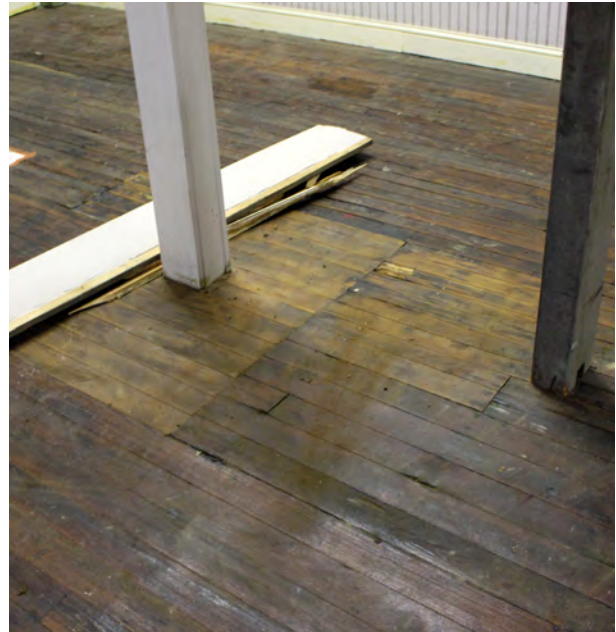
FIGURE 84 Interior, wood plank flooring transition from original construction to south wing.

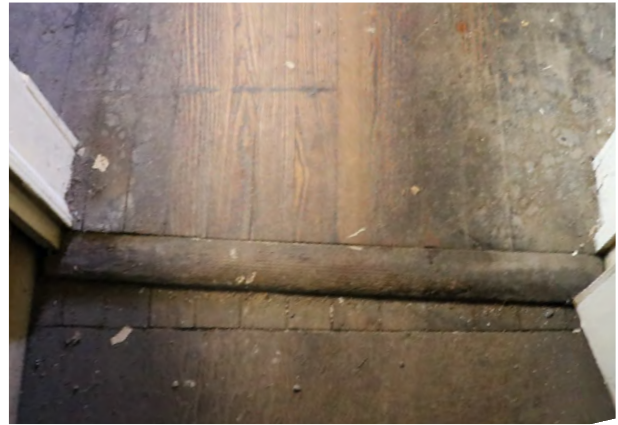
FIGURE 85 Interior, plywood flooring in north wing at transition to wood plank in office.

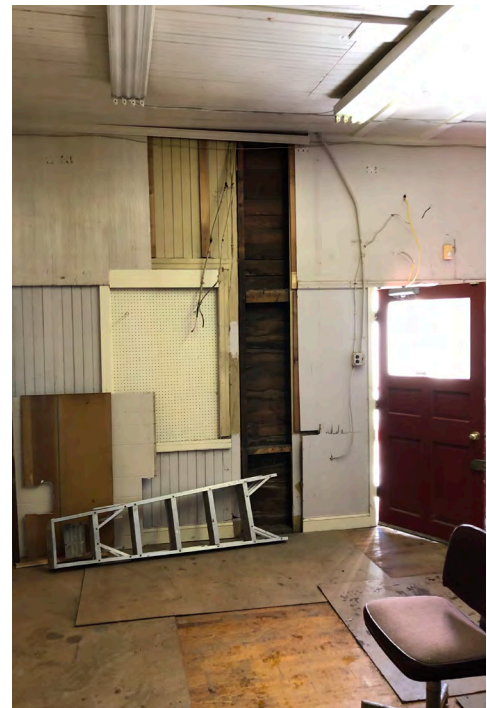
FIGURE 87 Interior, various layers of wall cladding materials revealed during exploratory demolition.

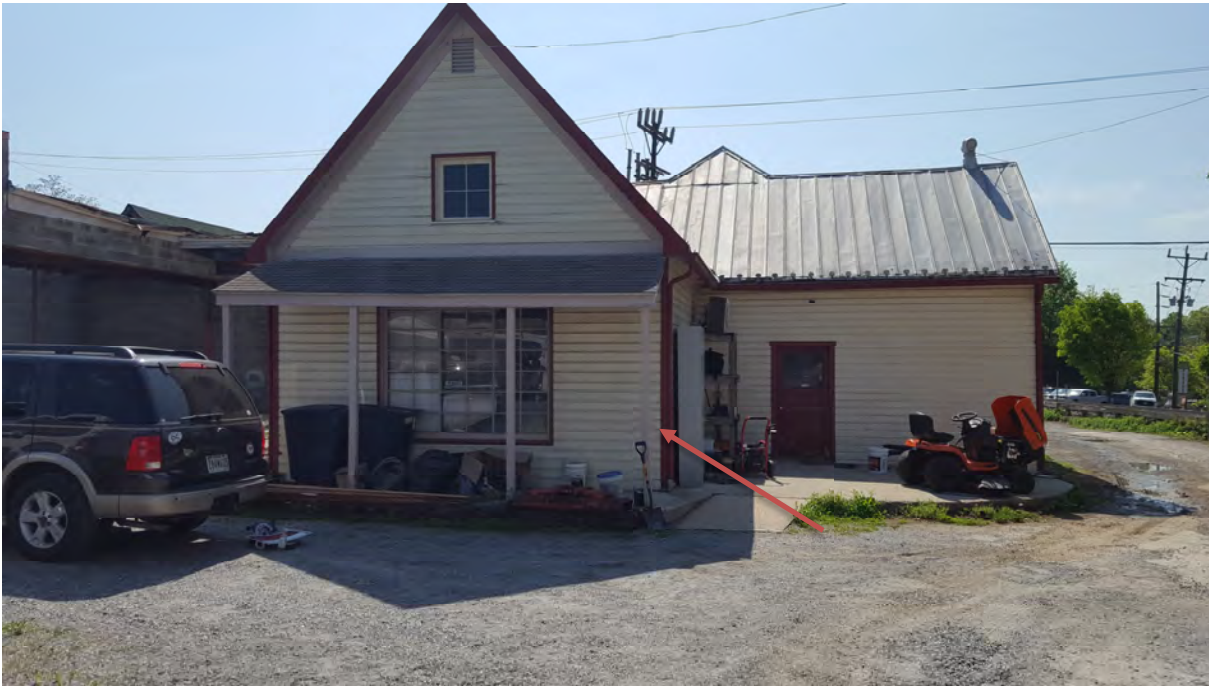
3. West Elevation (Note addition built in 1980s)

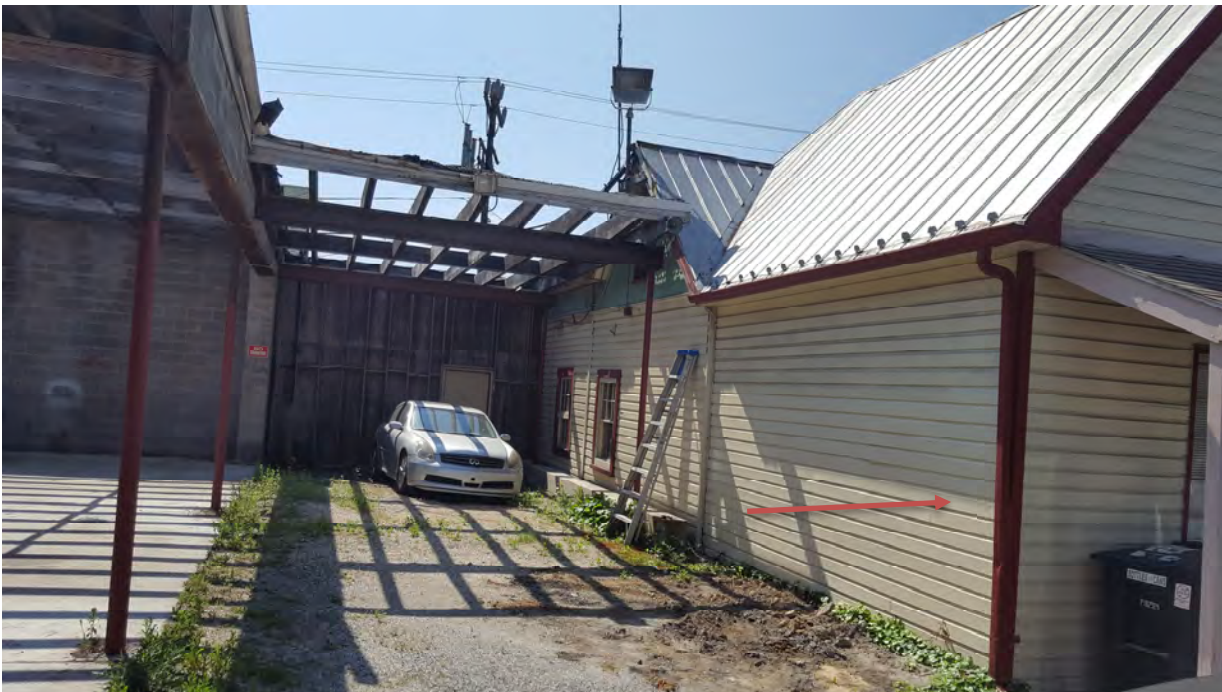
4. North Elevation (note addition built in the 1980s)

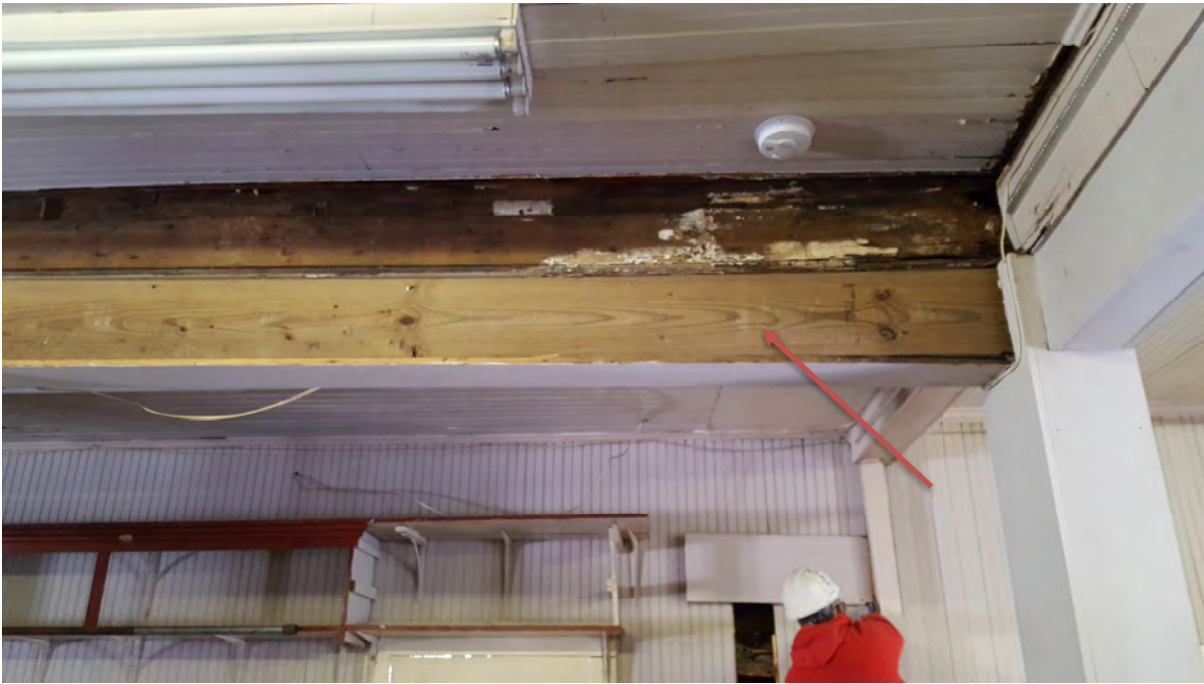
15. New wood beam placed below deteriorated wood beam on south wing of building.

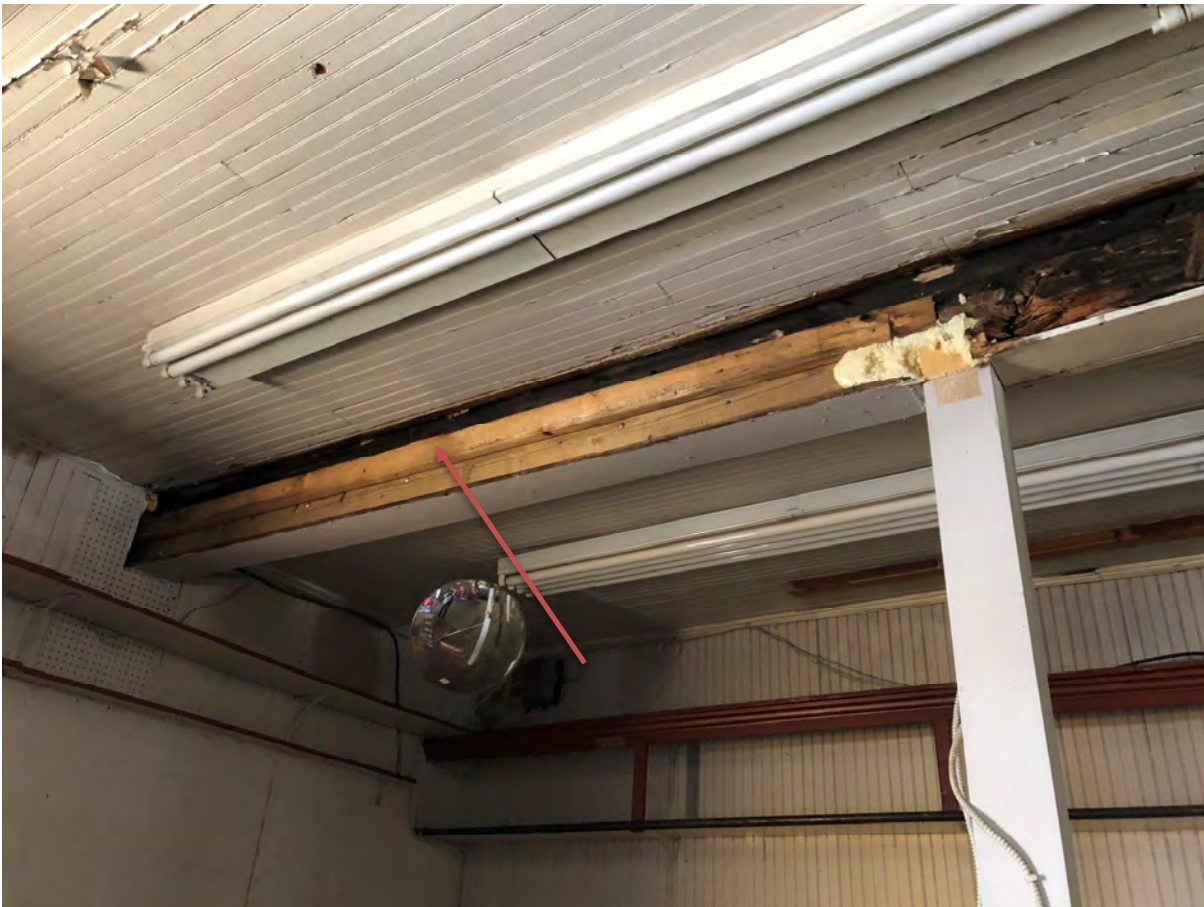
16. New wood beam placed at south wing of building.

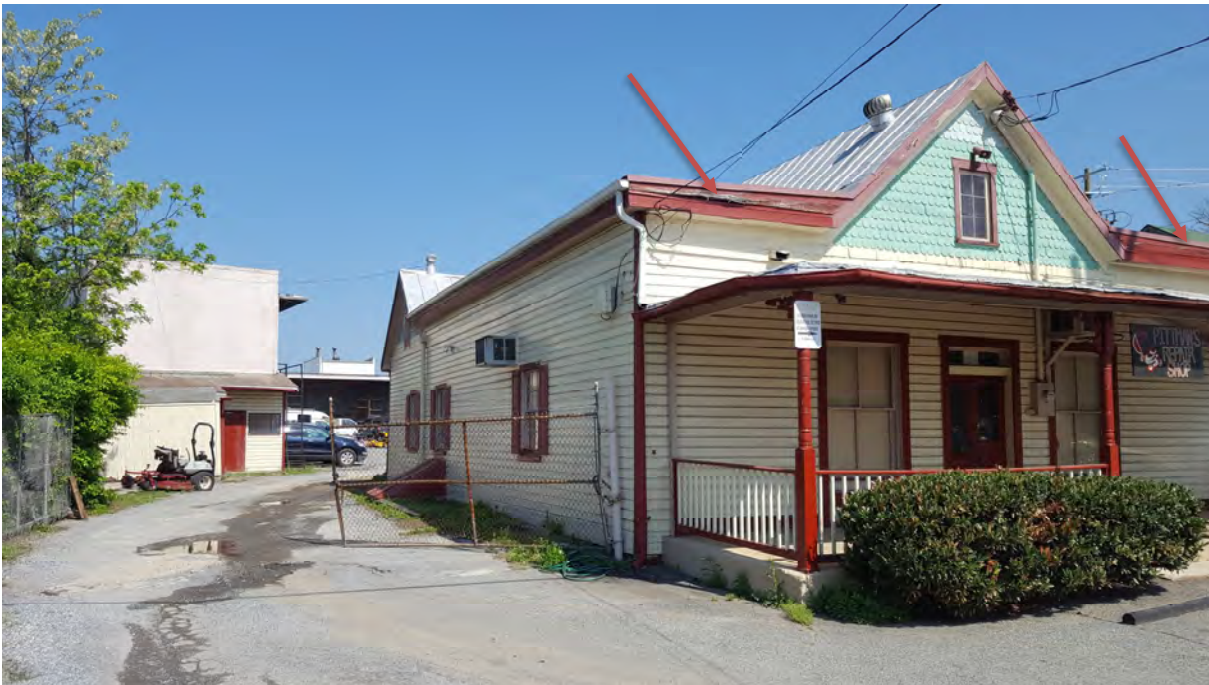
22. Low roof framing appears to have been over-built over existing roof framing on north and south wings of building.

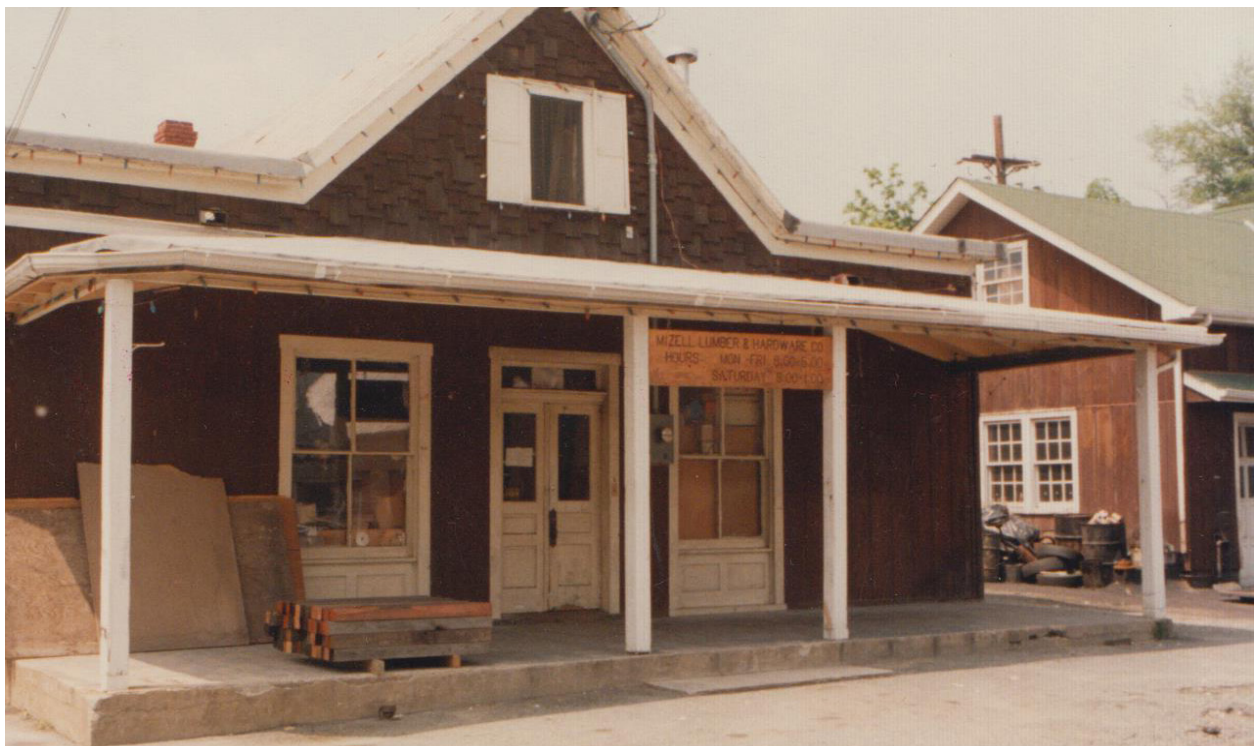
FIGURE 11 Partial view of 10520 St. Paul Street. Vertical siding and shed-roof canopy visible. E. Pen Stephens, 1983, Kensington Historical Society.

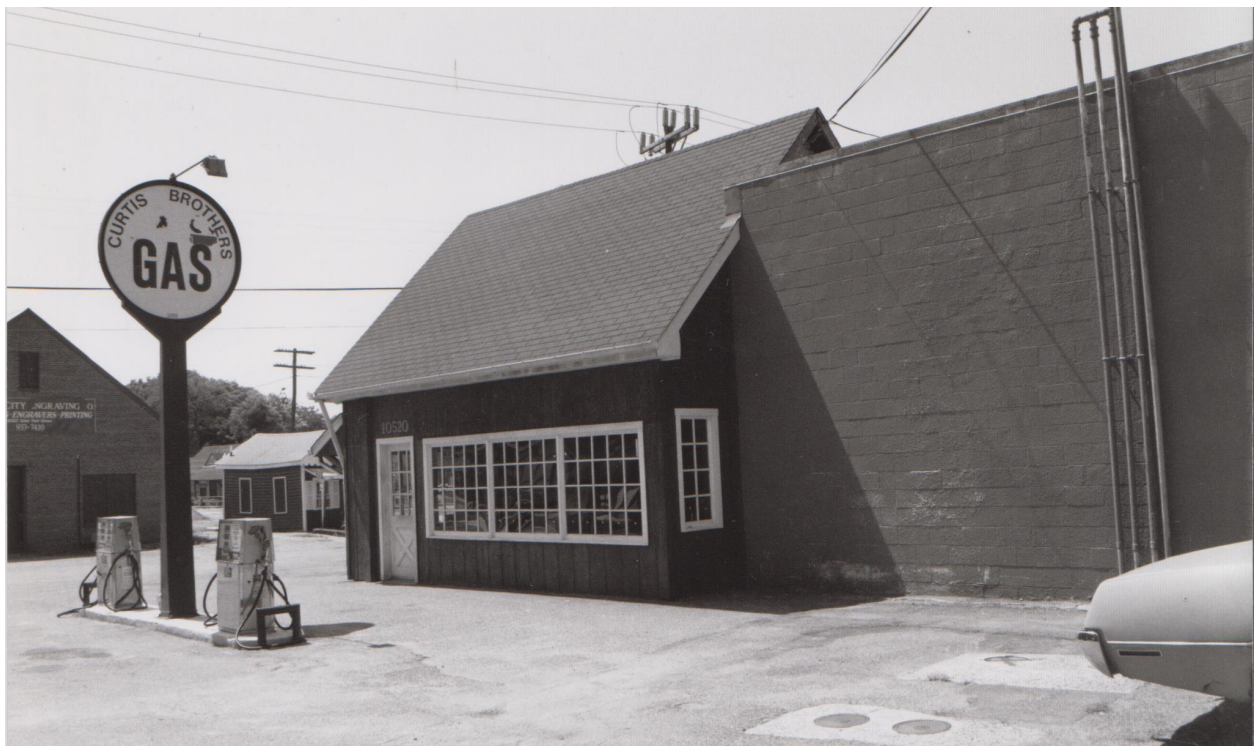
FIGURE 13 10520 St. Paul Street, looking southeast from Metropolitan Avenue. Non-original eight-light fixed window and concrete block shed visible. . EHT Traceries, July 1993.

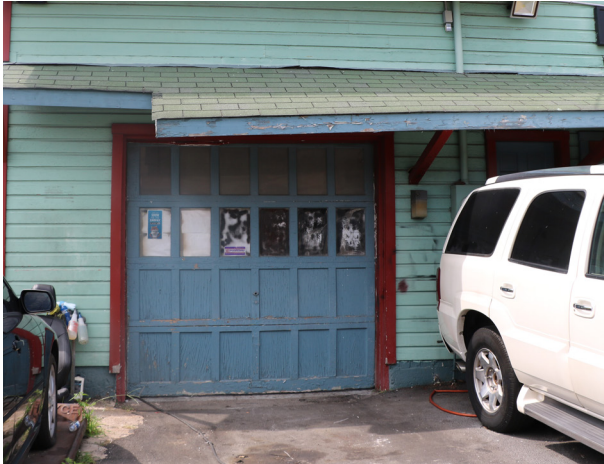
FIGURE 15 Garage door, east elevation.

The two entry doors do not appear to be original and are in good condition. The wood garage door is in fair condition exhibiting some deterioration including peeling and flaking paint.

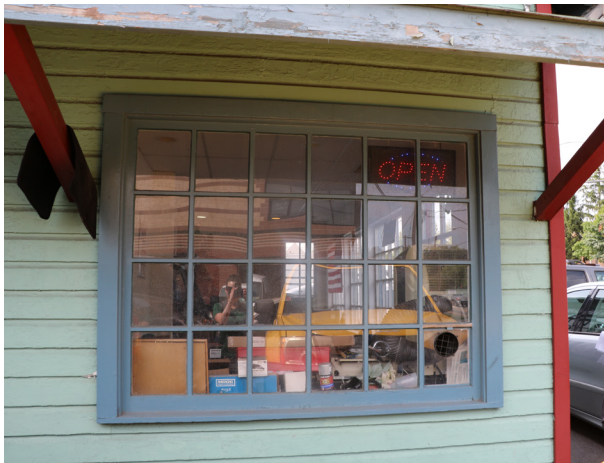
FIGURE 16 Non-original multi-light window, east elevation.

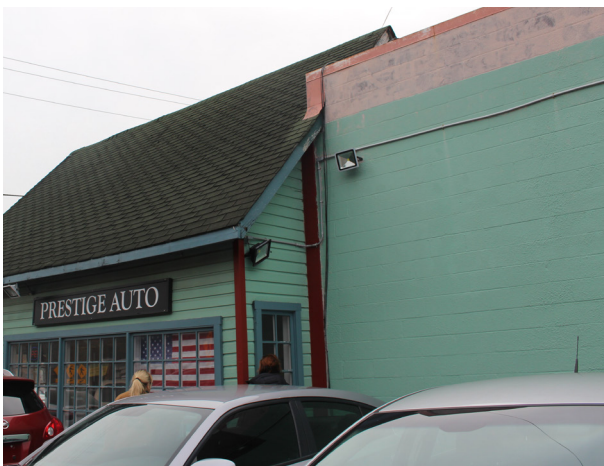
FIGURE 17 Partial and obstructed view with non-contributing concrete block shed, looking southeast.

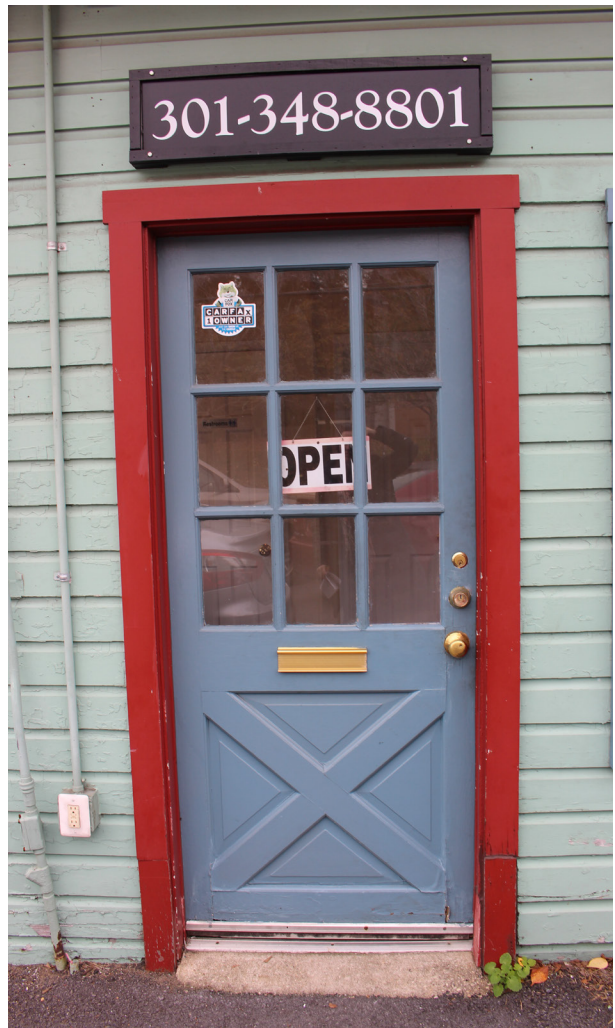
FIGURE 19 Primary entrance, north elevation.

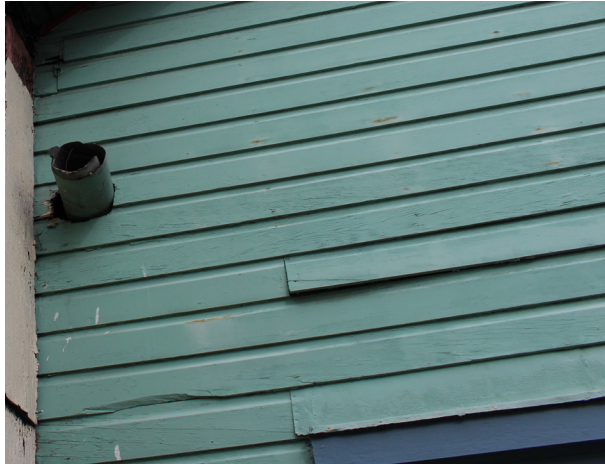
Wood Siding - The painted exterior wood cladding is in overall fair condition, exhibiting some deterioration including warped or missing boards, peeling and flaking paint, areas of wood rot, and termite damage. Damage to wood siding is especially prevalent at the ground level. Much of the painted wood trim appears to have been replaced and is in fair condition. The fascia and vergeboard at the roofline is also very deteriorated. Miscellaneous equipment including electrical conduit has been attached to the exterior walls.

FIGURE 20 Detail, wood siding, loose boards.

- Removal of the concrete block wall and structure at the west elevation;
- Rehabilitation of the building's exterior focusing on the repair and retention of historic fabric including repair of German lap siding, windows, and doors, and in-kind replacement where required;
- New construction of a hyphen/connector and rear addition joining the two historic buildings with the proposed new construction;
- Removal of the building's non-historic interiors to meet needs of future uses;
- Minor alterations to site hardscape elements to comply with accessibility and project requirements;
- Replacement and installation of new mechanical, electrical, and plumbing systems.

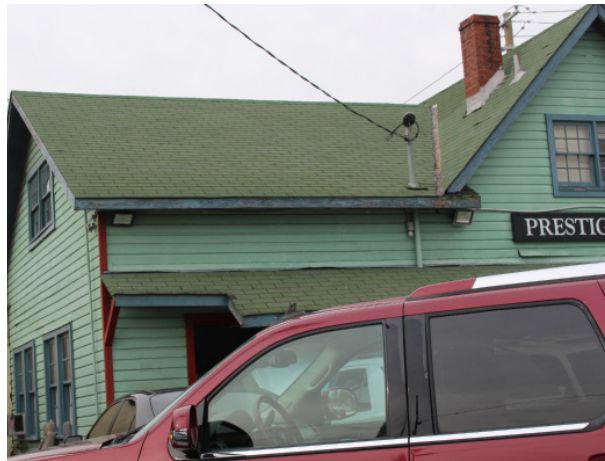
Roof - The asphalt shingle roof appears to be in fair condition. The shed roof canopy on the east elevation, however, is damaged and is sagging.

FIGURE 21 Asphalt shingle roof appears to be in generally good condition.
