**MONTGOMERY COUNTY HISTORIC PRESERVATION COMMISSION**  
**STAFF REPORT**

| <b>Address:</b> | 19811 Darnestown Road, Beallsville | <b>Meeting Date:</b> | 11/12/2025 |
| <b>Resource:</b> | Darby House<br>Beallsville Historic District | <b>Report Date:</b> | 11/5/2025 |
| <b>Proposal:</b> | Demolition of accessory structure and construction of new shed. | | |

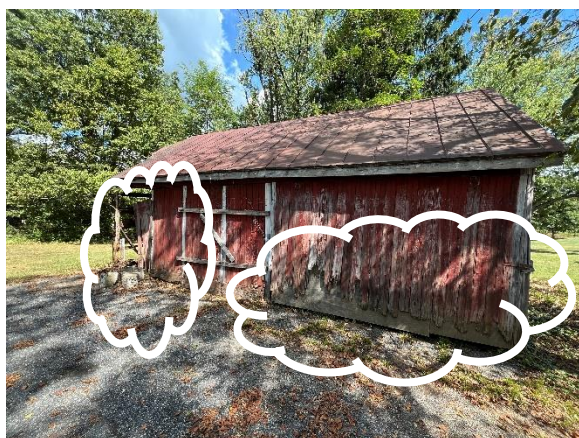
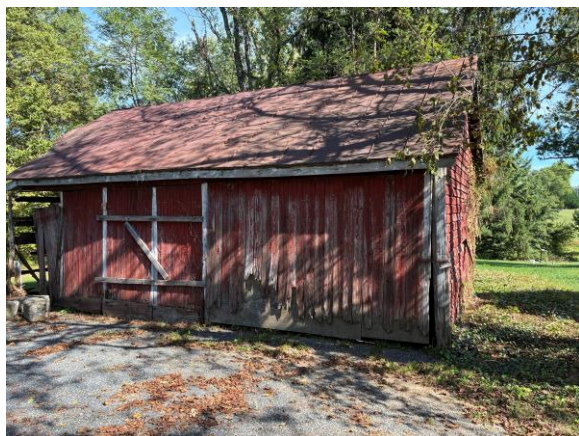
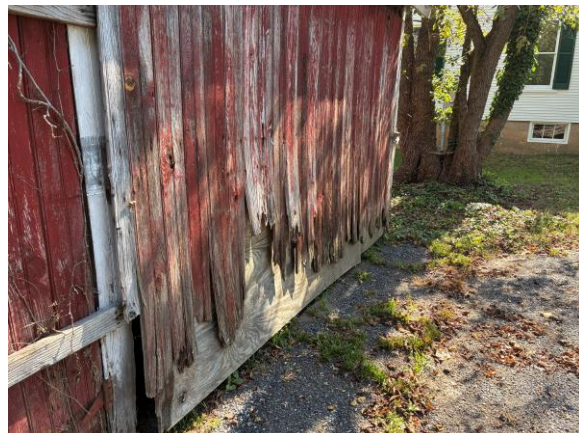
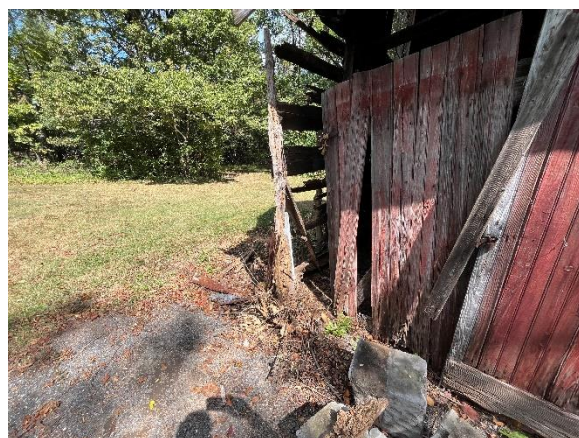
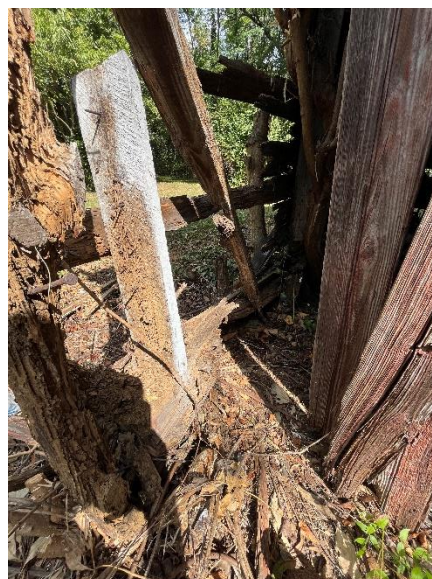
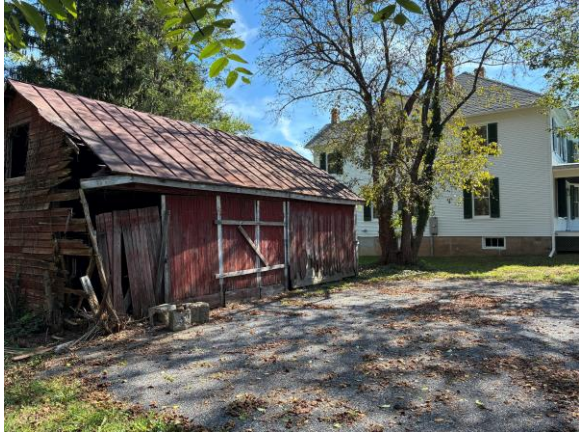
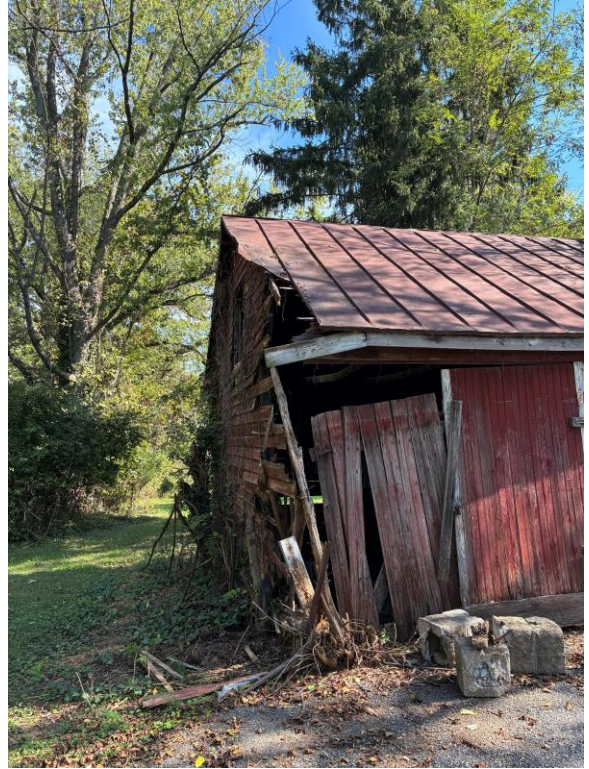
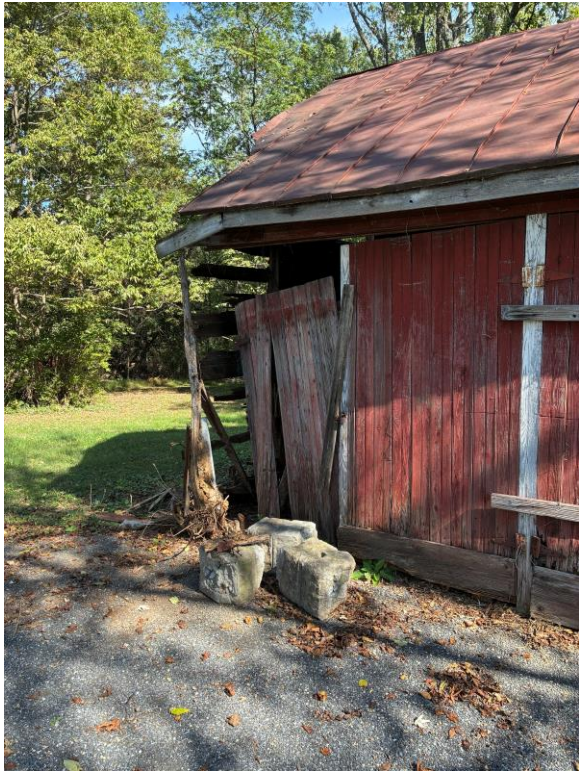
Note deterioration to sliding garage door. Boards are deteriorated; plywood added to rear for stability.

Note structural damage at southwest corner of front elevation: corner post and studs are missing, and roof is unsupported; sill is rotted.

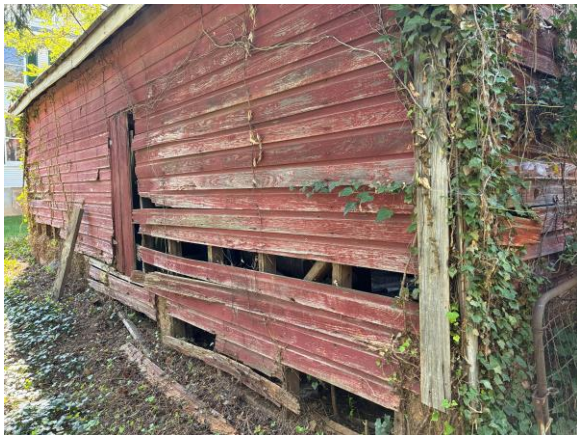
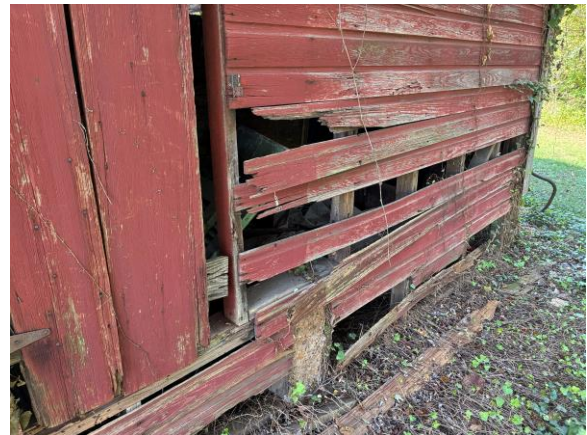
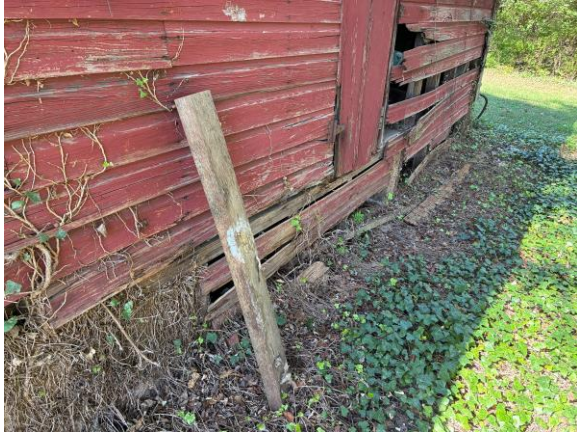
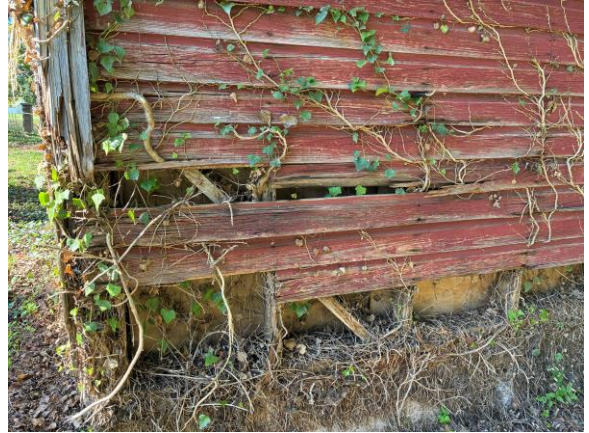
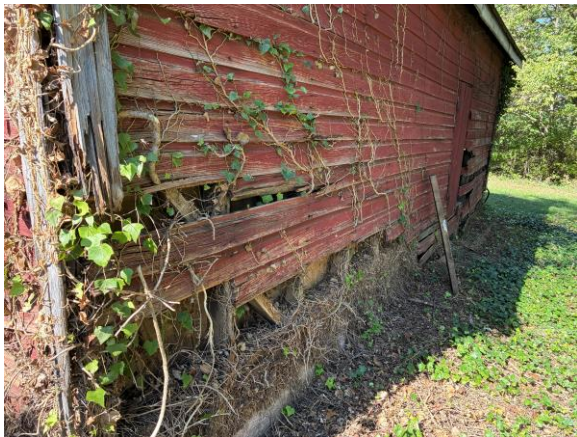
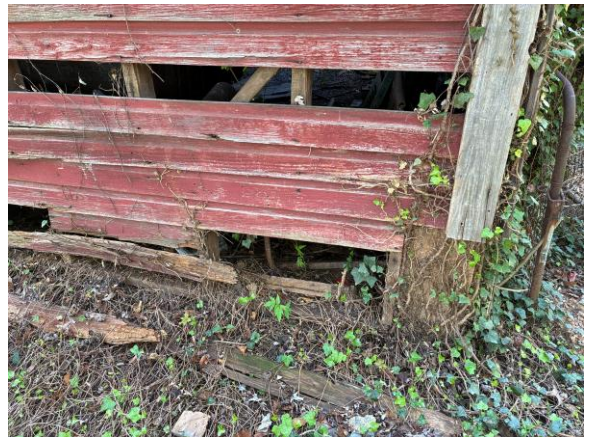
**Rear (north) elevation:**

Note missing and deteriorated siding, rotten sill

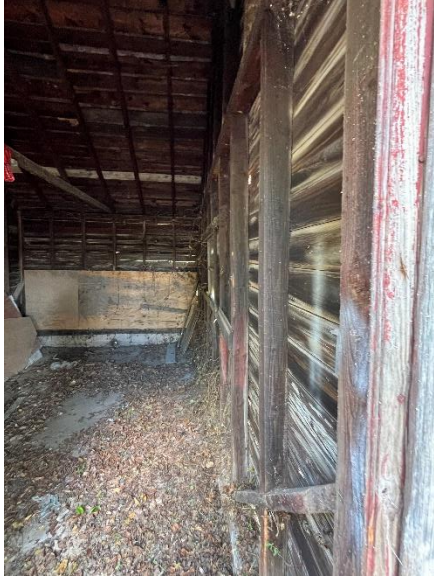
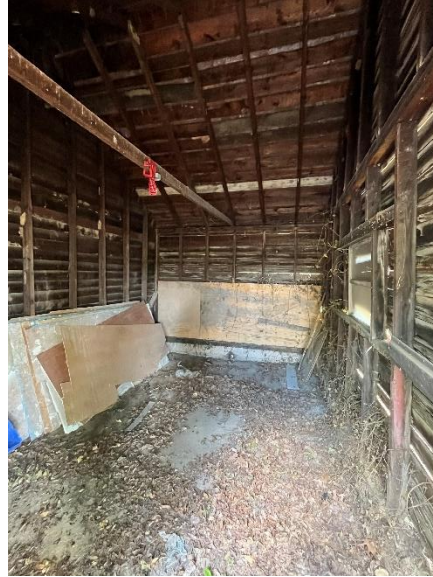
View of right (east) bay showing right side (east) and rear (north) elevations

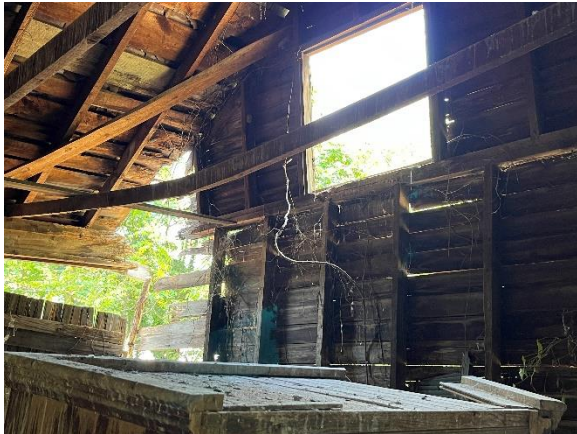
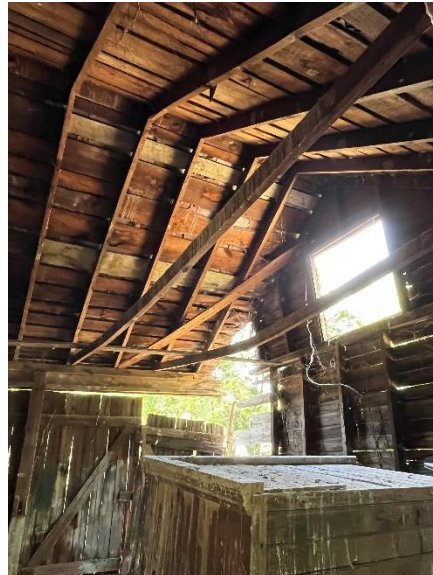
View of left (west) bay showing left side (west) and front (south) elevations

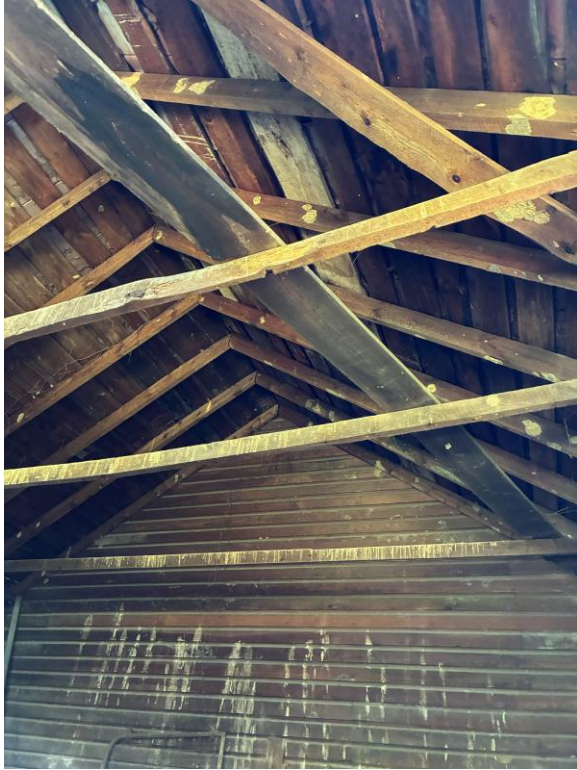
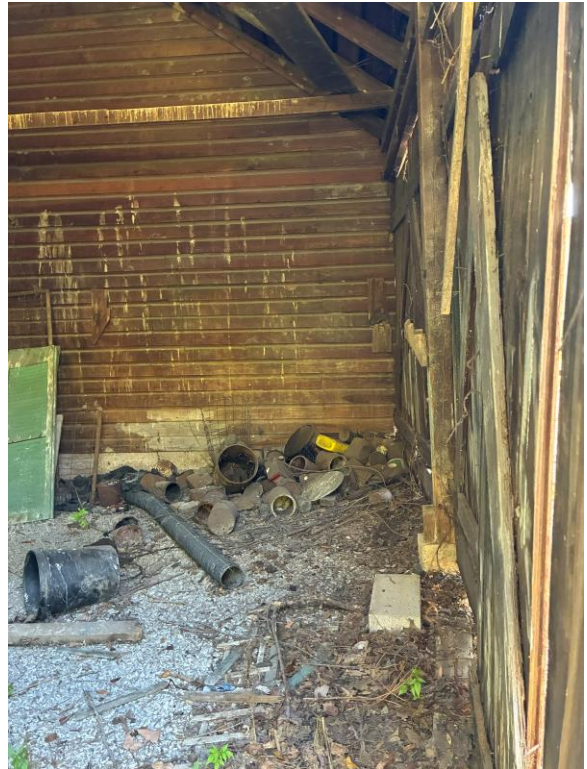
View of left (west) bay looking from southwest corner towards interior partition wall separating the two bays of the garage.

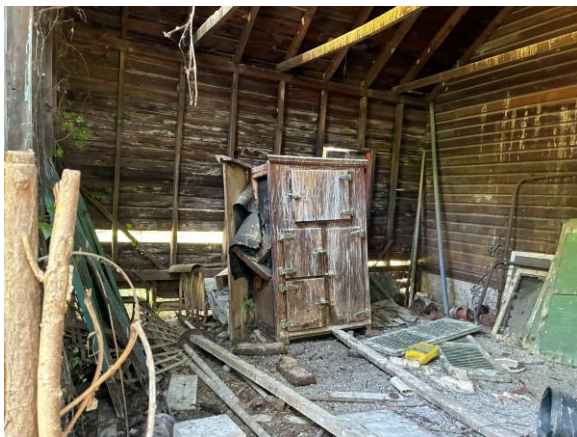
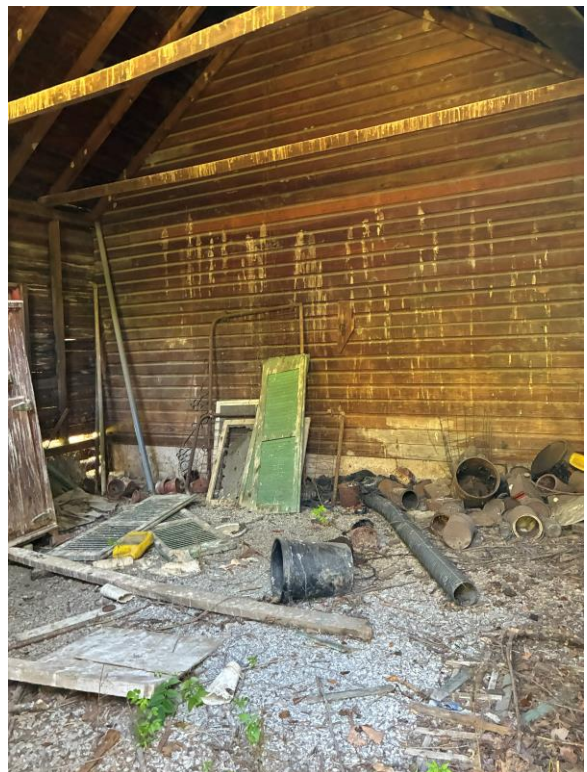
View of west (left) bay looking towards rear (north) wall, with interior partition wall at right
