**MONTGOMERY COUNTY HISTORIC PRESERVATION COMMISSION**  
**STAFF REPORT**

| <b>Address:</b> | 19811 Darnestown Road, Beallsville | <b>Meeting Date:</b> | 11/12/2025 |
| <b>Resource:</b> | Darby House<br>Beallsville Historic District | <b>Report Date:</b> | 11/5/2025 |
| <b>Proposal:</b> | Demolition of accessory structure and construction of new shed. | | |

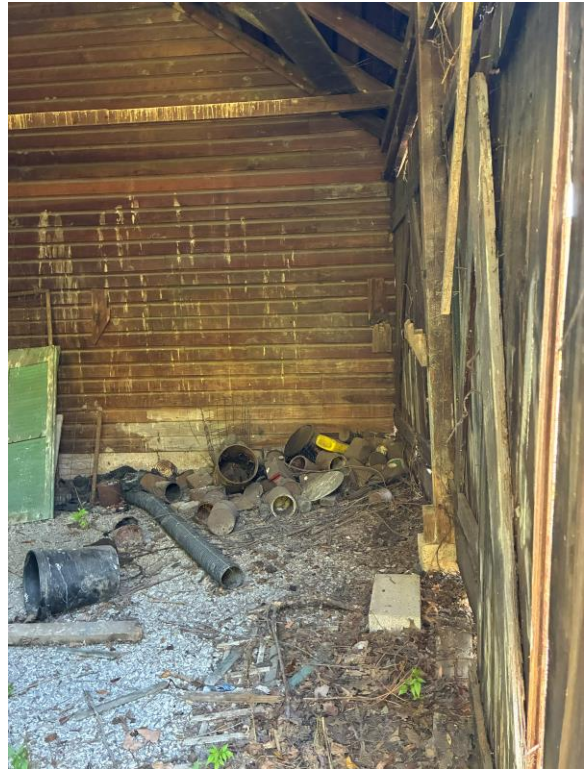
View of left (west) bay looking from southwest corner towards interior partition wall separating the two bays of the garage.

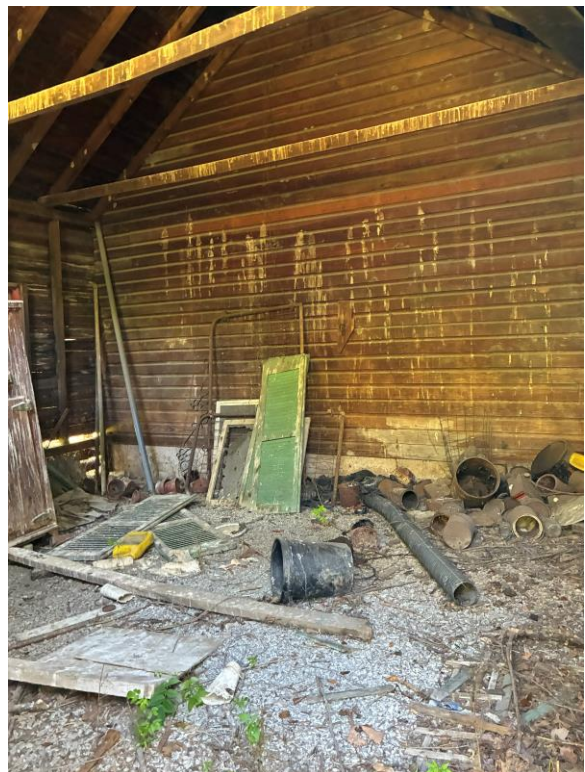
View of west (left) bay looking towards rear (north) wall, with interior partition wall at right

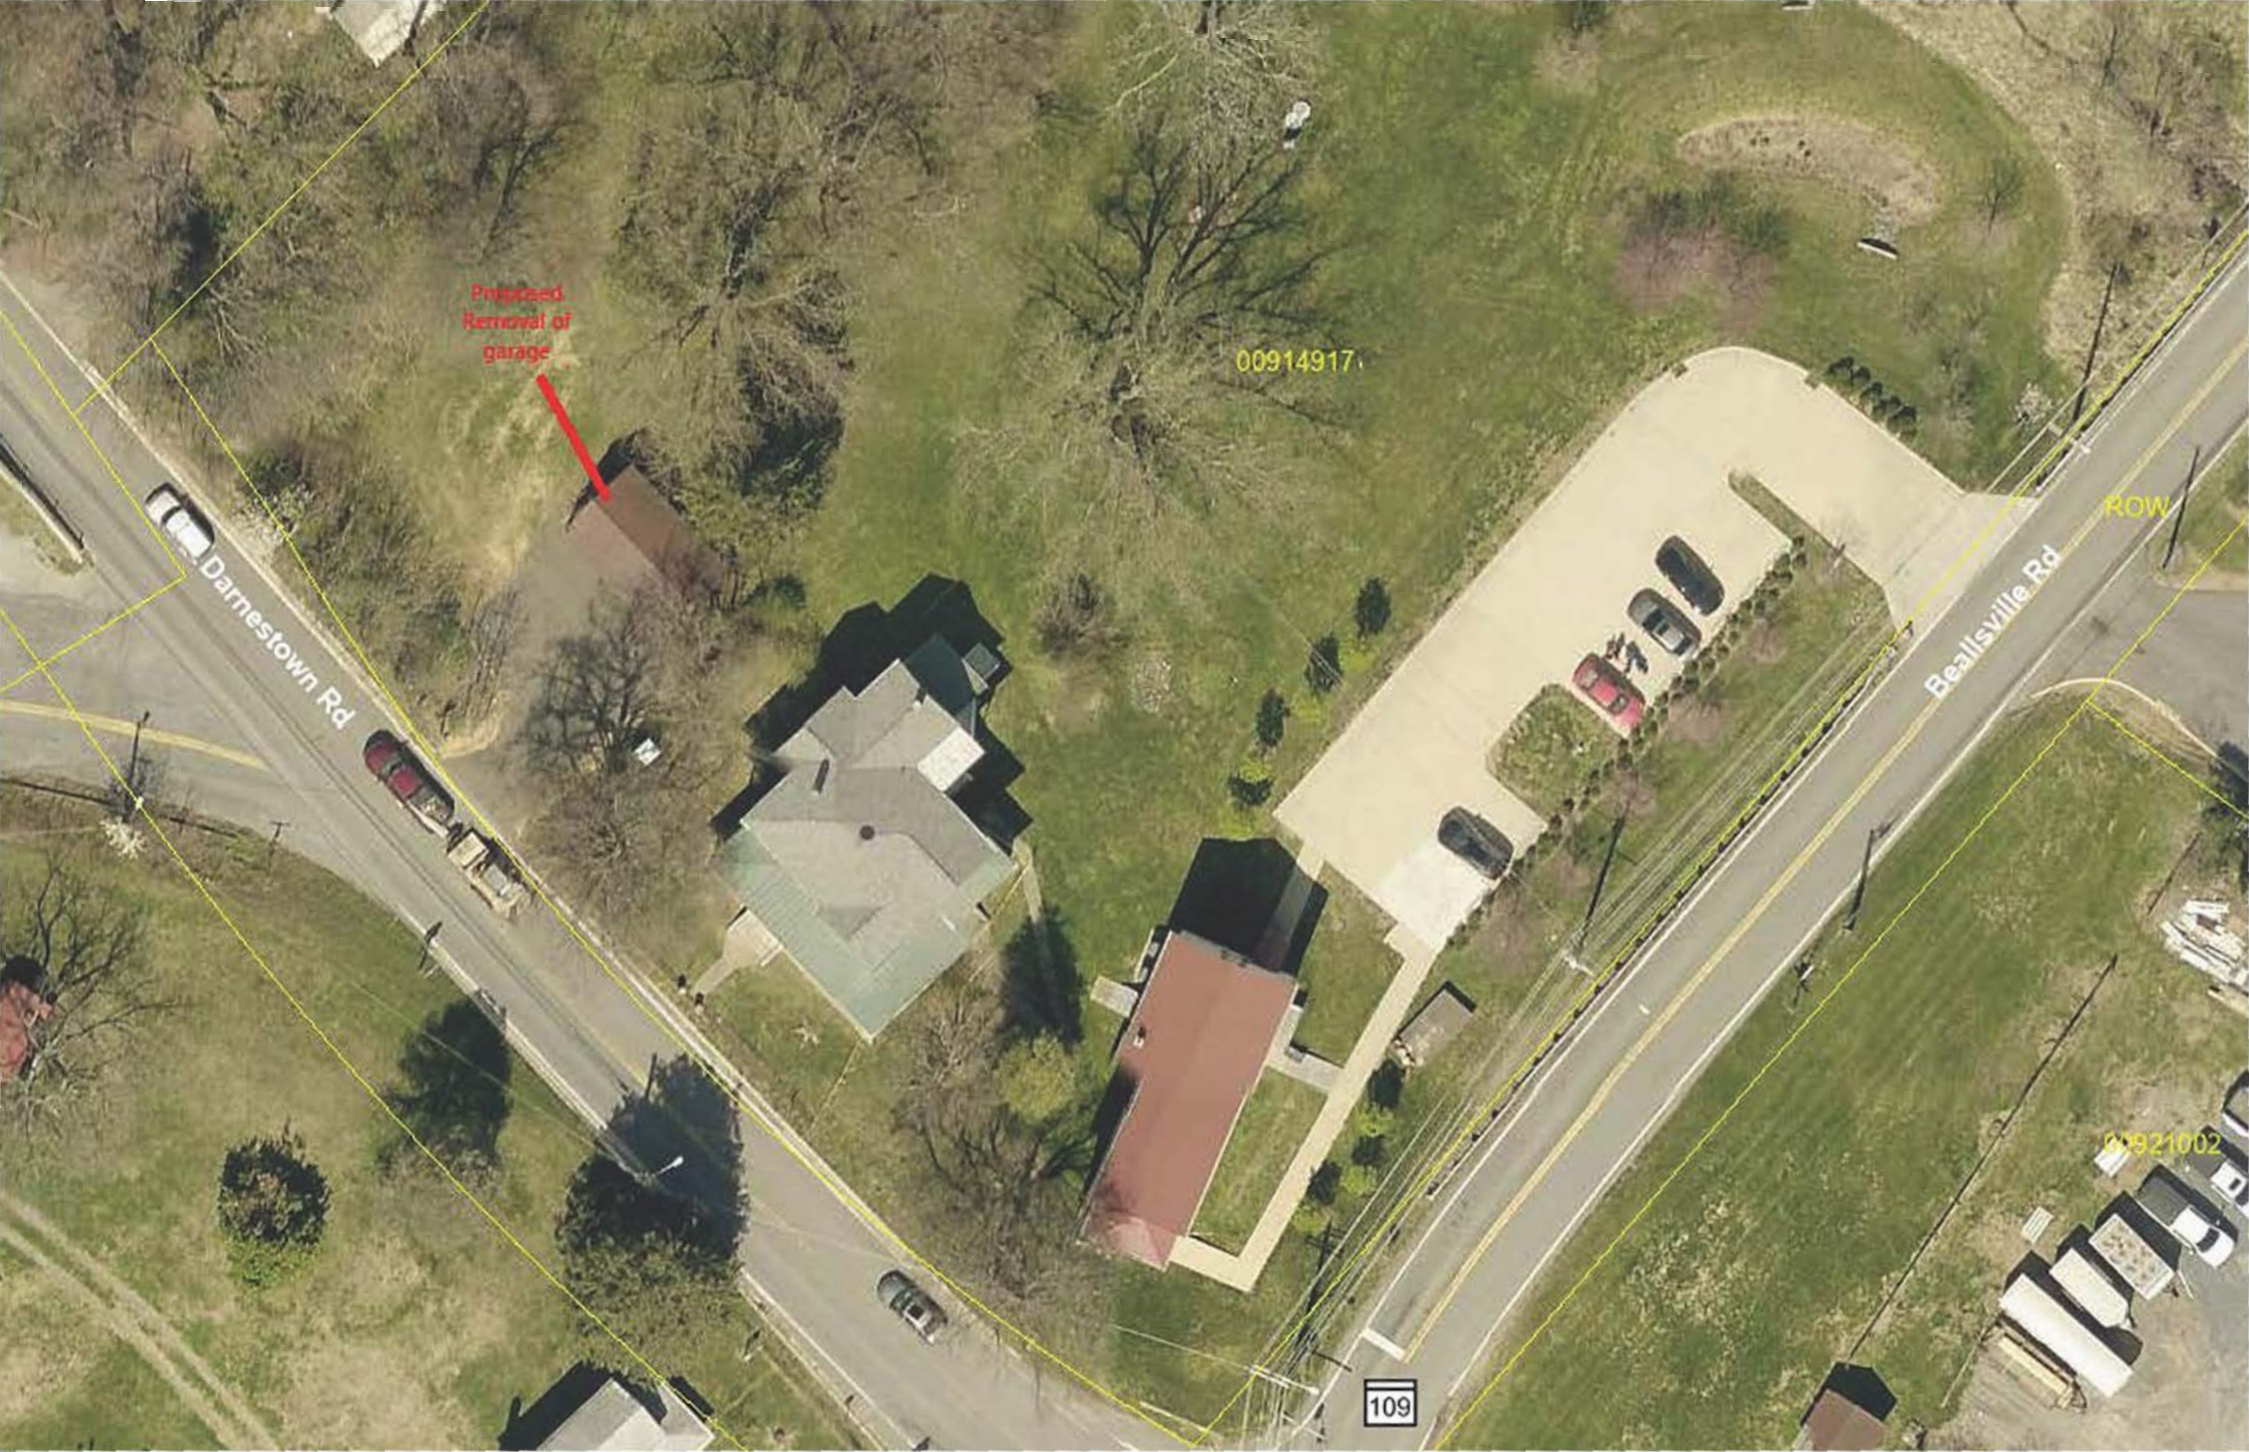
Proposed  
Removal of  
garage

The final work item that needs to be completed before the house can be listed for rent is the demolition of a structurally deteriorate accessory structure that presents an unsafe condition for future tenants. A small yard shed is proposed in the same location, to provide the future tenant with a secured location to store a lawnmower and other small yard items.
